**Attachment M.1 –
Summary of Testing and Mitigation for Arsenic**

Summary of Testing and Mitigation for Arsenic

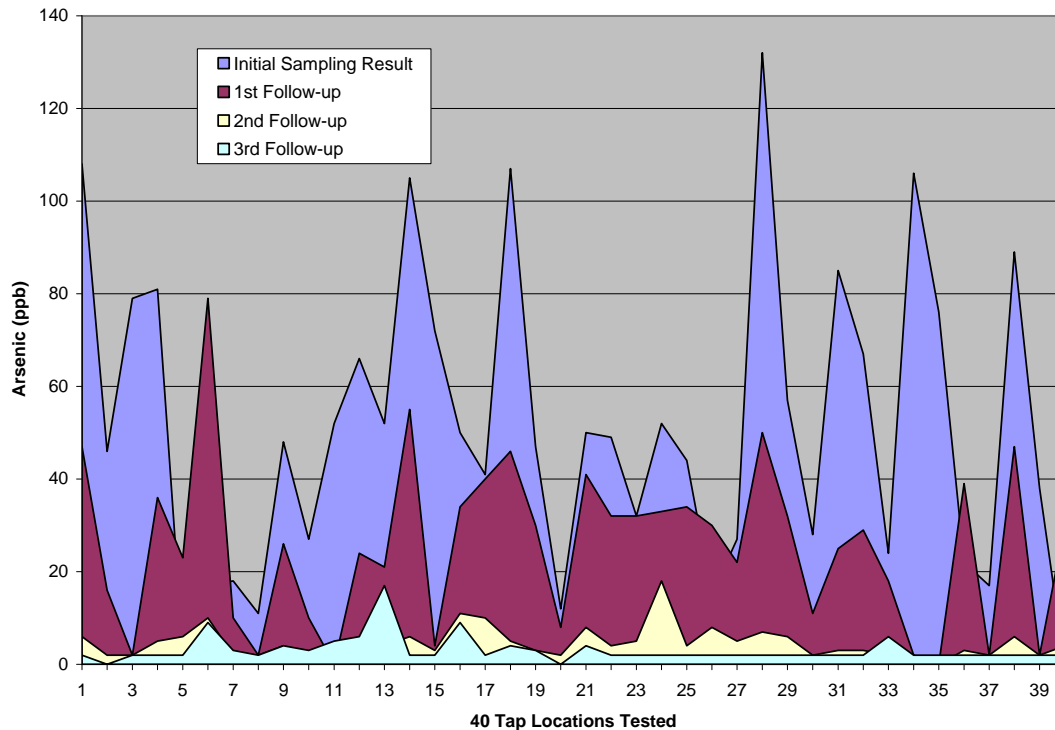
Table 1. Initial Arsenic Testing Results

Two rounds of follow-up sampling for arsenic of the 40 locations were performed in mid-April. Samples in the first round reflected water that had stood stagnant since they were tested in March. After the first round of sampling, the locations were then flushed per standard SPS protocol. The following morning they were sampled again so that the samples collected represented water that had stood for about 24 hours. The arsenic results for these 40 sources are shown in Table 1.

Of the 40 sources that had arsenic above 10 ppb in samples collected in March and/or April 2006, the arsenic concentrations in the May testing were less than 2 ppb for all but 10 of these sources, and only one source was above 10 ppb (see Table 1). There were only about 21 sources in 13 schools that had arsenic results above 10 ppb - approximately 0.6% (see Table 2). Of these 21 results, 8 of them were at one school (Denny Middle School). One other school had 2 sources with arsenic above 10 ppb and the rest of the high results were from a single source in a school.
