Seattle Public Schools -
Woodland Park Gravel Lot
1000 N. 50th St.
Seattle, WA 98103
Parcel: 0725049002

Tree Site Map

Grove Analysis

Table of Trees
Woodland Park Gravel Lot, Seattle, WA

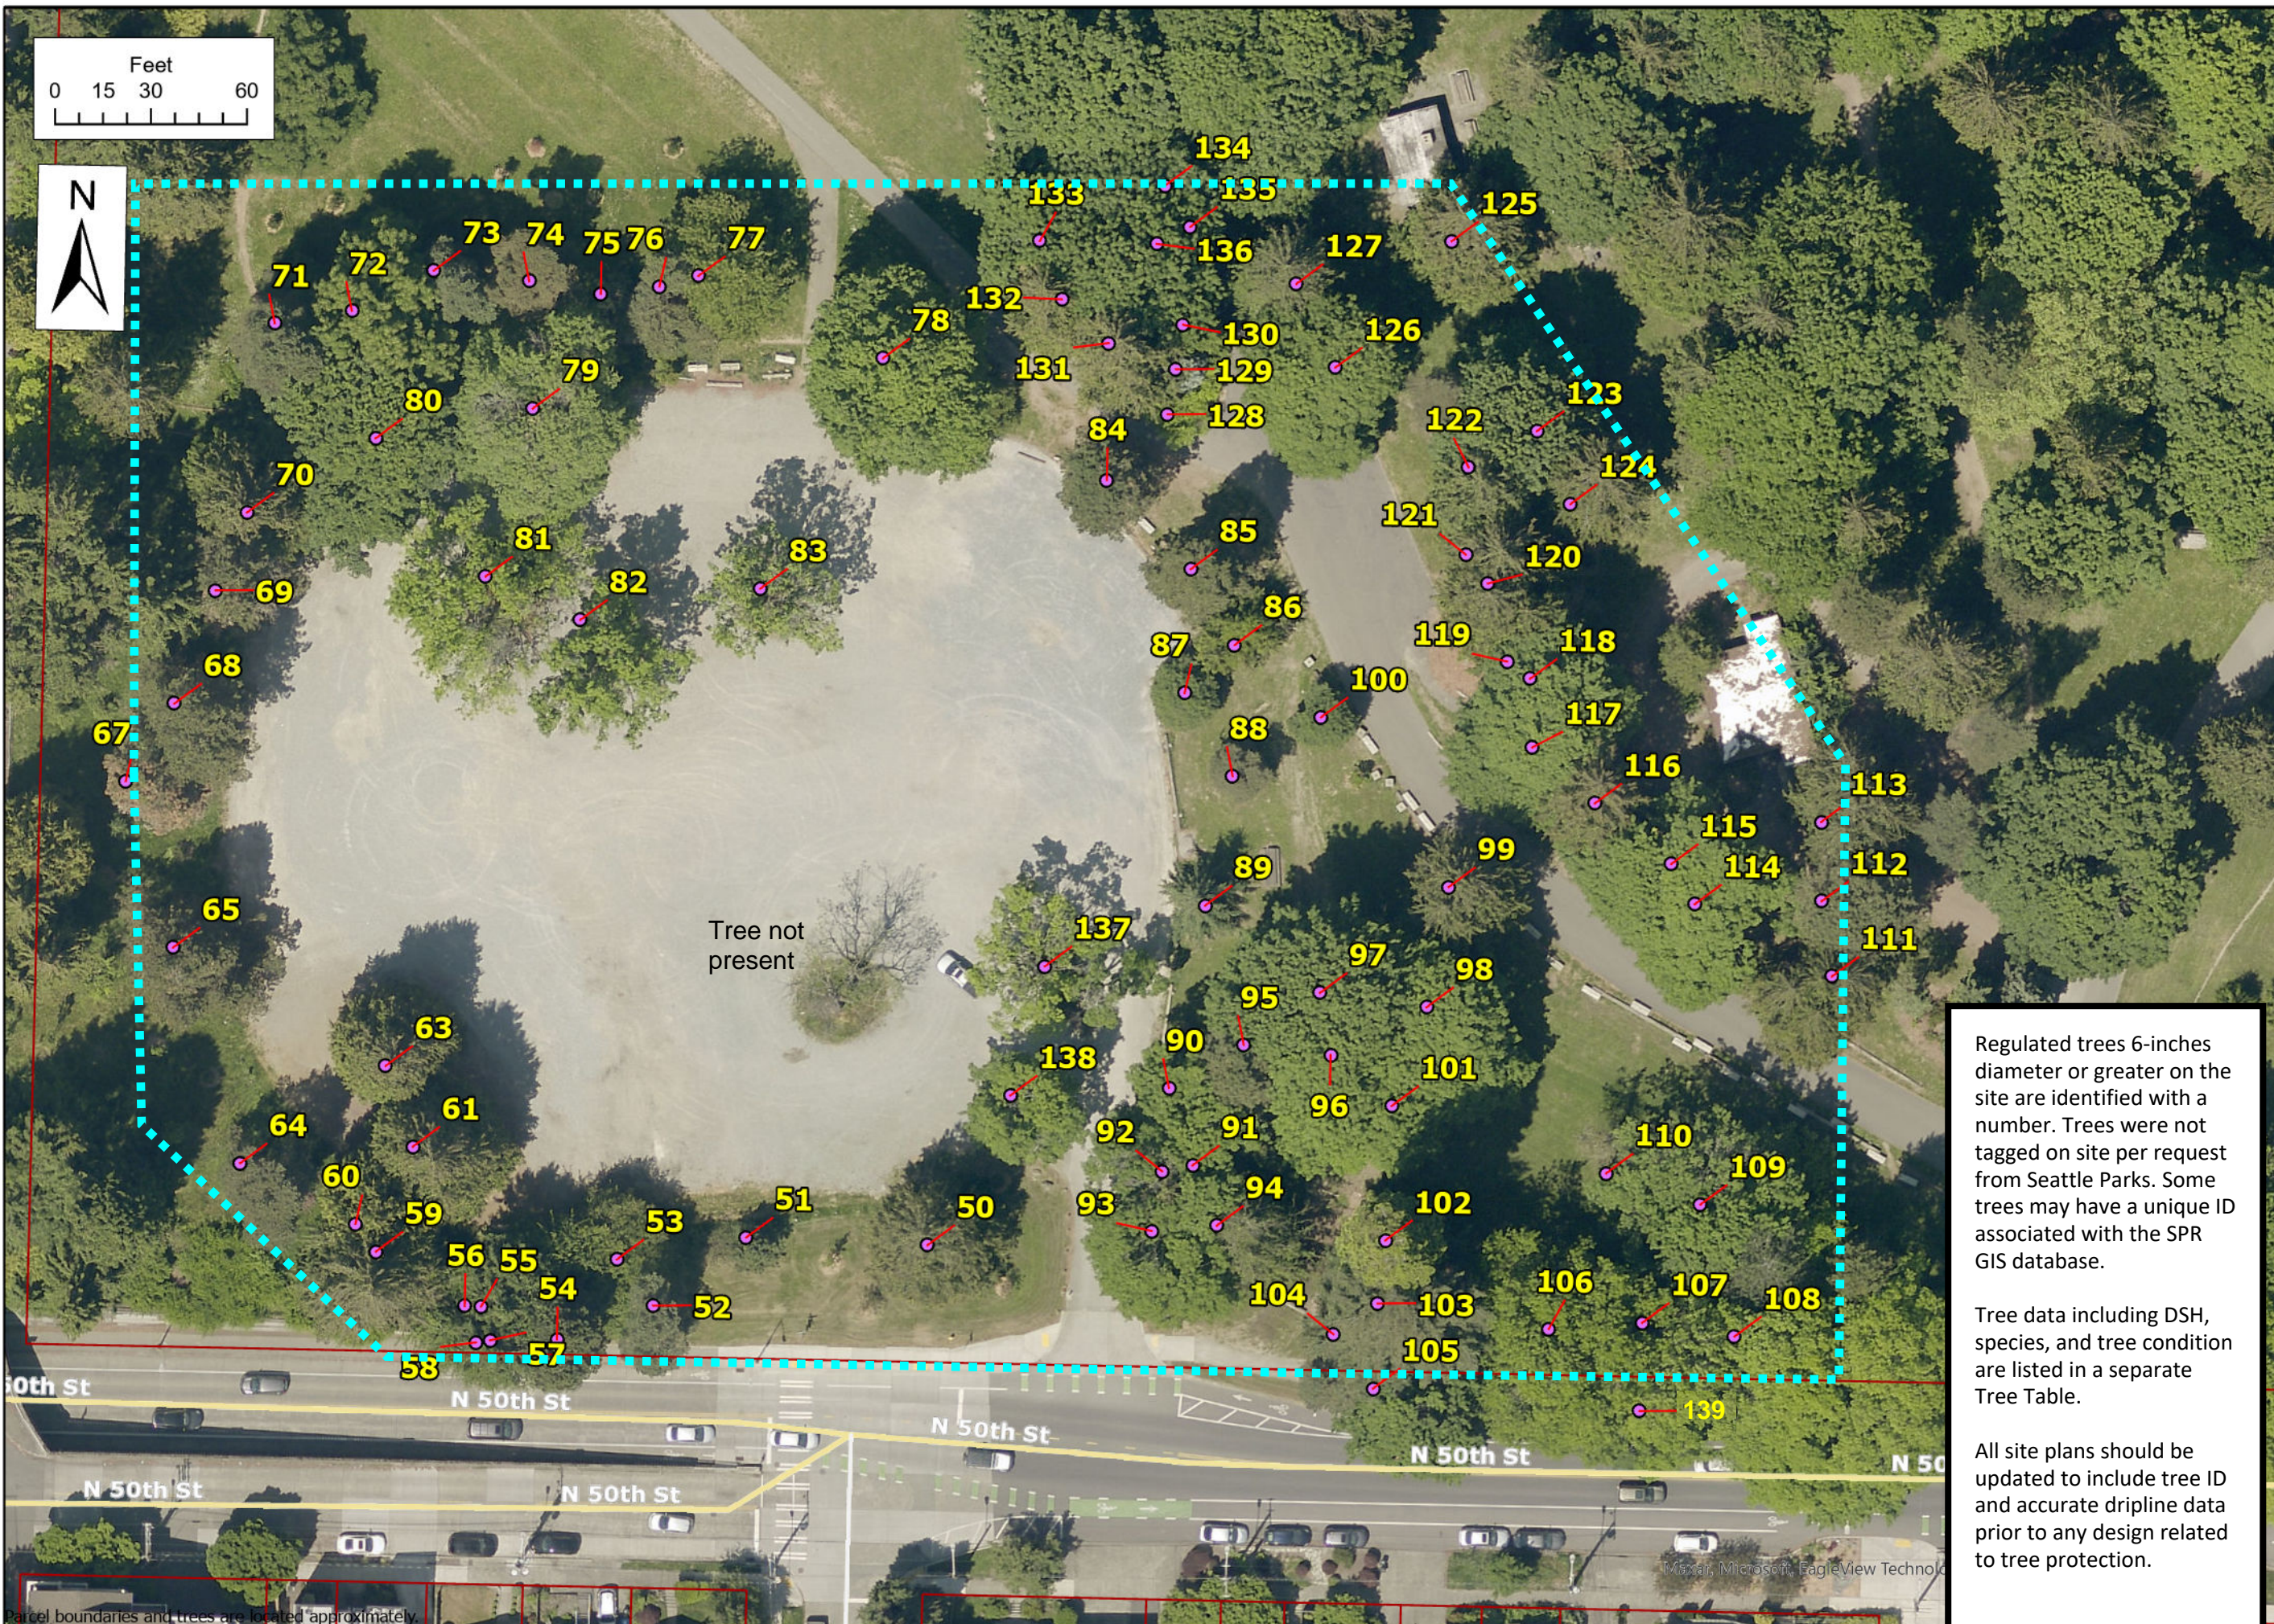
Regulated trees 6-inches diameter or greater on the site are identified with a number. Trees were not tagged on site per request from Seattle Parks. Some trees may have a unique ID associated with the SPR GIS database.

All site plans should be updated to include tree ID and accurate dripline data prior to any design related to tree protection.
