**Attachment R.10 -
Pb Release from New End-Use Plumbing
Components in Seattle Public Schools. Manuscript
submitted to Journal AWWA, 2006 (in review).**

Pb Release from New End-Use Plumbing Components in Seattle Public Schools

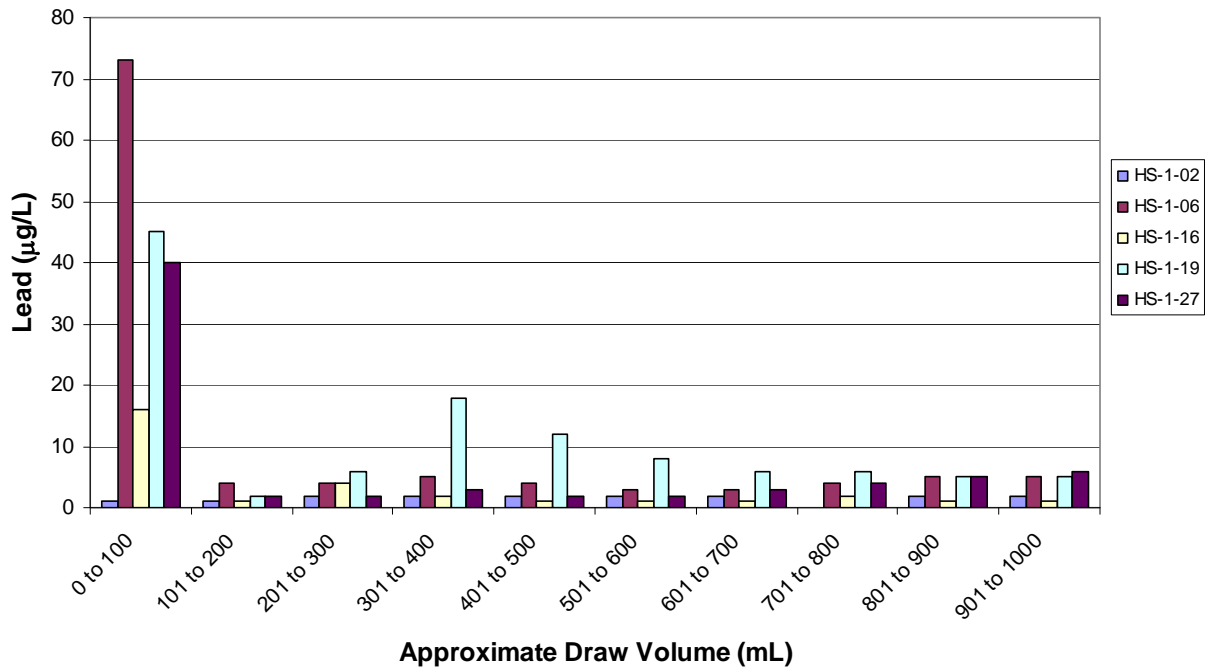
Figure 3. Segmented field sampling results (100-mL samples) for School HS-1.

Figure 3 shows results for 100-mL samples collected at School HS-1. Elevated Pb levels were observed in the first 100-mL samples collected at 4 of the 5 sources (HS-1-02 was the exception). Similar to School E-1, the first samples collected at most sources in HS-1 indicate that components near the exposed end of the source likely contributed lead to the water supply. Elevated Pb levels also were observed in the 3rd or 4th 100-ml samples (cumulative volume of 300-400 mL), which is consistent with observations of elevated Pb levels associated with the same cumulative volume of drawn water at E-1. However, at HS-1 the magnitude of the secondary Pb concentration was not as pronounced as observed by collecting 50-mL samples at E-1. Nonetheless, these results indicate that secondary sources (e.g., brass in components) likely contributed to elevated Pb levels in most sources at HS-1.

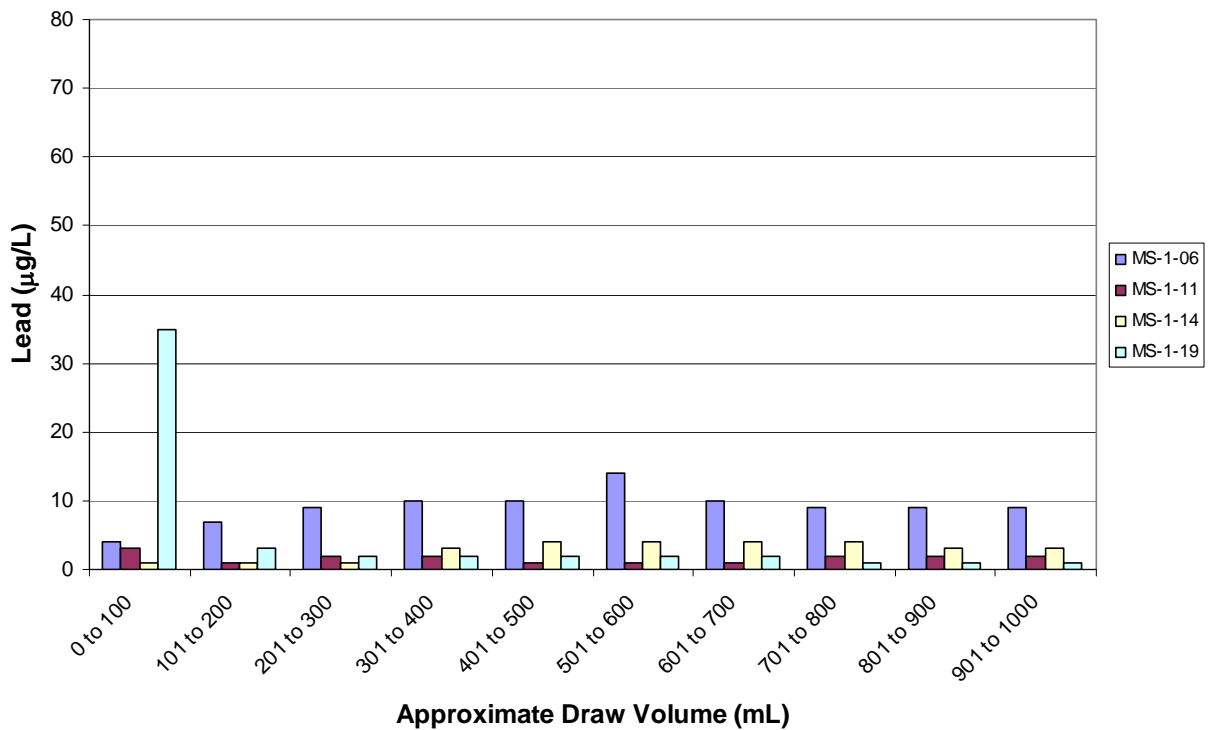
Figure 4. Segmented field sampling results (100-mL samples) for School MS-1.

Figure 4 shows results for 100-mL samples collected at School MS-1. For samples collected at this school, only 1 out of the total of 4 sources (MS-1-9) exhibited a markedly greater Pb concentration in the first 100-mL sample compared to the following samples. These data indicate that most of the end-use plumbing at the exposed end of the source at this school likely did not contain components that were releasing elevated levels of Pb to the water supply. Two of the sources (MS-1-06 and MS-1-14) exhibited a weak peaking trend in subsequent samples, which likely indicated a secondary source of lead.

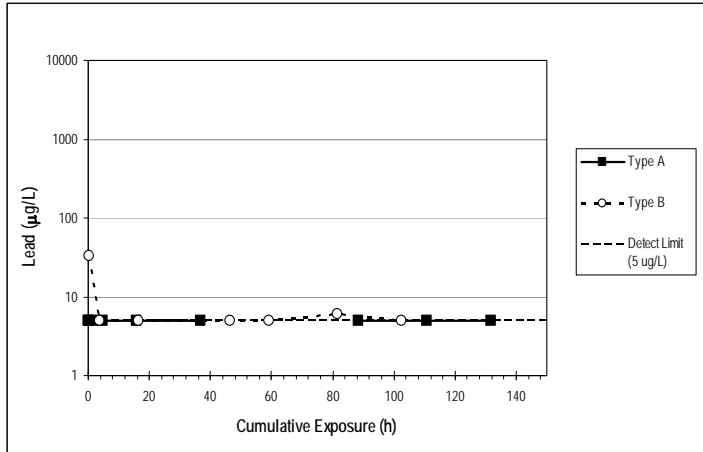
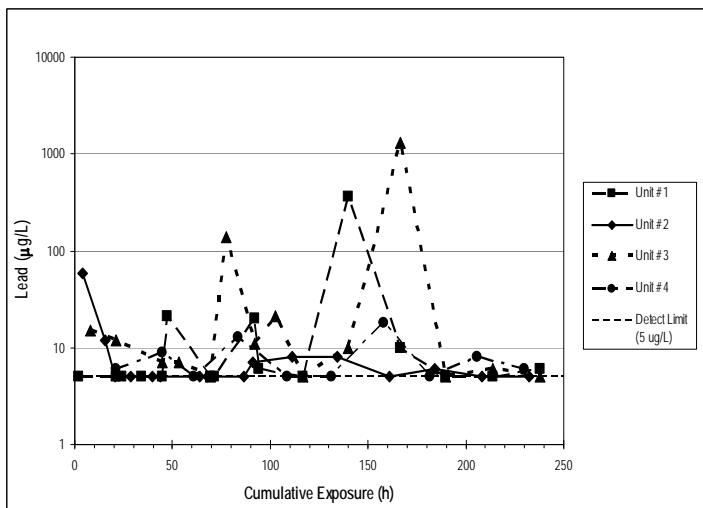
Figure 6. Lead concentration in tap water as a function of cumulative exposure of bubbler heads to tap water during (a) flow-through testing (Type A and Type B bubbler heads) and (b) stagnation testing (Type A bubbler head tested in quadruplicate). (c) Bubbler head with valve held opened during flow-through testing.

Laboratory Testing Results. Pb concentrations are shown in Figure 6 for two types of low-lead bubbler heads typically installed at drinking water fountains in Seattle Public Schools. Results of “flow-through” testing on one of each type of bubbler head (identified as Type A and Type B) are shown as a function of cumulative exposure to tap water in Figure 6a. Results of “stagnation” testing conducted in quadruplicate using one type of bubbler head (identified as Type A) are shown in Figure 6b. Both testing procedures yielded elevated Pb levels (33-60 ppb) during initial exposure for both types of bubbler heads. Stagnation testing exhibited periodic spikes in Pb up to 1,300 µg/L for a cumulative exposure period of nearly 200 hours. Flushing and repeated exposure to tap water reduced Pb levels with time and the data generally appeared to approach stabilized lead levels near the detection limit of 5 µg/L at the end of

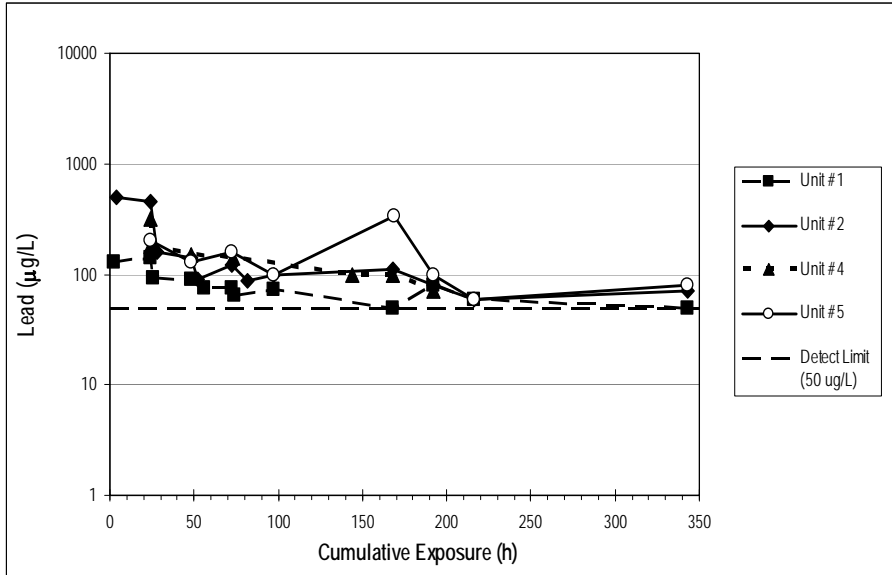
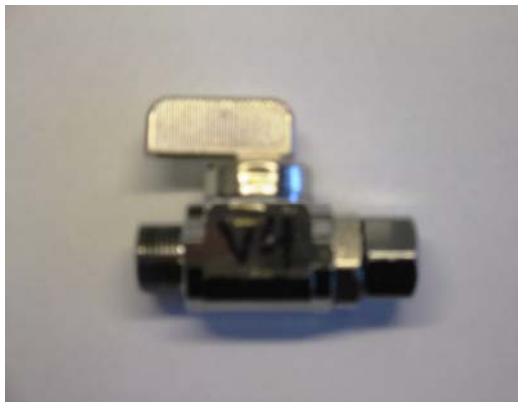
Figure 7. Stagnation testing in quadruplicate of a typical brass shutoff valve. (a) Lead concentration in tap water as a function of cumulative exposure and (b) enlarged view of brass shutoff valve.

Pb results for a brass shutoff valve commonly used in Seattle Public Schools are shown in Figure 7a. The shutoff valve (Figure 7b) was tested in quadruplicate. Results of stagnation testing indicate elevated Pb levels up to 500 µg/L during initial exposure. Some Pb fluctuations and spikes were observed during testing. Due to the small volume of water contained within the valve (~2 mL), the analytical detection limit was 50 µg/L for samples collected during stagnation testing. Overall, Pb levels declined with repeated exposure to a range of 50-80 µg/L after a cumulative exposure of 343 h.

The greatest initial Pb concentration was observed in water exposed to standard brass specimens (~8% Pb by weight) compared to new low-lead or non-leaded brass materials. For example, the initial Pb levels associated with the brass shutoff valves (Figure 7) and elbow connectors (Figure 9) were generally greater than the initial Pb levels in the bubbler heads (Figure 6). The bubbler heads that were tested in this study were reportedly made of new low-lead or non-leaded brass materials and the initial Pb levels were observed to be correspondingly lower than standard brass materials.

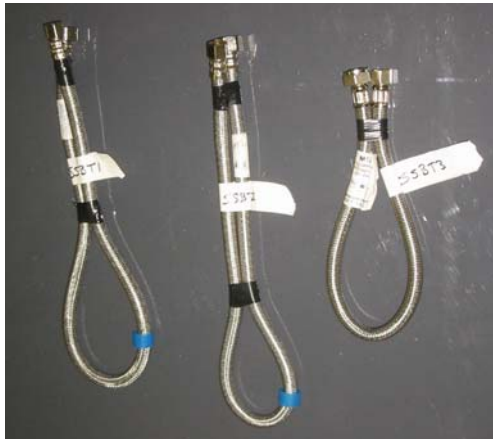
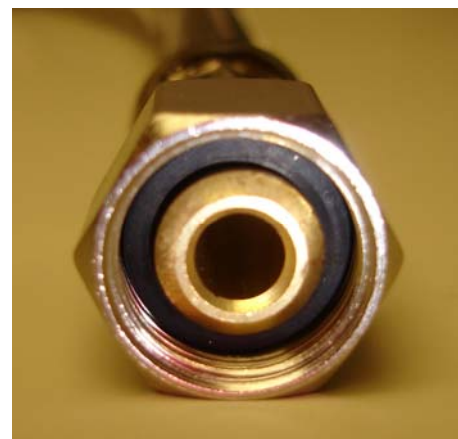
Figure 8. Stagnation testing in triplicate of a flexible connector with brass ferrules at both ends. (a) Pb concentration in tap water as a function of cumulative exposure time, (b) specimens prepared for testing, and (c) enlarged view of brass ferrule at one end of flexible connector.

Figure 8a shows Pb results for an 18-inch (45.7 cm) flexible connector as a function of cumulative exposure to tap water using the stagnation procedure. Testing was conducted in triplicate. This component (Figure 8b) does not contain a mechanical moving part such as a valve. Results indicate elevated Pb levels (68-250 µg/L) during initial exposure time and a gradual decline to 9-29 µg/L after nearly 23 days of cumulative exposure to tap water. The source of lead was attributed to the brass ferrules at both ends of the flexible connector, as shown in Figure 8c.

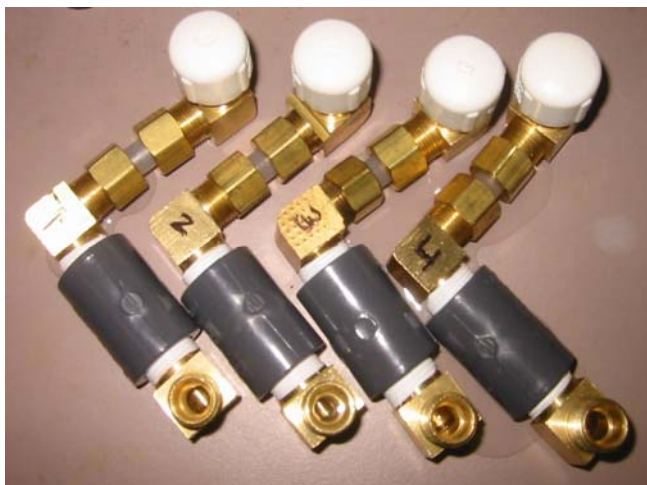
Figure 9. Stagnation testing in quadruplicate of three brass elbows linked together. (a) Lead concentration as a function of cumulative exposure to tap water and (b) specimens prepared for testing.

Pb results are shown in Figure 9a for brass-elbow-connector units as a function of cumulative exposure to tap water. Each test unit was assembled by connecting three brass elbows in series with plastic couplings (Figure 9b). The units were assembled for the purpose of allowing sufficient volume of tap water in contact with the inside of the component. Unit testing was conducted in quadruplicate. Results indicate elevated Pb levels in the range of 770-1,100 µg/L following contact for up to 24 h. With repeated exposures, the lead levels showed some

variability and generally declined to the range of 220-360 µg/L after approximately 6 days of exposure to tap water.
