John Muir Elementary Early Learning Addition Project

Final SEPA Checklist

*Subsurface Exploration, Geologic Hazard,
and Geotechnical Engineering Report*

JOHN MUIR ELEMENTARY SCHOOL EARLY LEARNING ADDITION

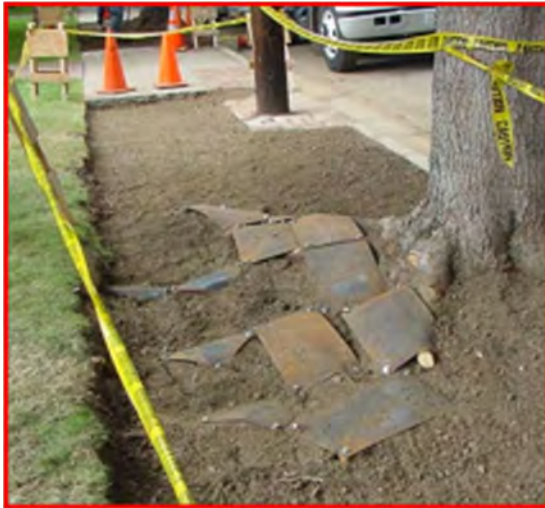
Figure 1. Photo Credit to Gordon Mann. Taken from the Seattle Department of Transportation Trees and Sidewalks Operations Plan ¹

There is the potential for the walkway between the trees to be replaced where it is lifting (Photo 2). Alternative methods should be considered prior to severing the roots. One approach to consider is the use of steel plates over the roots, which will extend the life of the pavement (Figure 1). I have attached a TSI Steel Plate Installation Specification that can be referred to in determining the preferred approach.

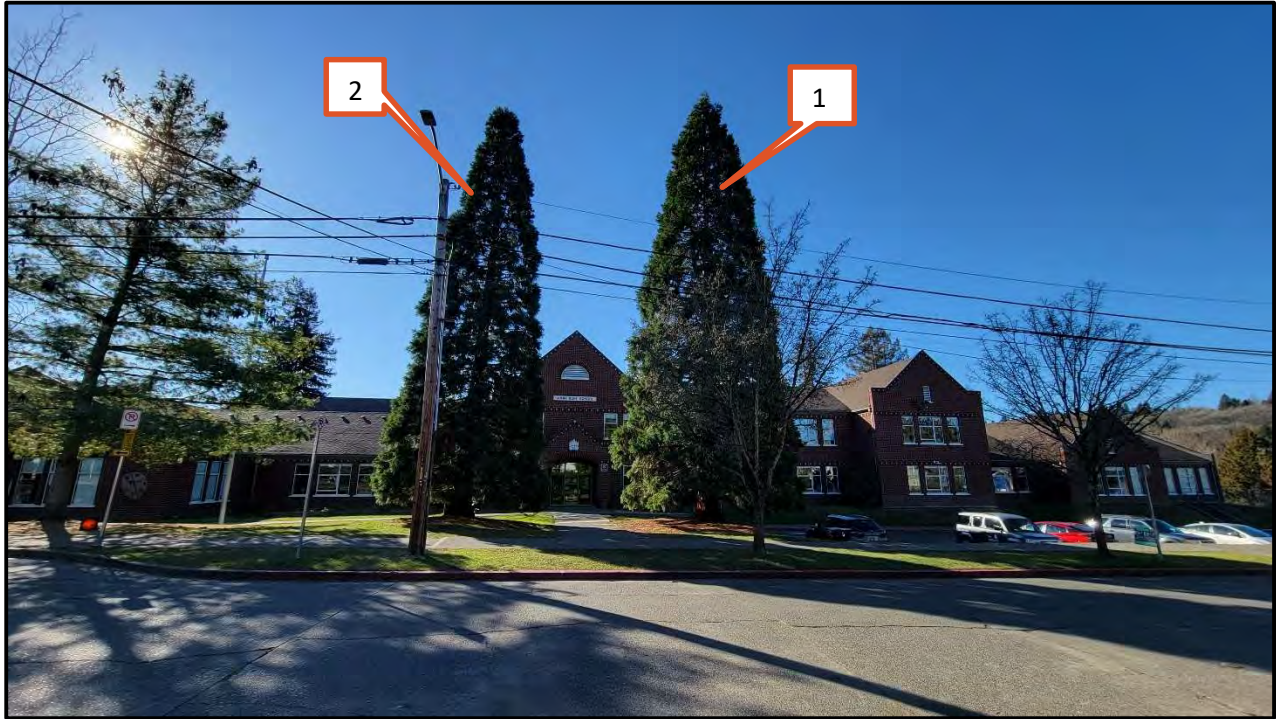
Photo 1. View looking to the south at trees 1 and 2.

These trees are proposed to be retained. Plans are being developed that would likely require improvements within the root zone. A preferred protected area is 21 radial feet around the tree, extending from the base and nothing below the dripline. Any activity within the 21 feet should be addressed according to the guidelines within the Tree and Plant Protection Specification (attached).

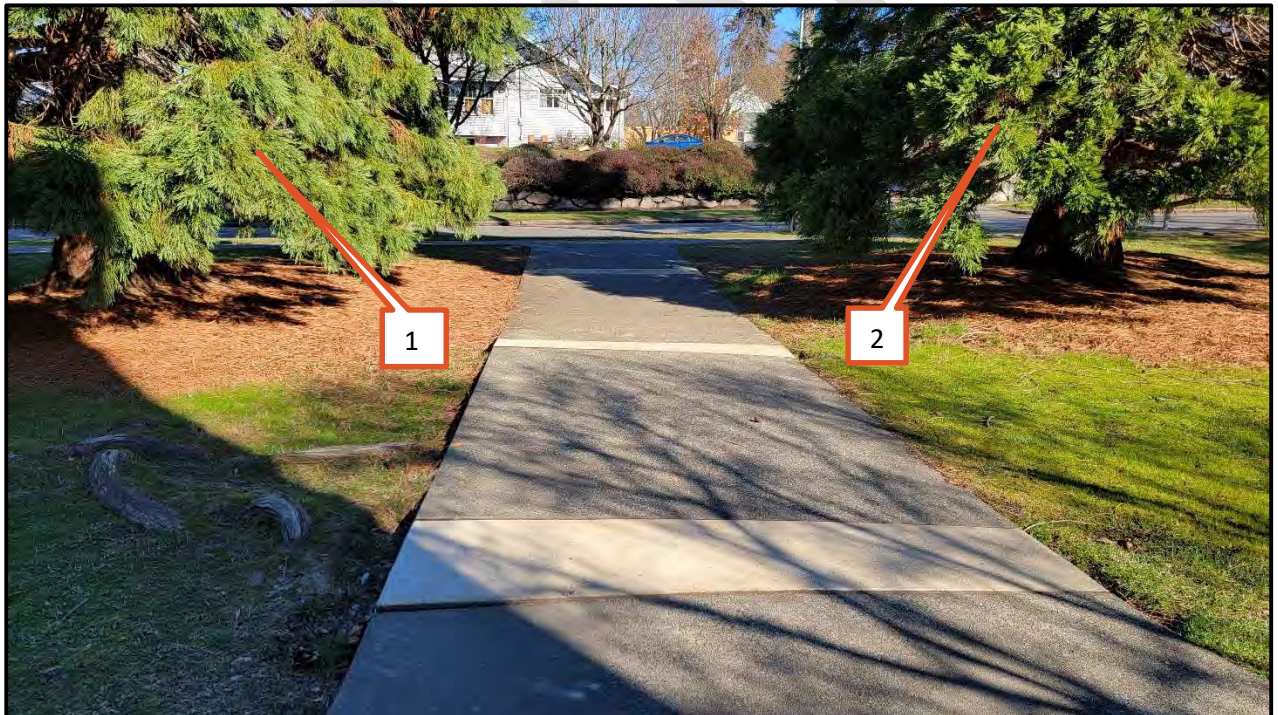
Photo 2. View looking to the north at the base of trees 1 and 2. Structural roots have been cut at the walkway where conflicts have occurred. Future walkway repair should consider alternative methods prior to root removal.

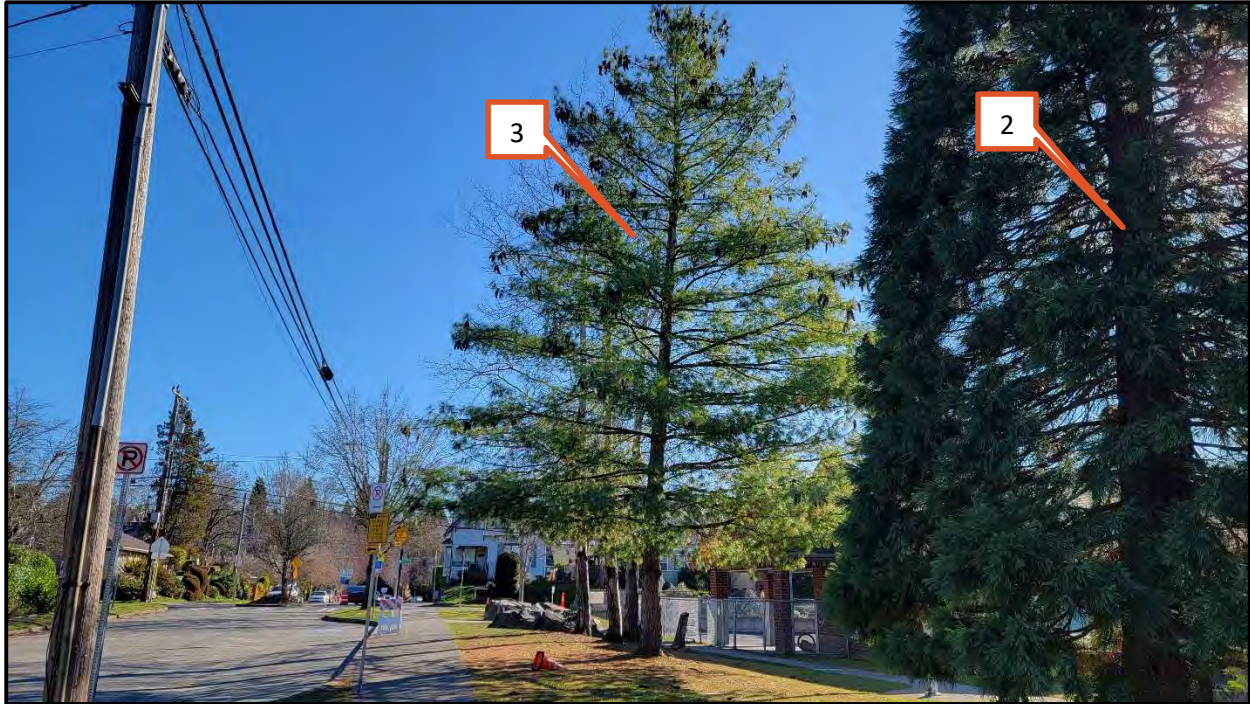
Photo 3. View looking to the east at tree 3.

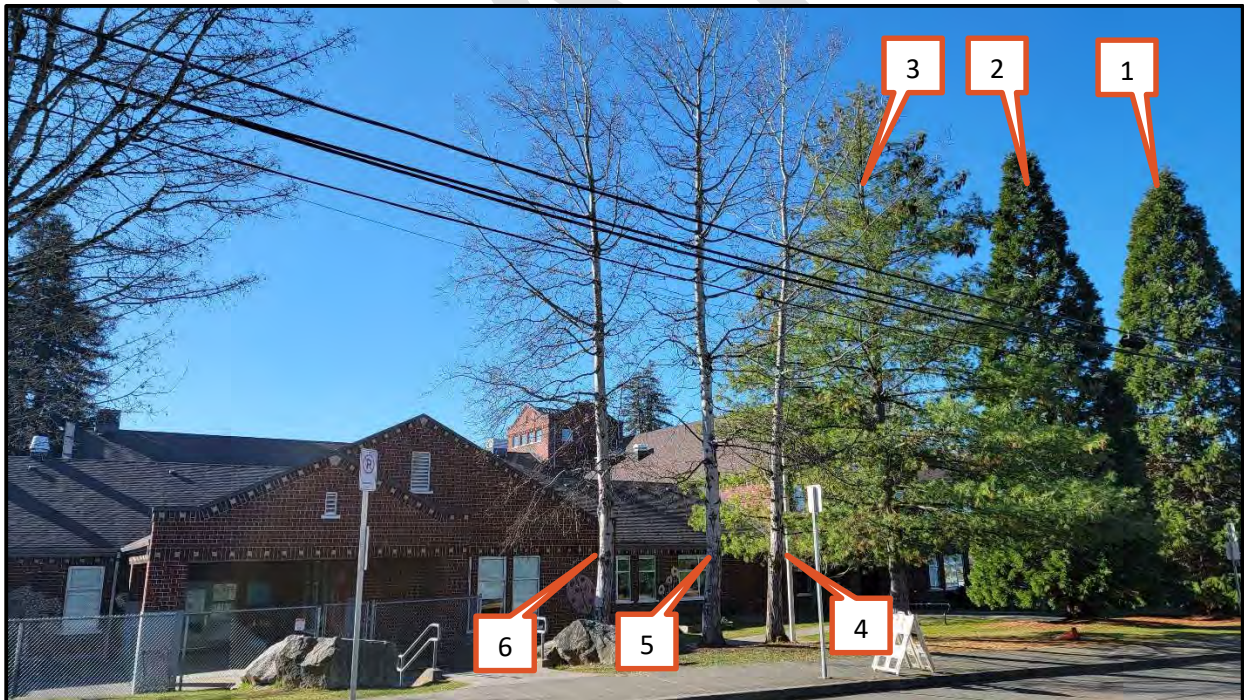
Photo 4. View looking to the south at trees 1, 2, 3, 4, 5 and 6.

Three exceptional size Quaking aspen trees appear to be in good health and structure (Photo 4). There was a fourth aspen tree adjacent with these trees that had failed at the roots (Photo 5). It is not clear as to why the tree failed, but it appears that the shallow root system pulled out from the high sand texture soil. Sandy soils provide limited holding areas for roots, which reduces friction, and can result in roots

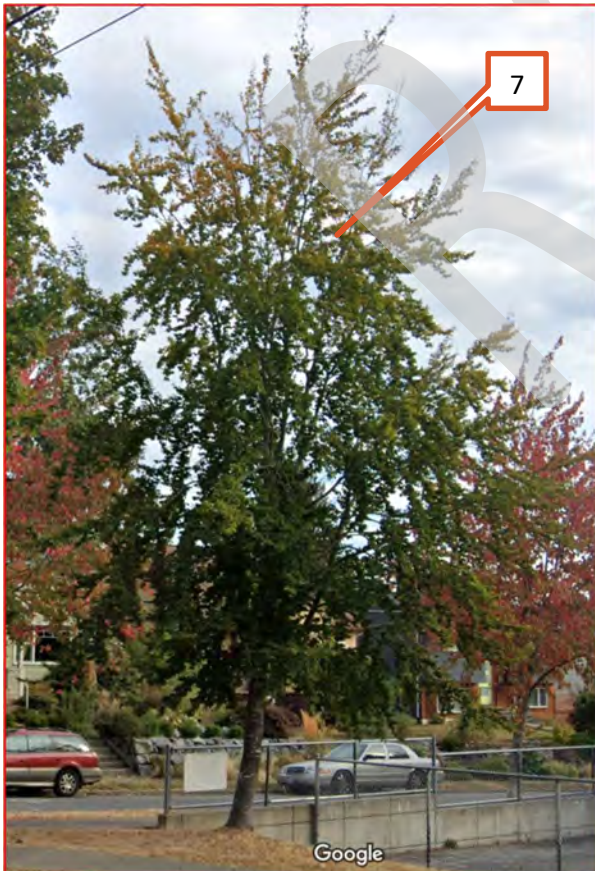
Photo 6. View looking to the southeast at tree 7. (Source Google Street View)

A European birch tree in good health and structure (Photo 6). The tree is within the proposed building envelope and will need to be removed (Figure 3).

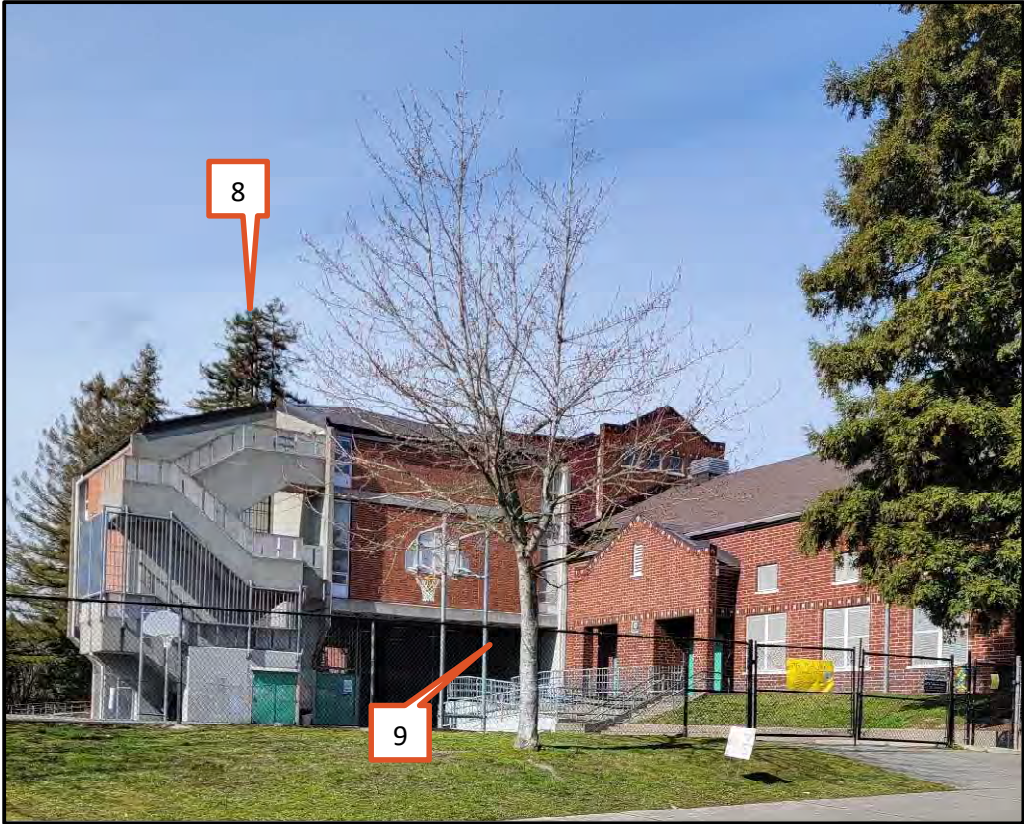
Photo 7. View looing to the west at trees 8 and 9. Both trees are currently proposed to be retained.

A Giant sequoia is located within the central portion of the site (Photo 7). The facade of the adjacent upper classroom area is proposed to be improved. This will likely require a minor level of clearance pruning on the east side of the tree to allow for scaffolding to be erected. This pruning will have a negligible consequence for the tree. The root zone area should be protected with a minimum of 6 inches of arborist woodchips placed over the soil surface. A ¼ inch thick plywood layer can be placed over the mulch for additional protection.

A Red maple tree is in good health and structure (Photo 7). The root system from this tree is shallow in a heavily compacted soil area. There are no current plans available that indicate there will be any negative impacts to the tree. The tree is proposed to be retained.
