Van Asselt School Addition Project

Draft SEPA Checklist

March 2021

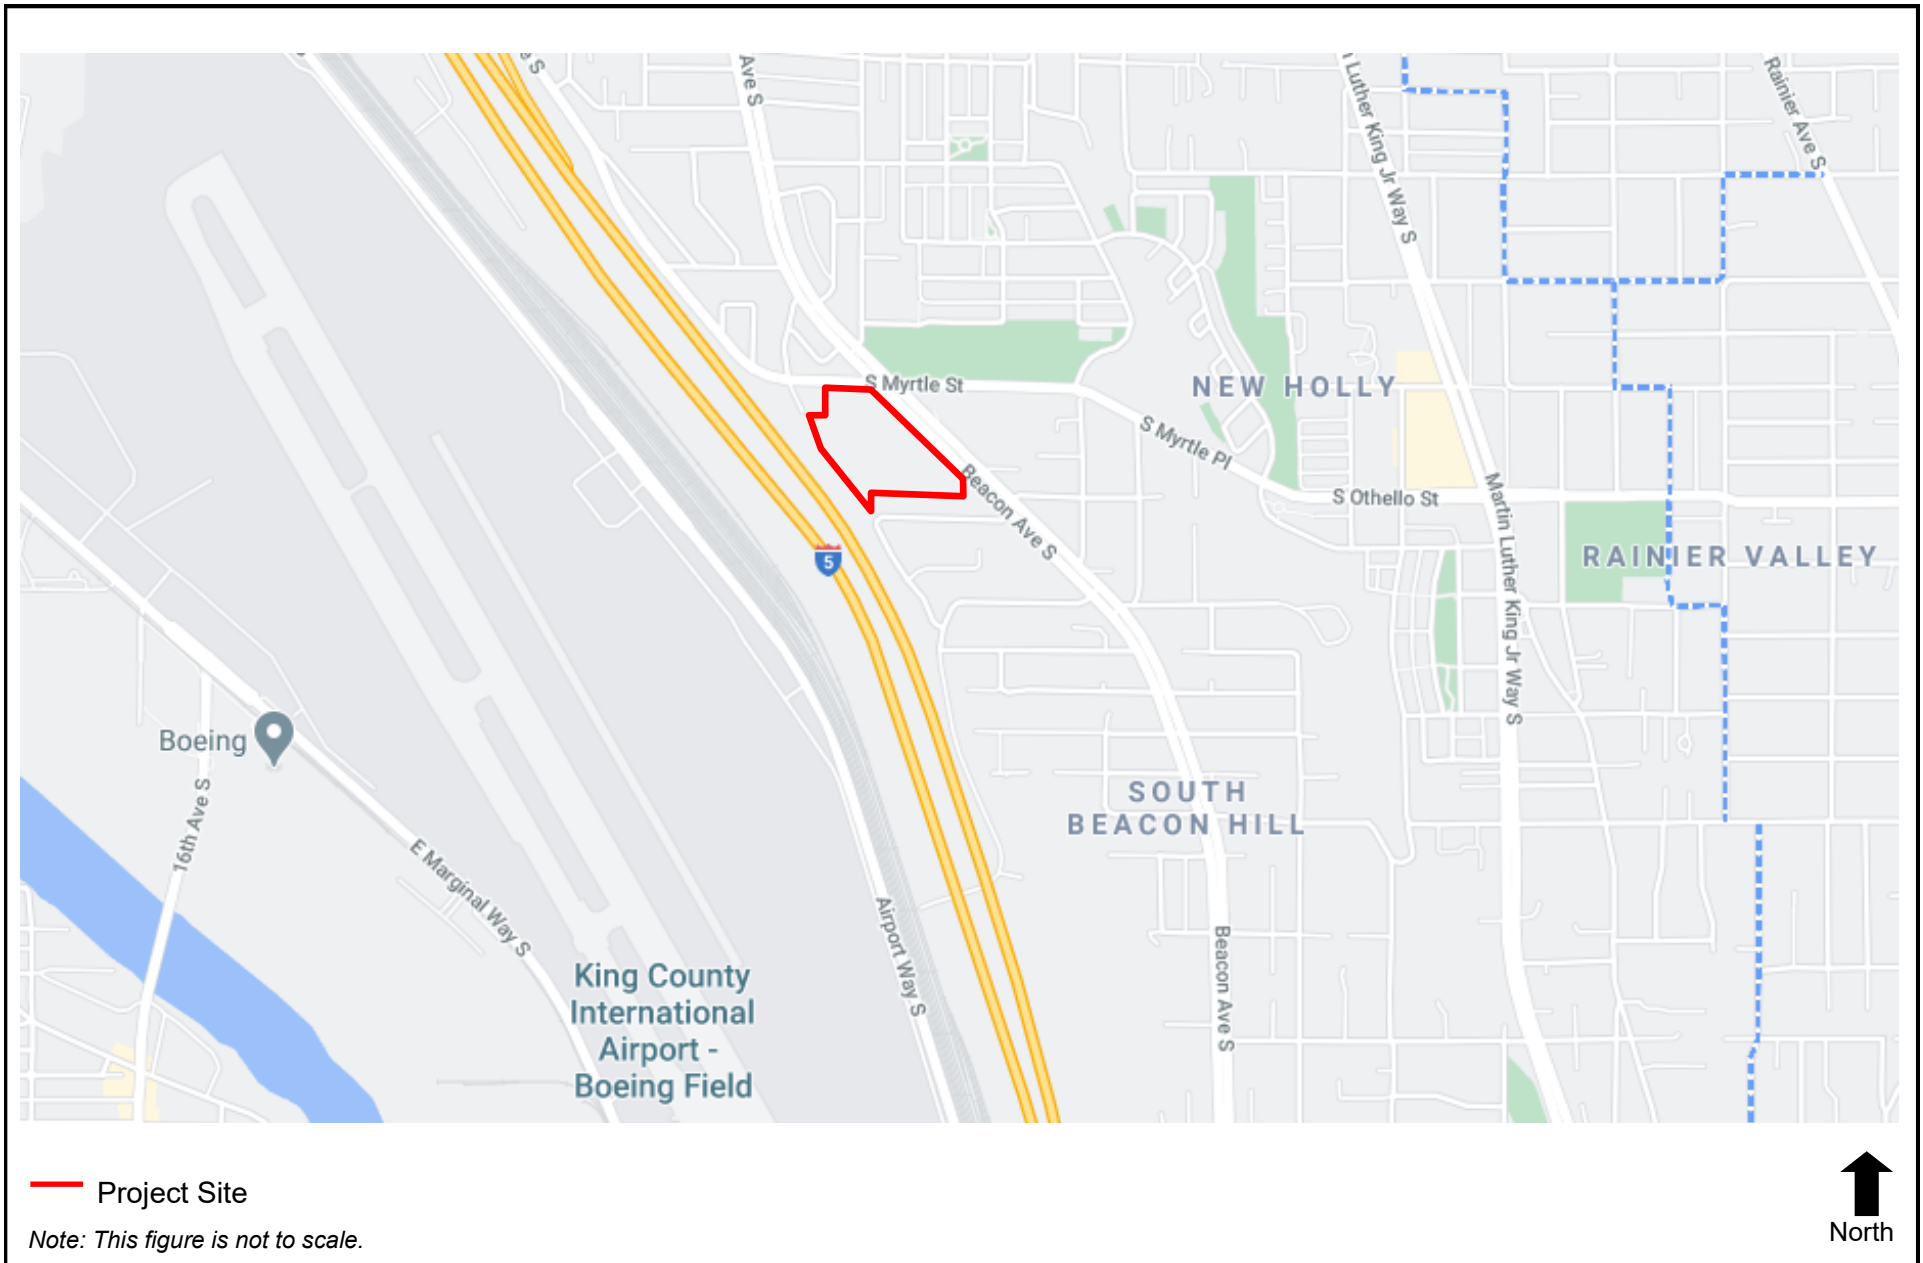
Figure 1
Vicinity Map

Figure 1 is a vicinity map that shows the Van Asselt School campus and the surrounding neighborhood in the site vicinity. The school campus site is outlined in red on the map.

Source: Google Maps and EA Engineering, 2020

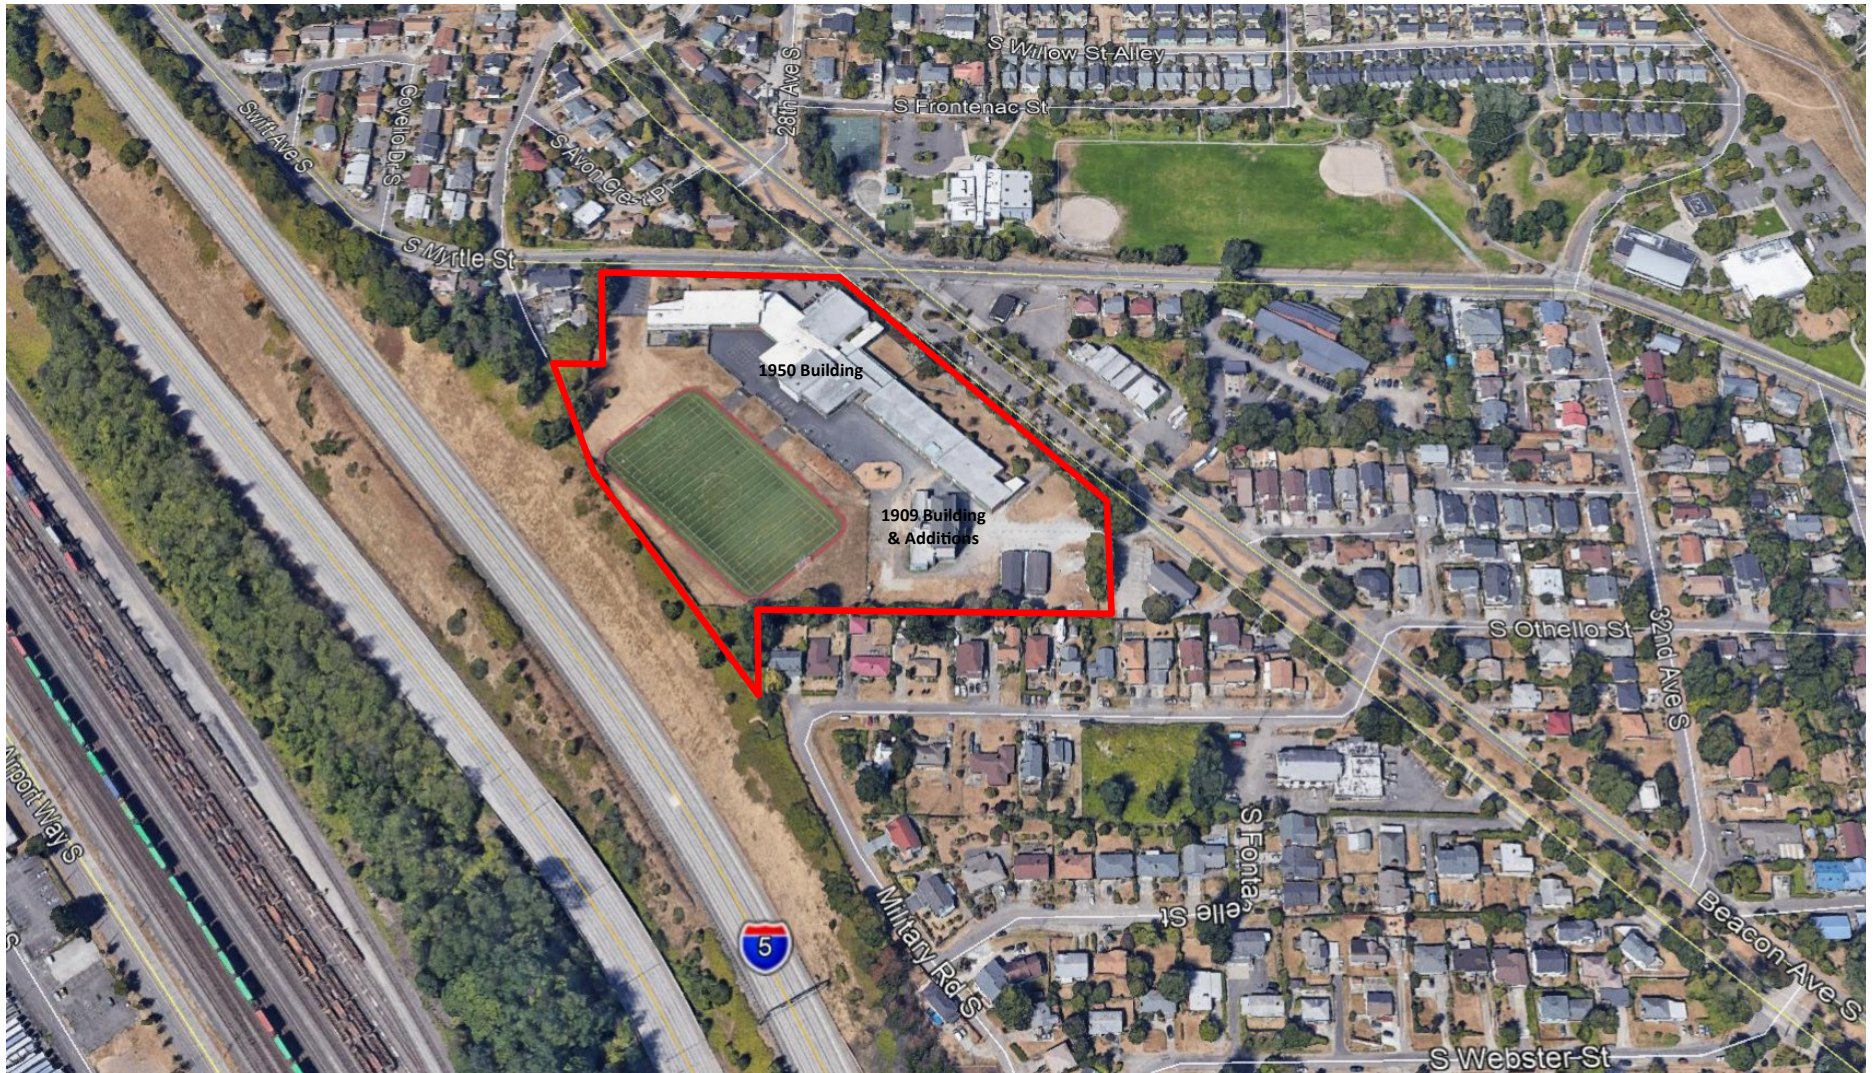
Figure 2
Aerial Map

— Project Site

The site of the proposed **Van Asselt School Addition Project** is located adjacent to the 3-story 1909 building in the south portion of the site. The site of the proposed addition is currently comprised of grass and paved areas (see **Figure 2** for an aerial photo of the existing site and **Figure 3** for the proposed site plan of the project).

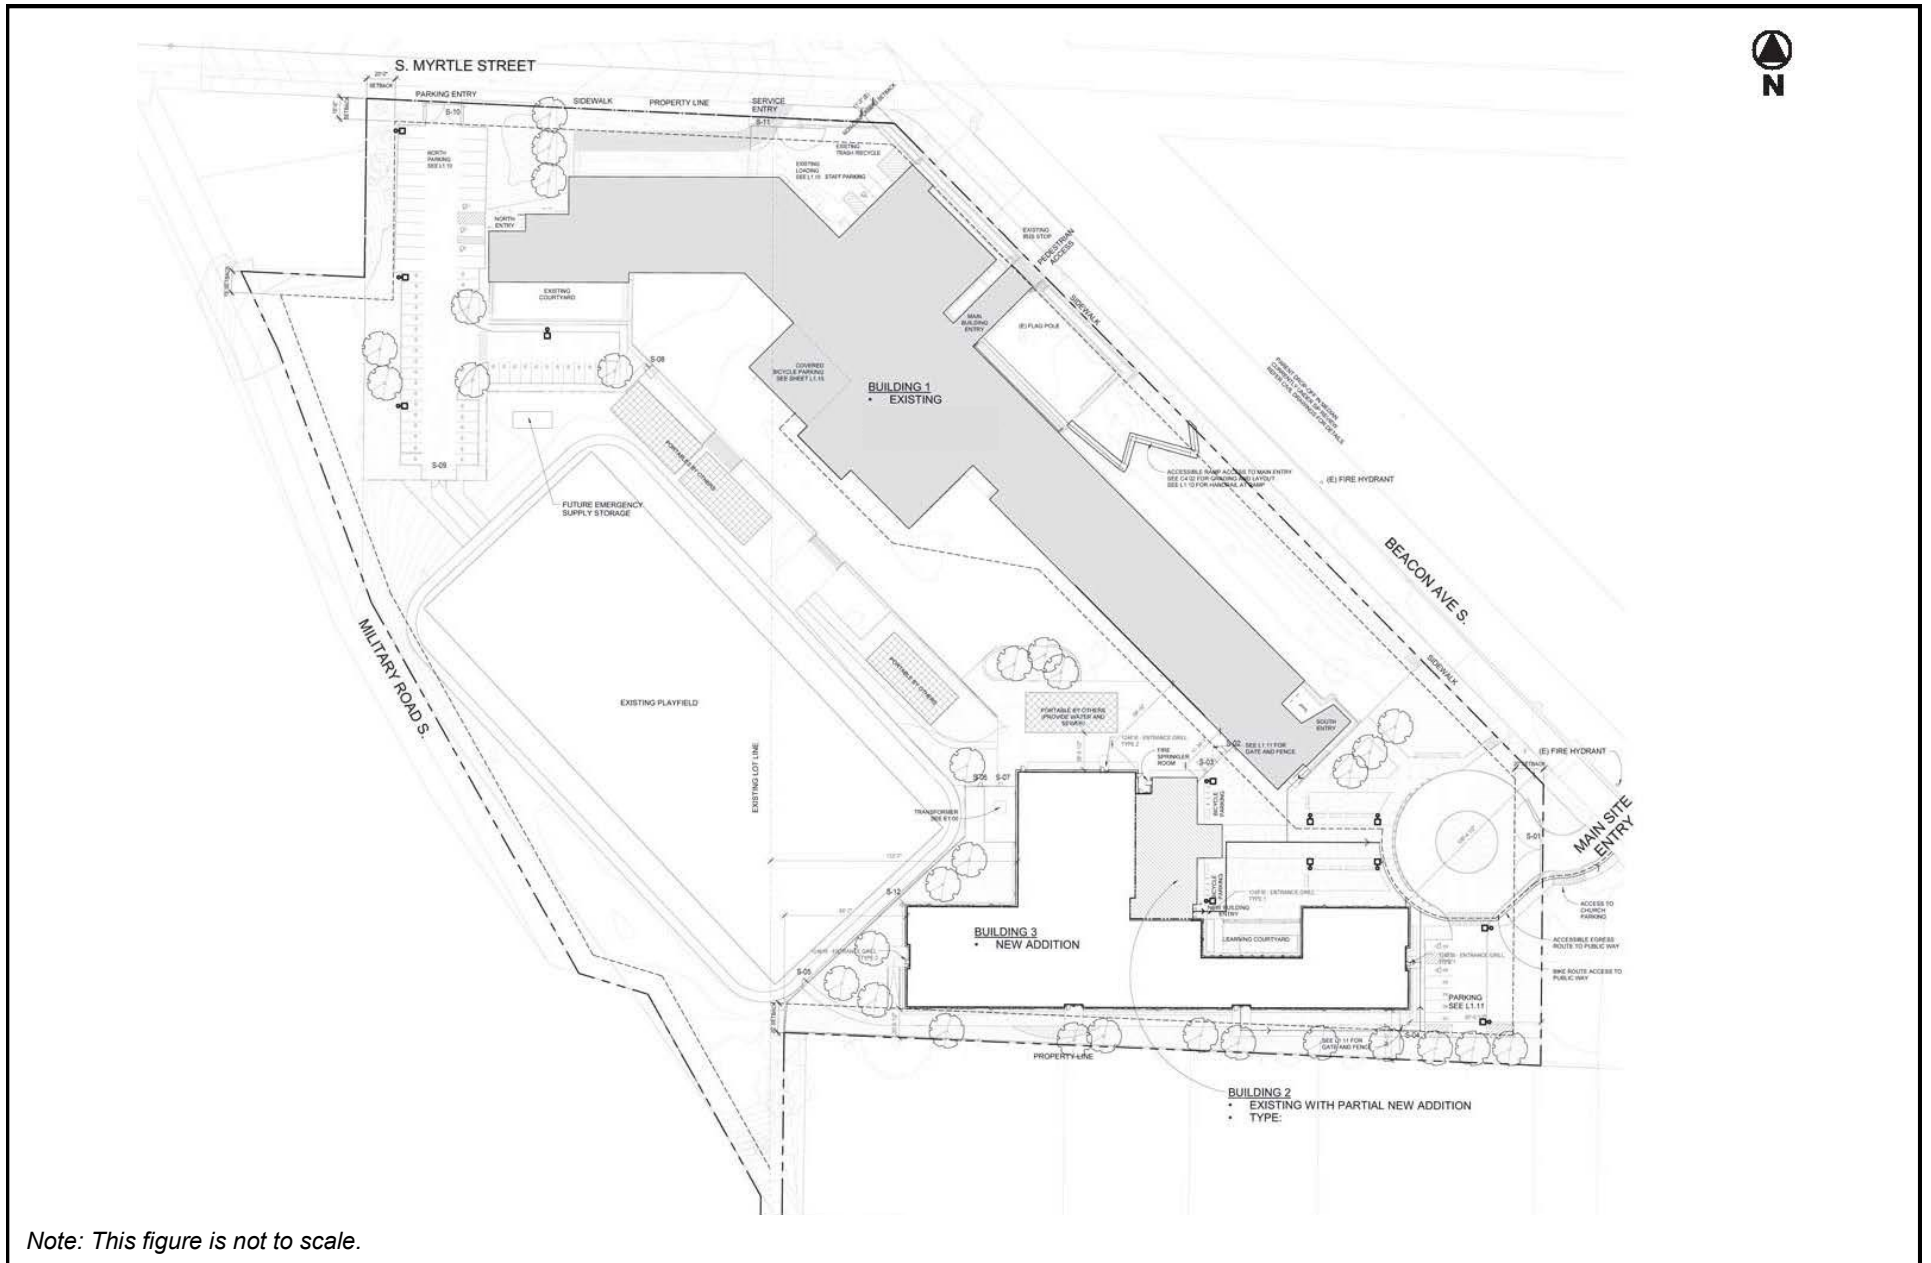
Figure 3
Site Plan

Figure 3 is a site plan of the proposed project. The entire school campus is shown on the plan. The proposed new building addition and other proposed project site features are labeled on the site.

Source: Bassetti Architects, 2021

The proposed project would add approximately 62,000 gsf of new permanent building space and renovate portions of the existing 1909 building (approximately 8,400 gsf of renovated building space). The proposed building addition would be located to the west and south of the existing 1909 building (see **Figure 3** for the proposed site plan) and would include 26 classrooms, a new gymnasium, learning commons areas, administrative space, and support space (restrooms, custodial spaces, etc). The proposed renovation to the 1909 building would include four new classrooms, storage space, and student locker areas.

Views of the site would generally continue to be reflective of the existing school uses on the site. Views of the proposed addition would primarily be available from areas that are proximate to the east and south boundaries of the school campus (see **Figure 3** for the proposed site plan). The proposed addition would increase the amount of building area on the site, but as noted above, the proposed height of the addition would be shorter than the existing three-story 1909 building. Existing, retained mature trees and proposed landscaping would provide a partial buffer/screen that would obscure some of the proposed building addition along the southern portion of the site.

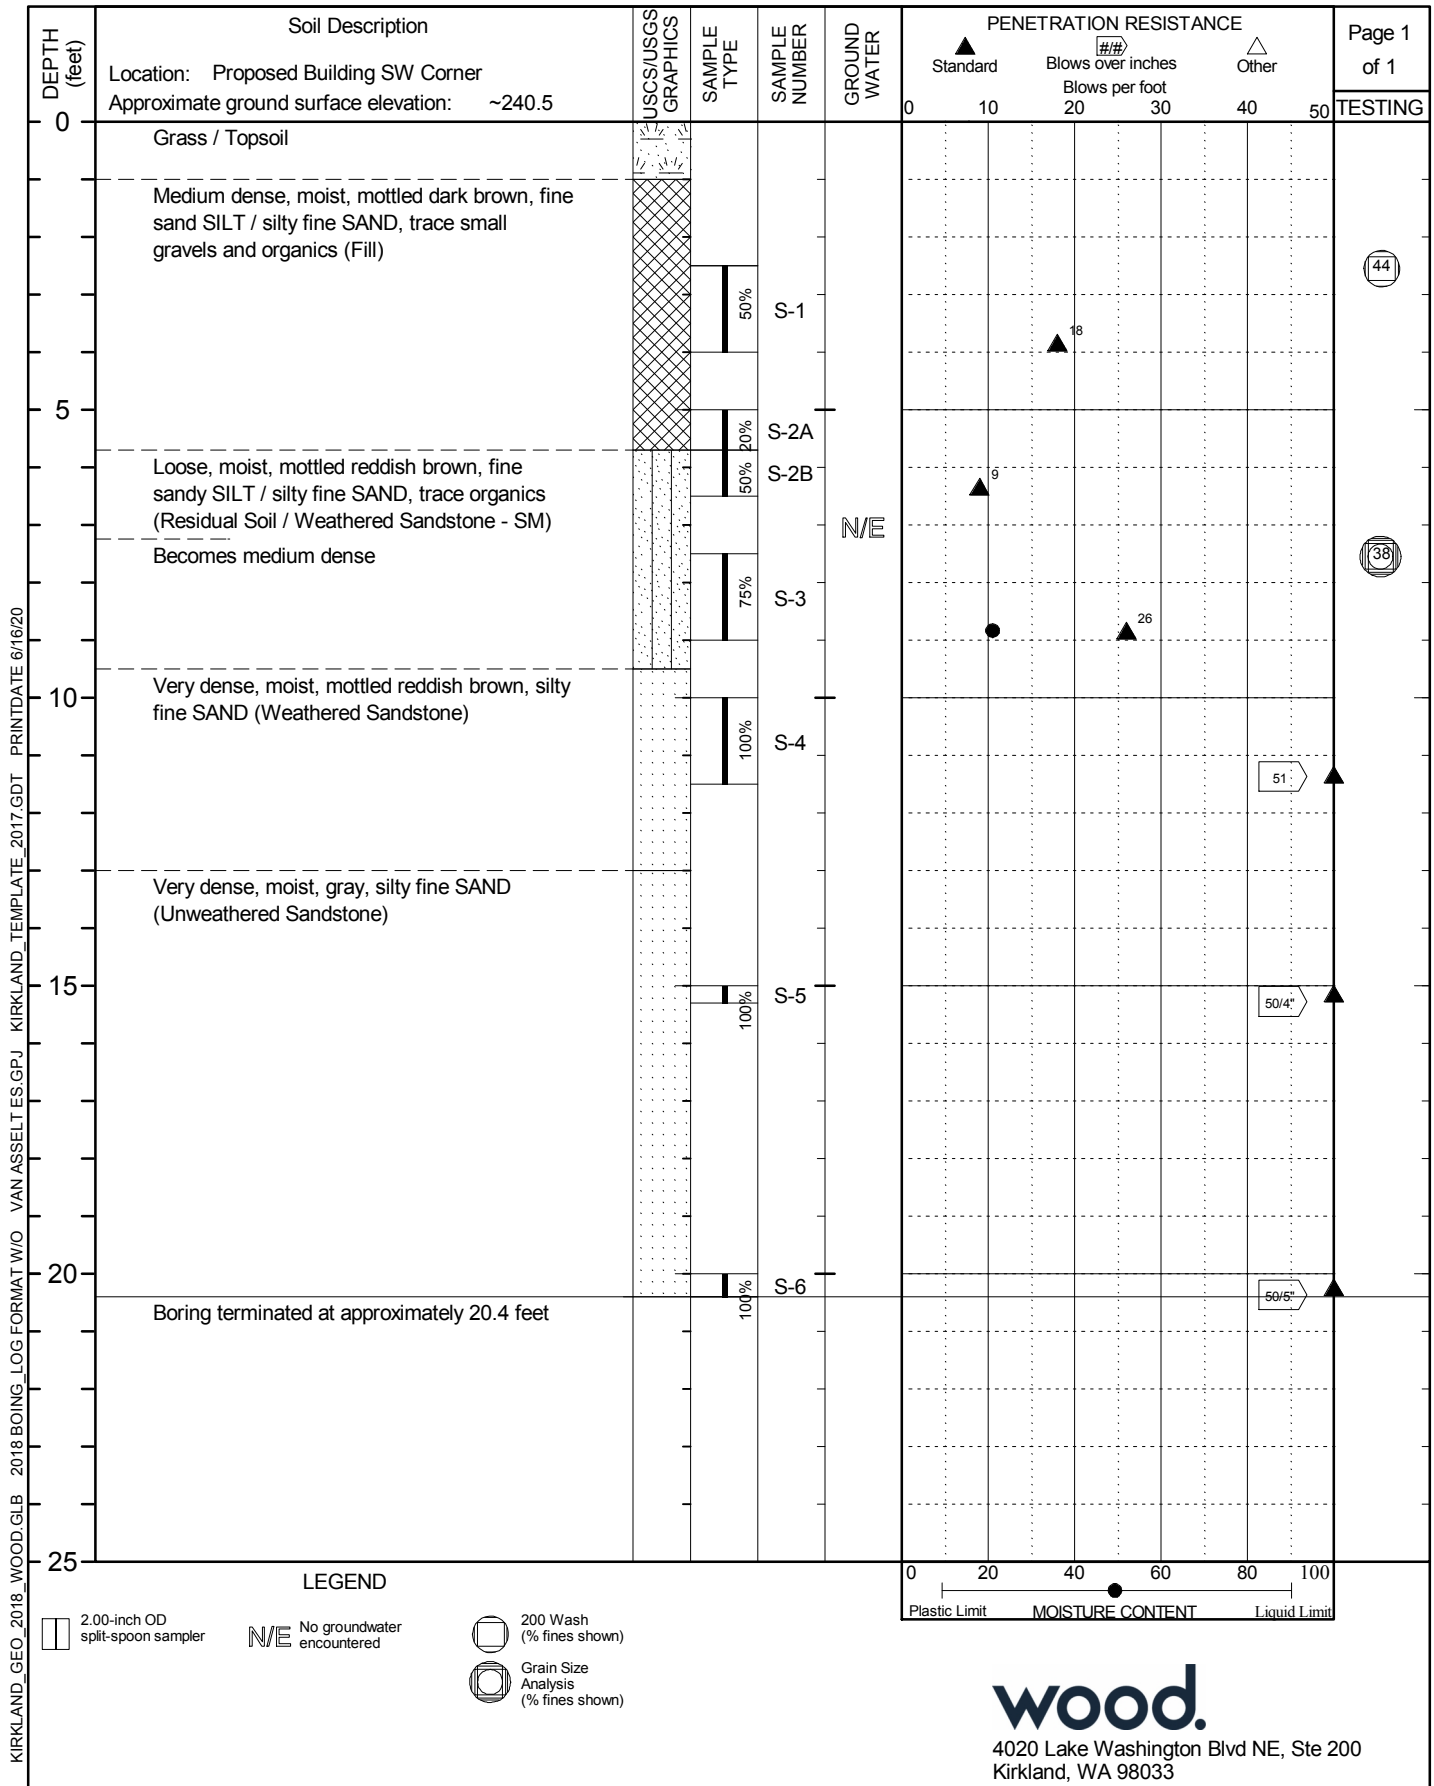
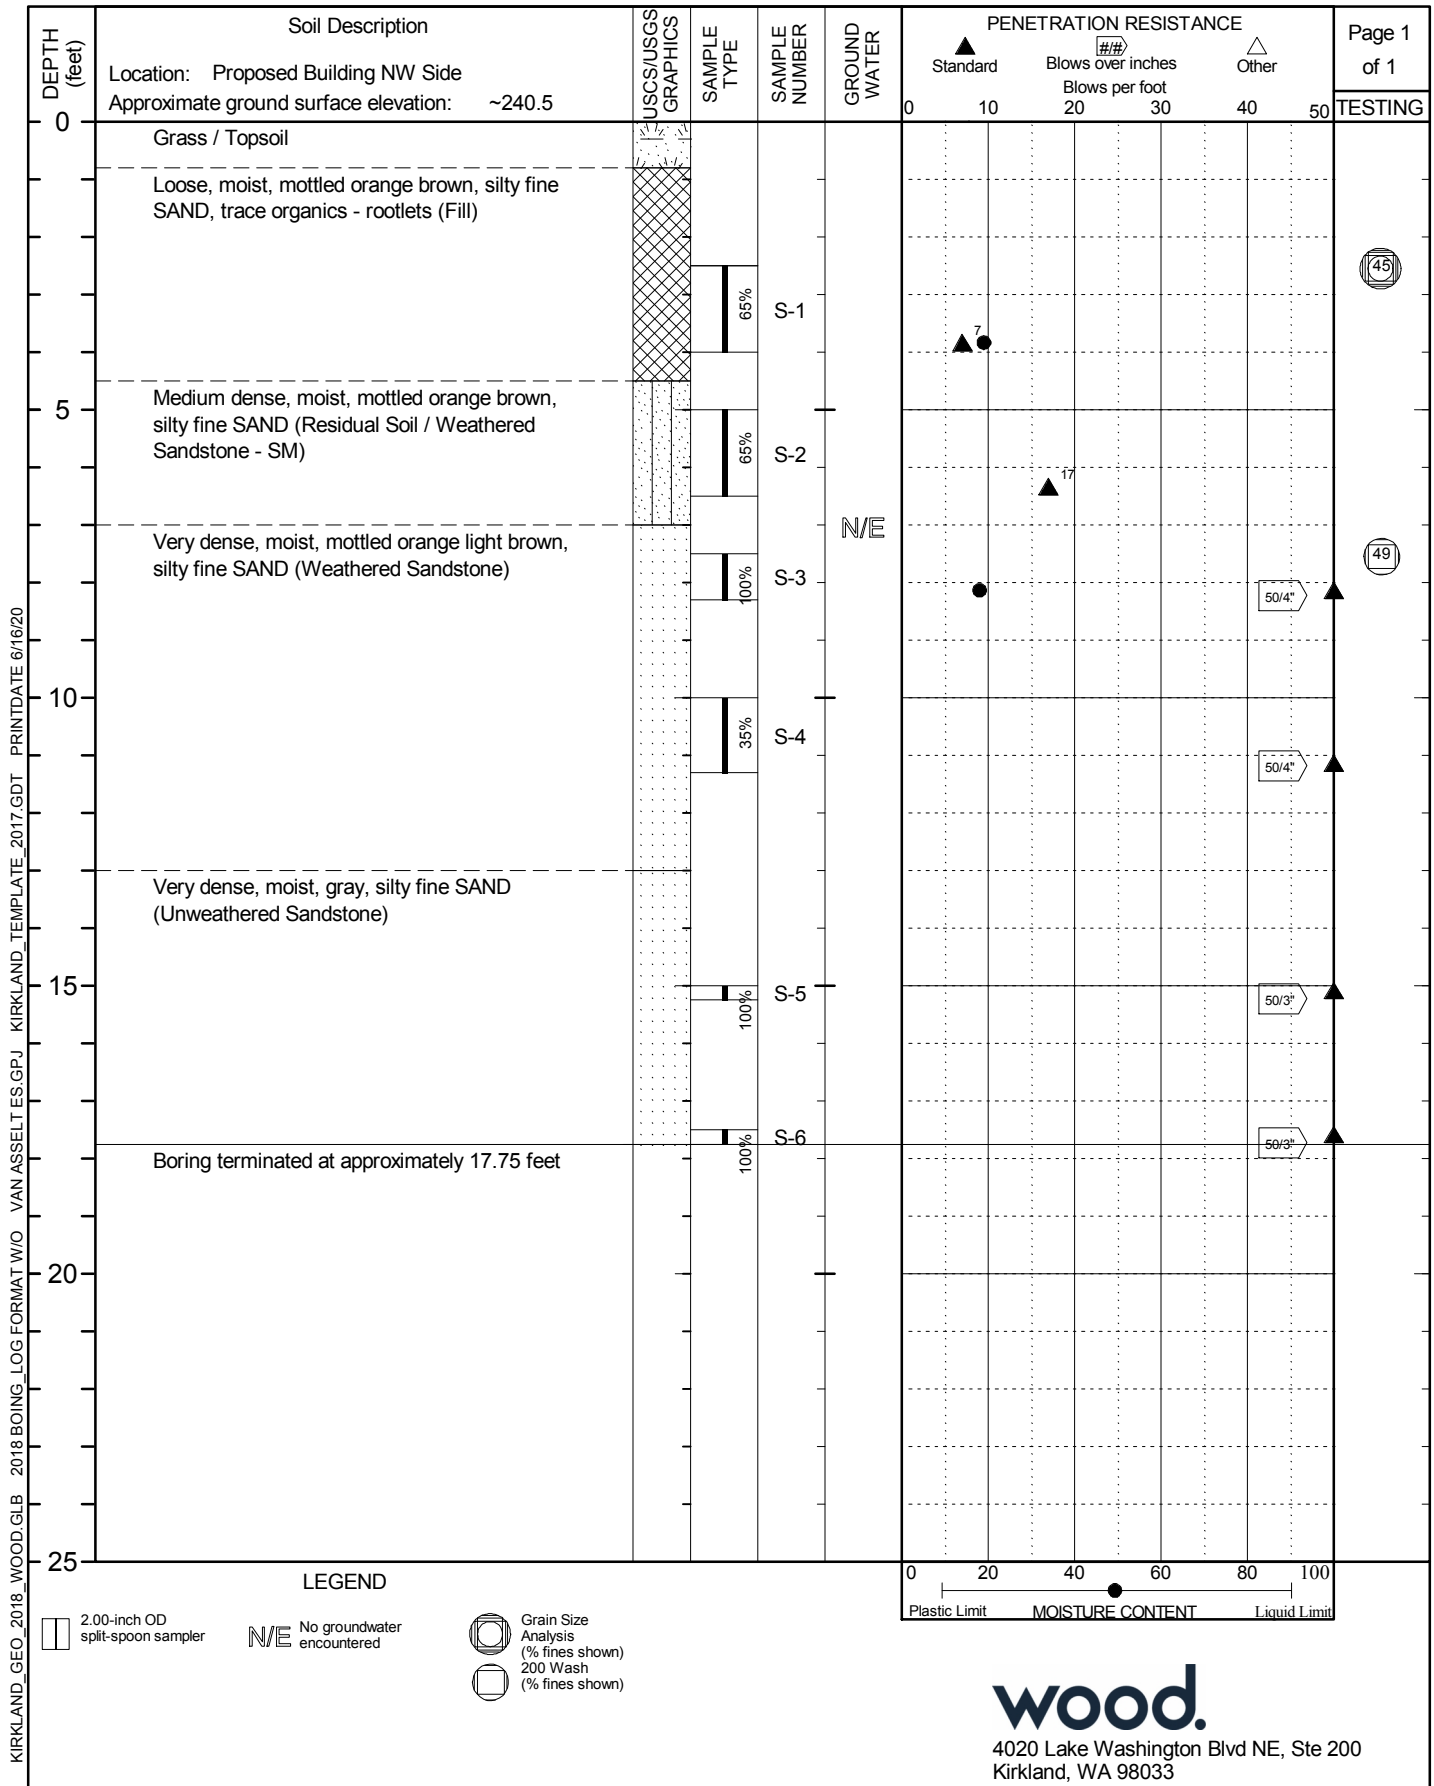
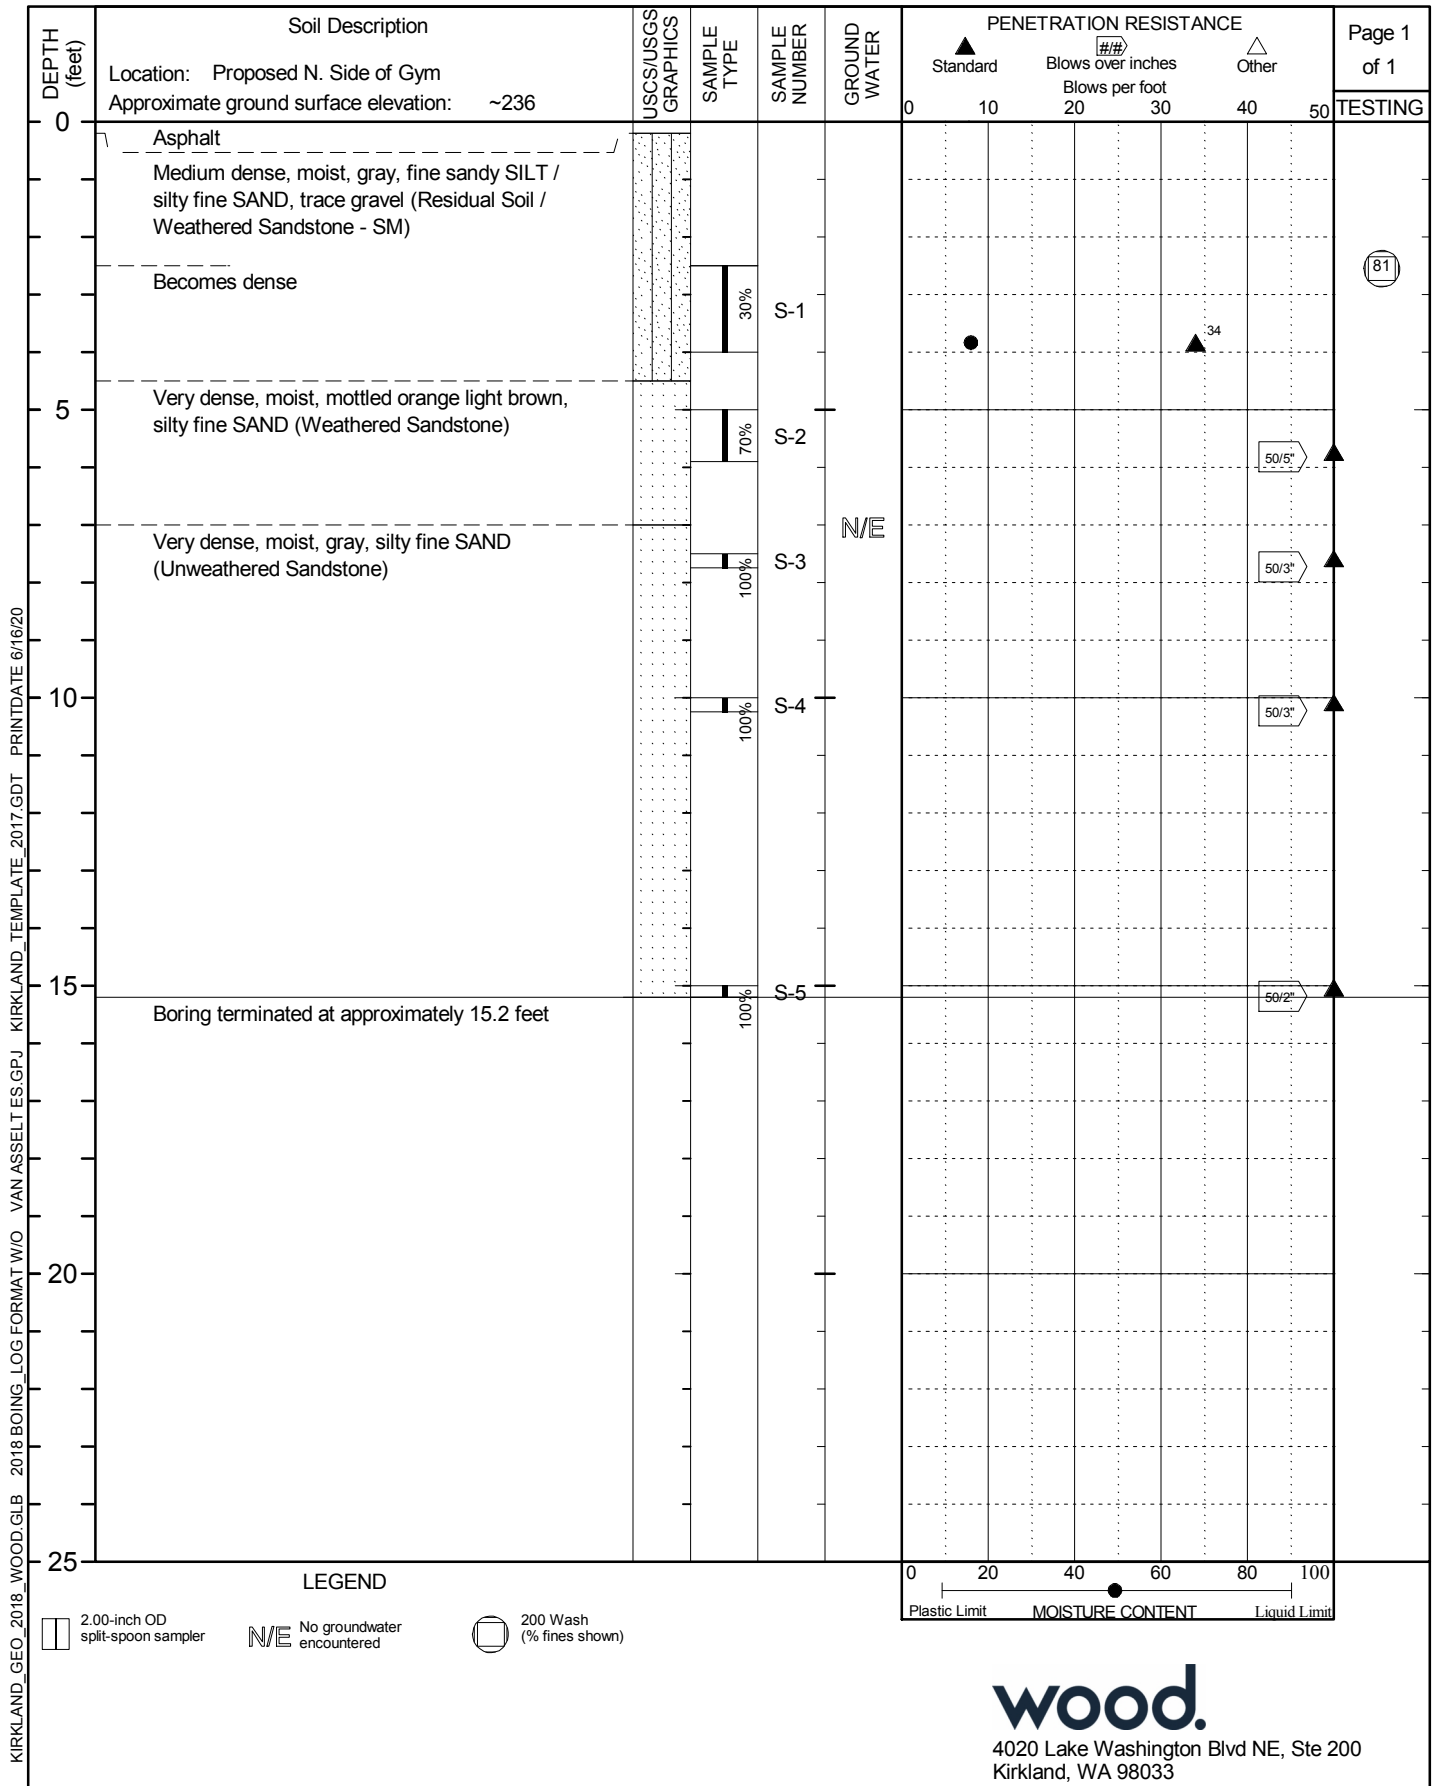
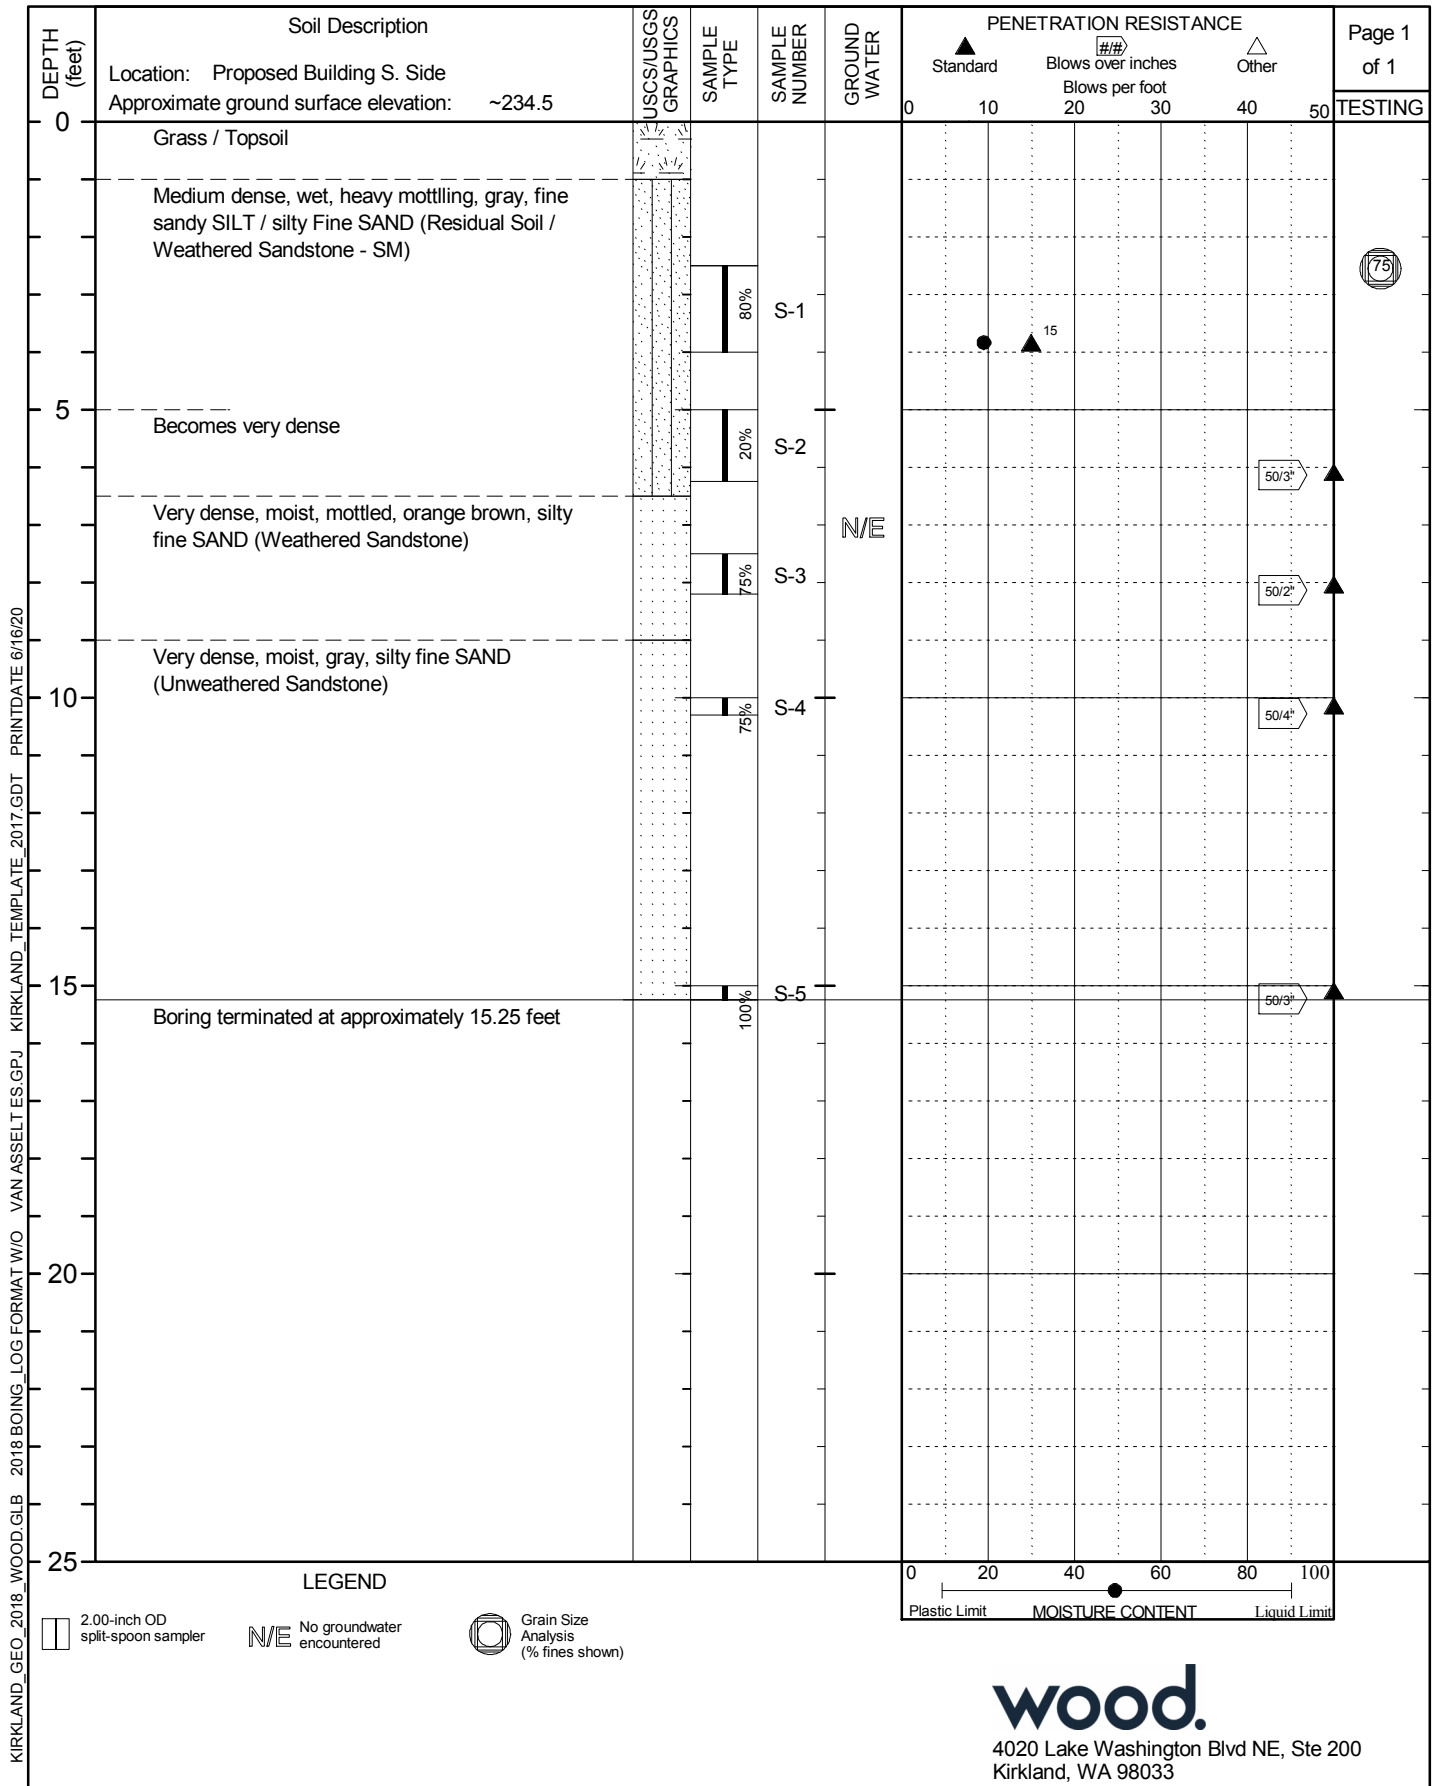
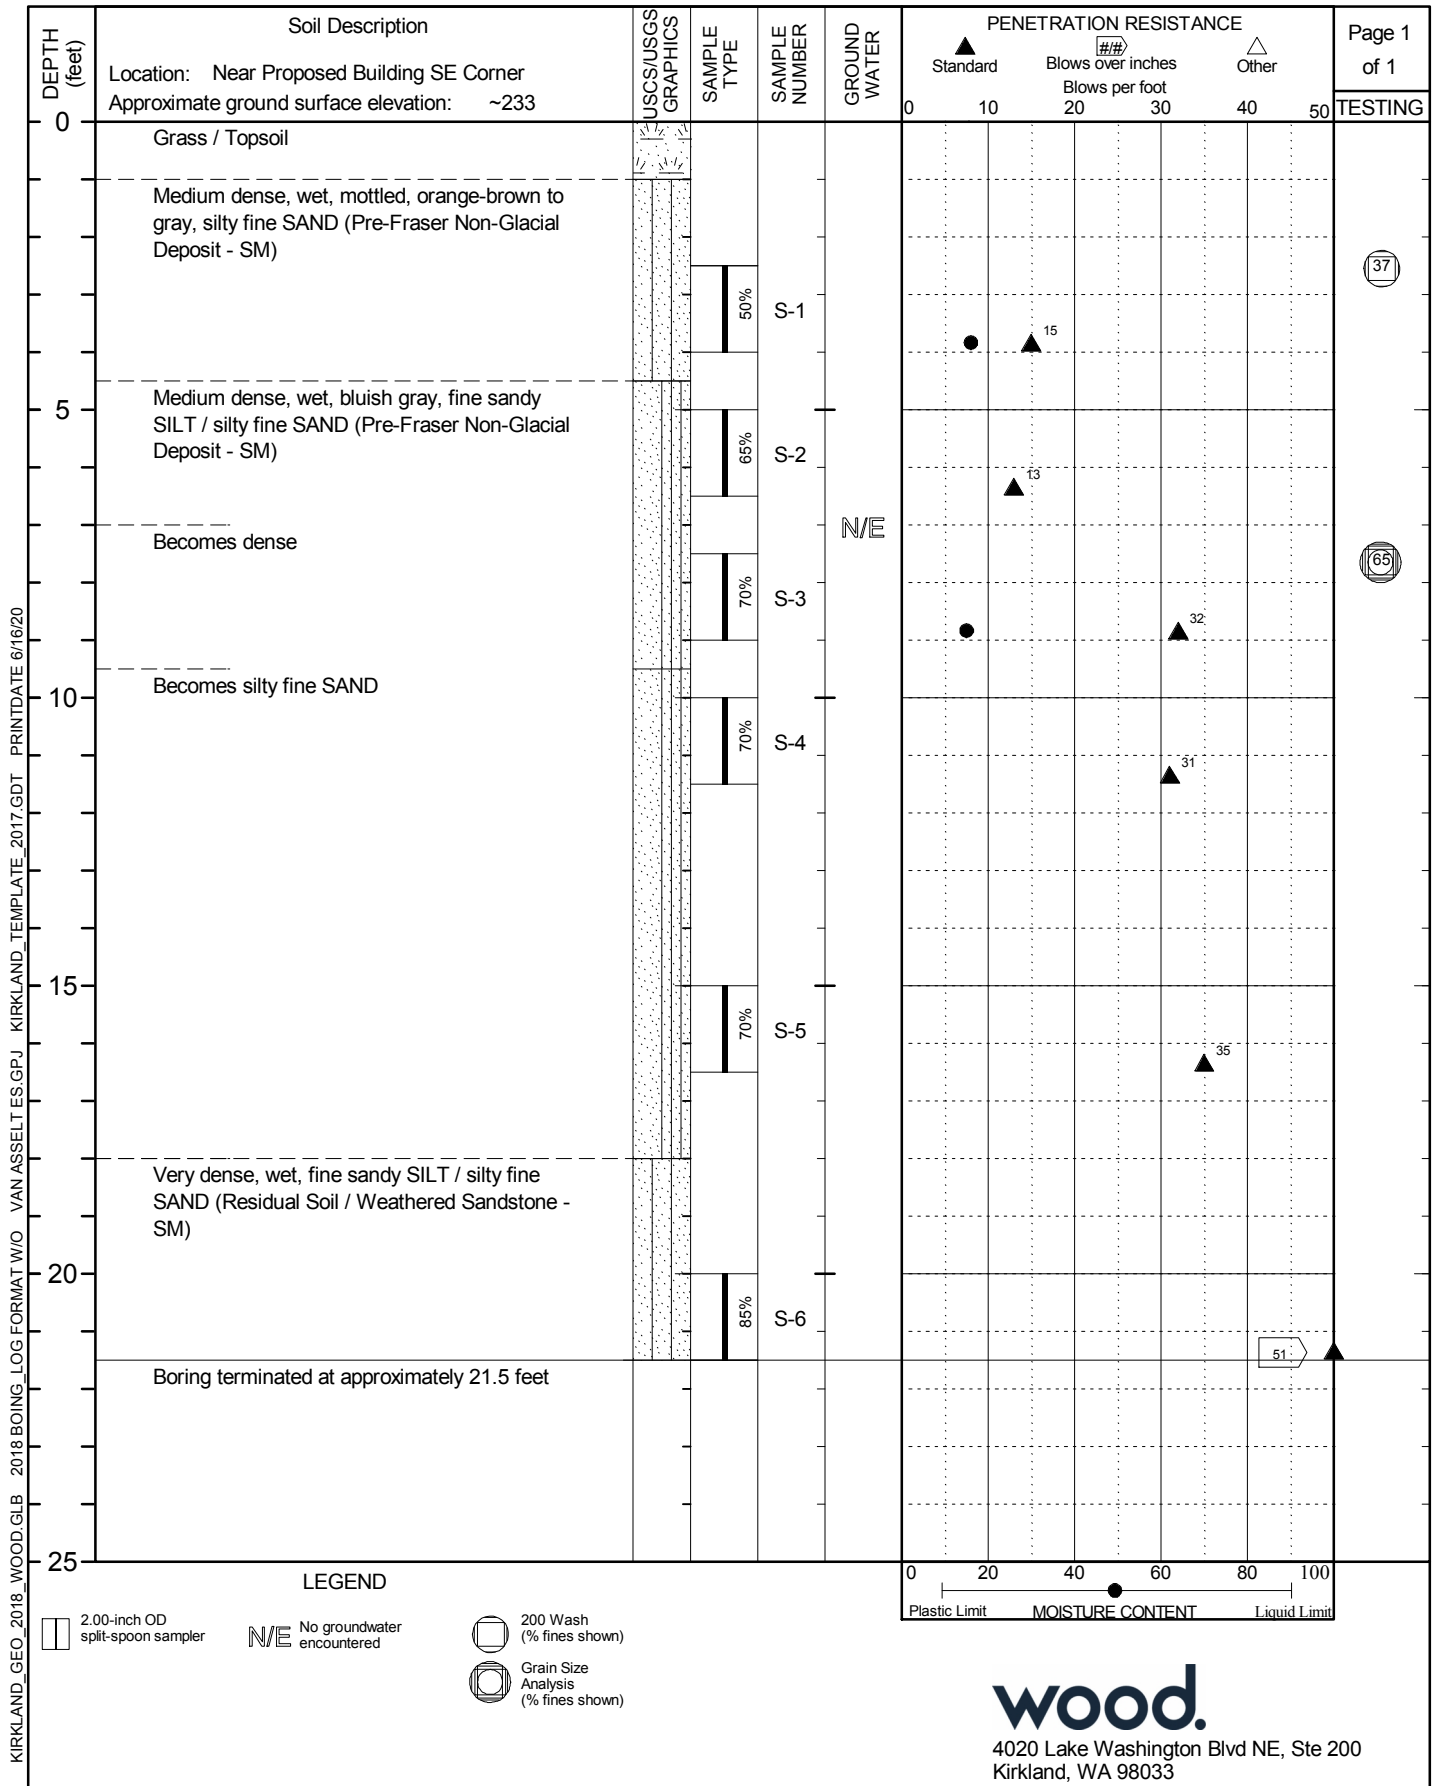
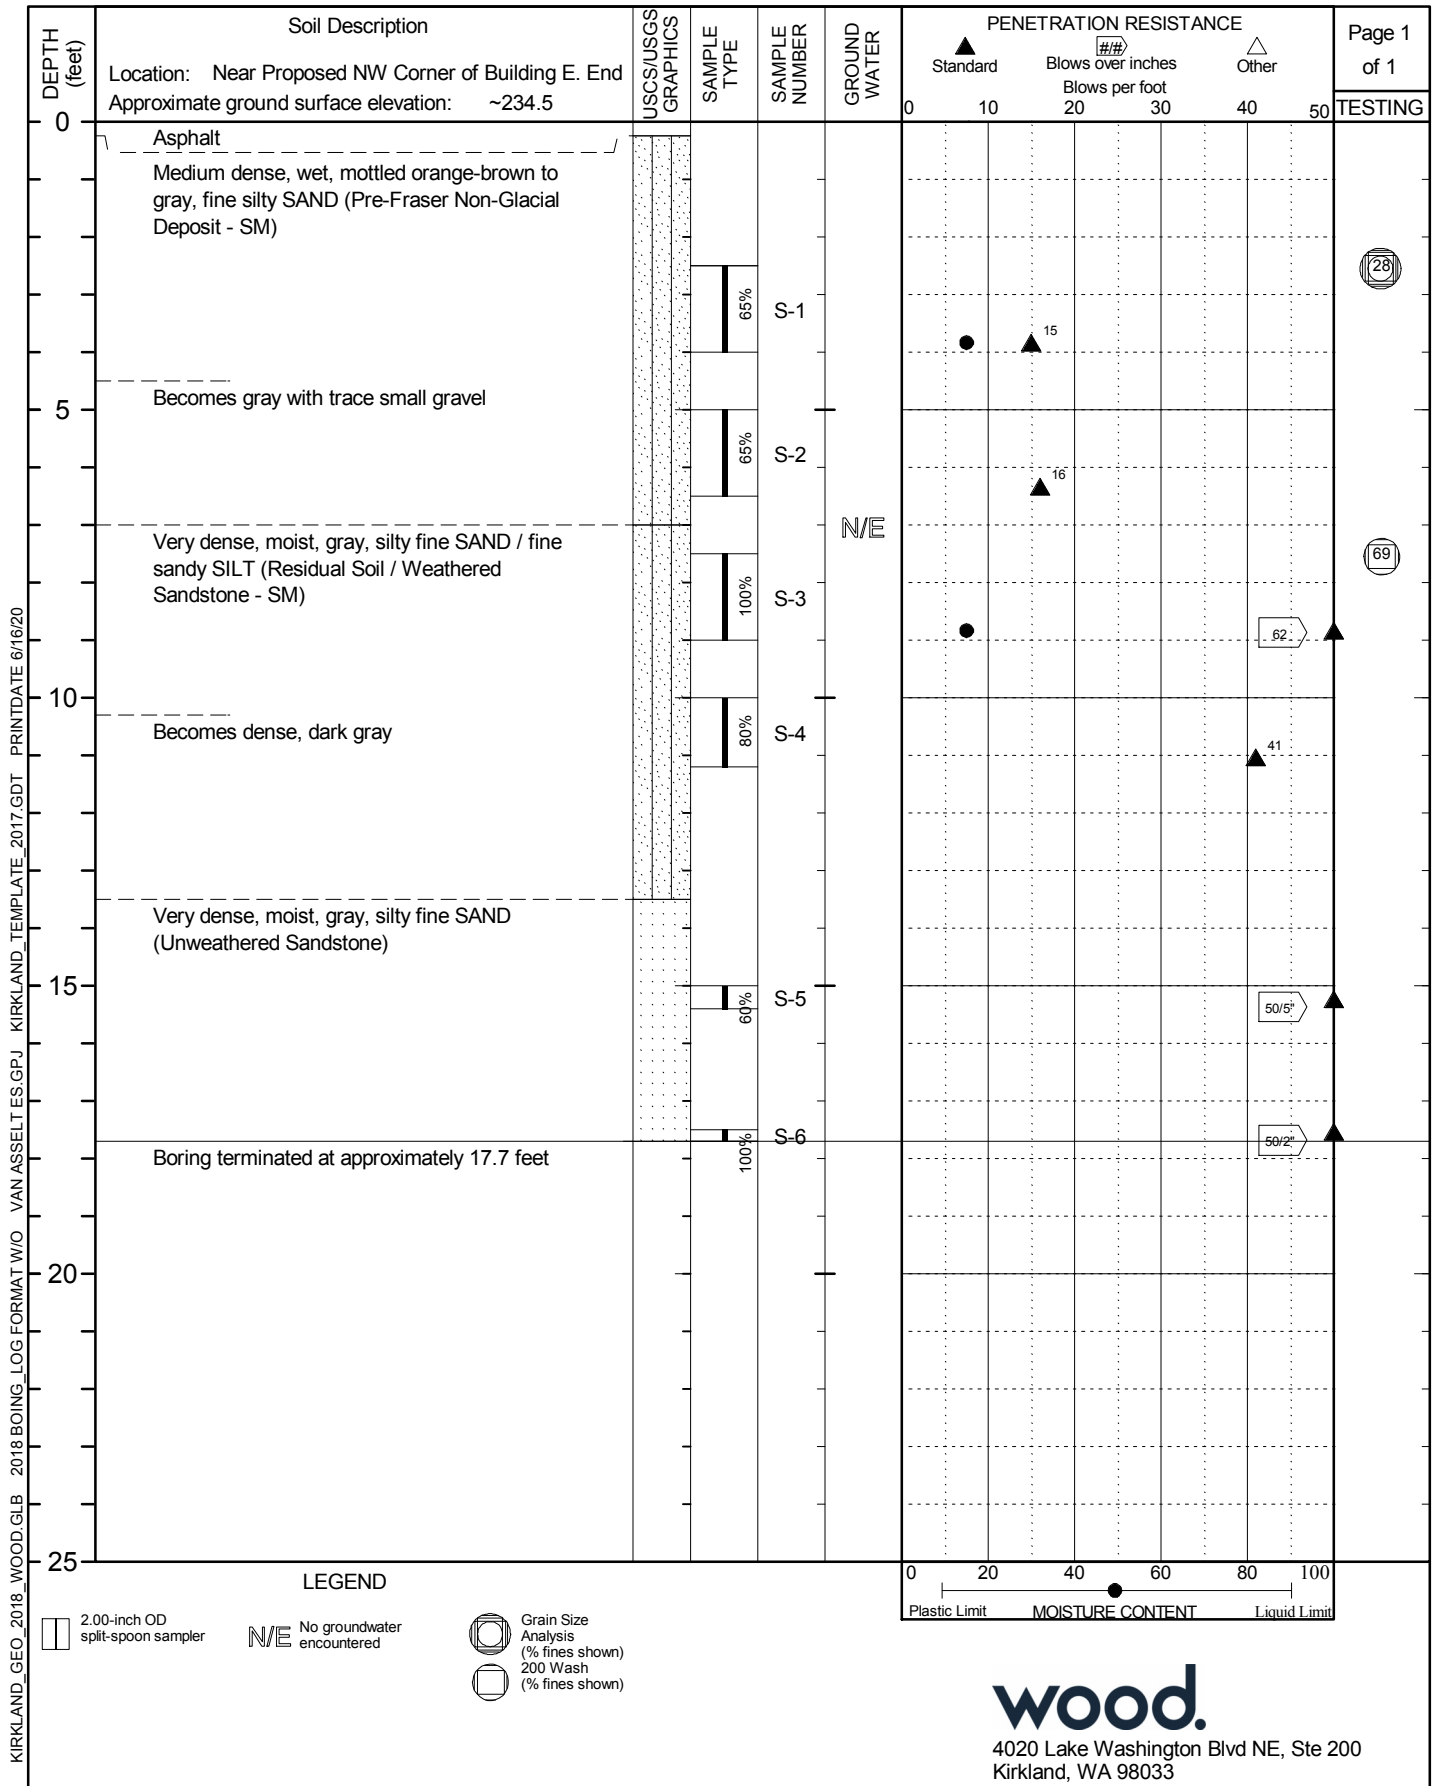
The enclosed boring logs describe the vertical sequence of soils and materials encountered in each boring, based primarily on field classifications and supported by subsequent laboratory examination and testing. Where a soil contact was observed to be gradational, boring logs indicate the average contact depth. Where a soil type changed between sample intervals, we inferred the contact depth. The boring logs also graphically indicate the blow count, sample type, sample number, and approximate depth of each soil sample obtained from the borings. If groundwater was encountered in a borehole, the approximate groundwater depth is depicted on the boring log. Groundwater depth estimates are typically based on the moisture content of soil samples, the wetted height on the drilling rods, and the water level measured in the borehole after the auger has been extracted.

Drilled by: Boretac

Drilling Method: HSA

Throughout the drilling operation, soil samples were obtained at 2.5- or 5-foot depth intervals by means of the standard penetration test (SPT) per ASTM D-1586. This testing and sampling procedure consist of driving a standard 2-inch-diameter steel split-spoon sampler 18 inches into the soil with a 140-pound hammer free-falling 30 inches. The number of blows required to drive the sampler through each 6-inch interval was counted, and the total number of blows struck during the final 12 inches was recorded as the standard penetration resistance, or "SPT blow count." If a total of 50 blows were struck within any 6-inch interval, the driving was stopped, and the blow count was recorded as 50 blows for the actual penetration distance. The resulting standard penetration resistance values indicate the relative density of granular soils and the relative consistency of cohesive soils.
