Van Asselt School Addition Project

Draft SEPA Checklist

March 2021

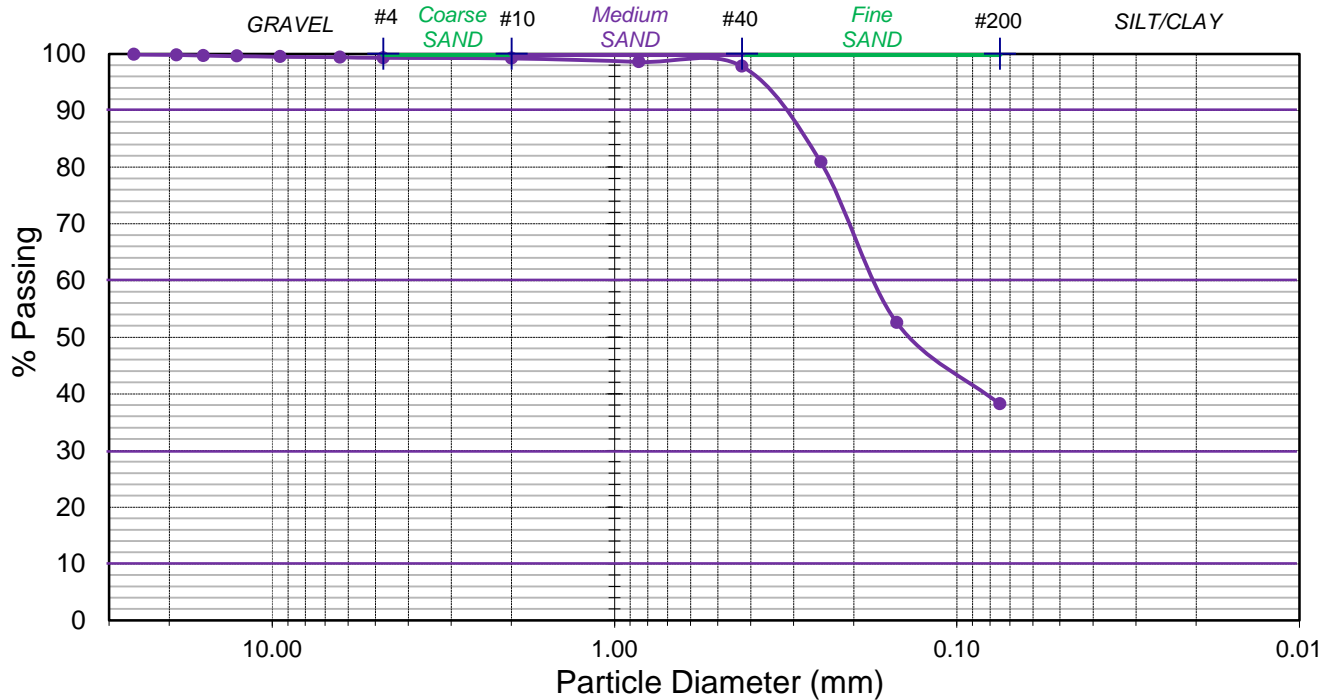
USCS Soil Classification: SM - silty SAND

Sieve Number	Diameter (mm)	Soil Retained (%)	Soil Passing (%)	Particles
1"	25.4	0.1	99.9	Gravel
3/4"	19.05	0.1	99.8	
5/8"	15.9	0.1	99.7	
1/2"	12.7	0.1	99.6	
3/8"	9.5	0.1	99.5	
1/4"	6.35	0.1	99.4	
#4	4.75	0.1	99.3	
#10	2.0	0.1	99.2	Sand
#20	0.85	0.6	98.6	
#40	0.425	0.8	97.8	
#60	0.25	16.9	80.9	
#100	0.150	28.3	52.6	
#200	0.075	14.4	38.2	
Pan	< 0.075	38.2	38.2	Fines
	TOTAL:	100.0	0.0

Grain Size Distribution Curve Results:

% Gravel: 0.7 % Solids: 78.6
 % Sand: 61.1 % Moisture: 21.4
 % Fines: 38.2 % Organics: ----

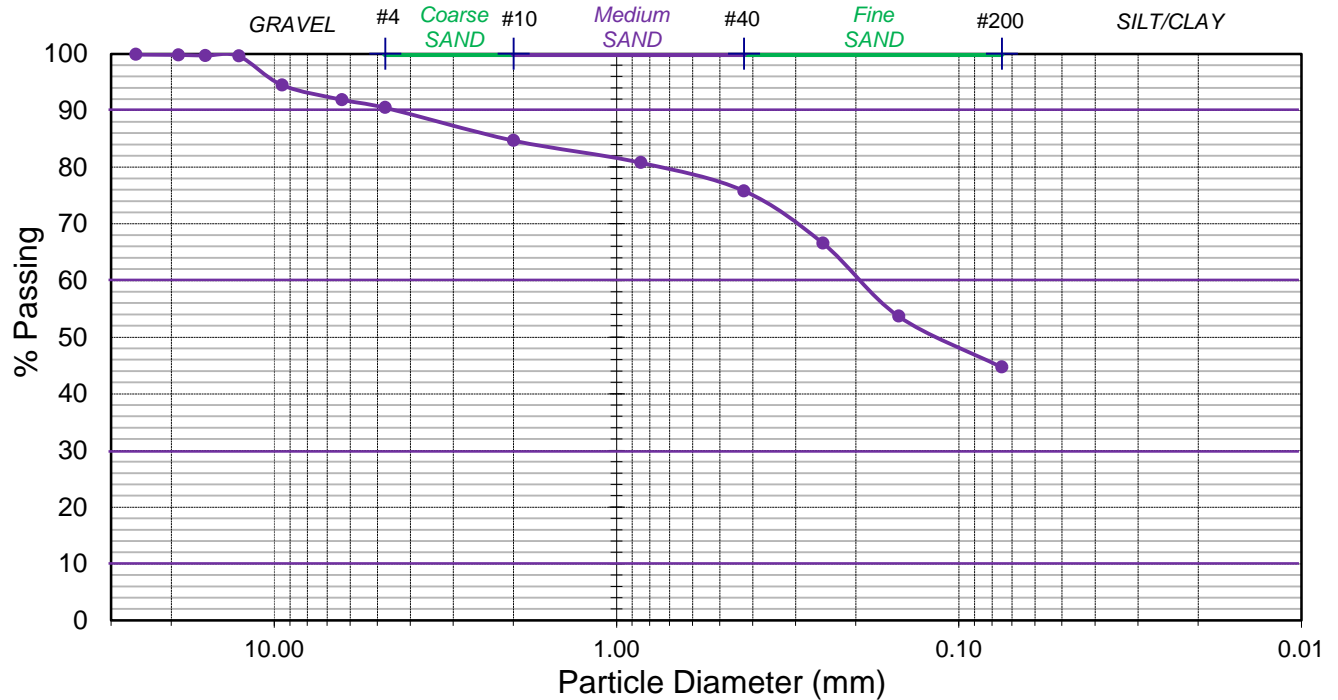
USCS Soil Classification: SM - silty SAND, some gravel

Sieve Number	Diameter (mm)	Soil Retained (%)	Soil Passing (%)	Particles
1"	25.4	0.1	99.9	Gravel
3/4"	19.05	0.1	99.8	
5/8"	15.9	0.1	99.7	
1/2"	12.7	0.1	99.6	
3/8"	9.5	5.1	94.5	
1/4"	6.35	2.6	91.9	
#4	4.75	1.4	90.5	
#10	2.0	5.8	84.7	Sand
#20	0.85	3.9	80.8	
#40	0.425	5	75.8	
#60	0.25	9.2	66.6	
#100	0.150	12.9	53.7	
#200	0.075	9	44.7	
Pan	< 0.075	44.7	44.7	Fines
	TOTAL:	100.0	0.0

Grain Size Distribution Curve Results:

% Gravel: 9.5 % Solids: 81.2
 % Sand: 45.8 % Moisture: 18.8
 % Fines: 44.7 % Organics: ----

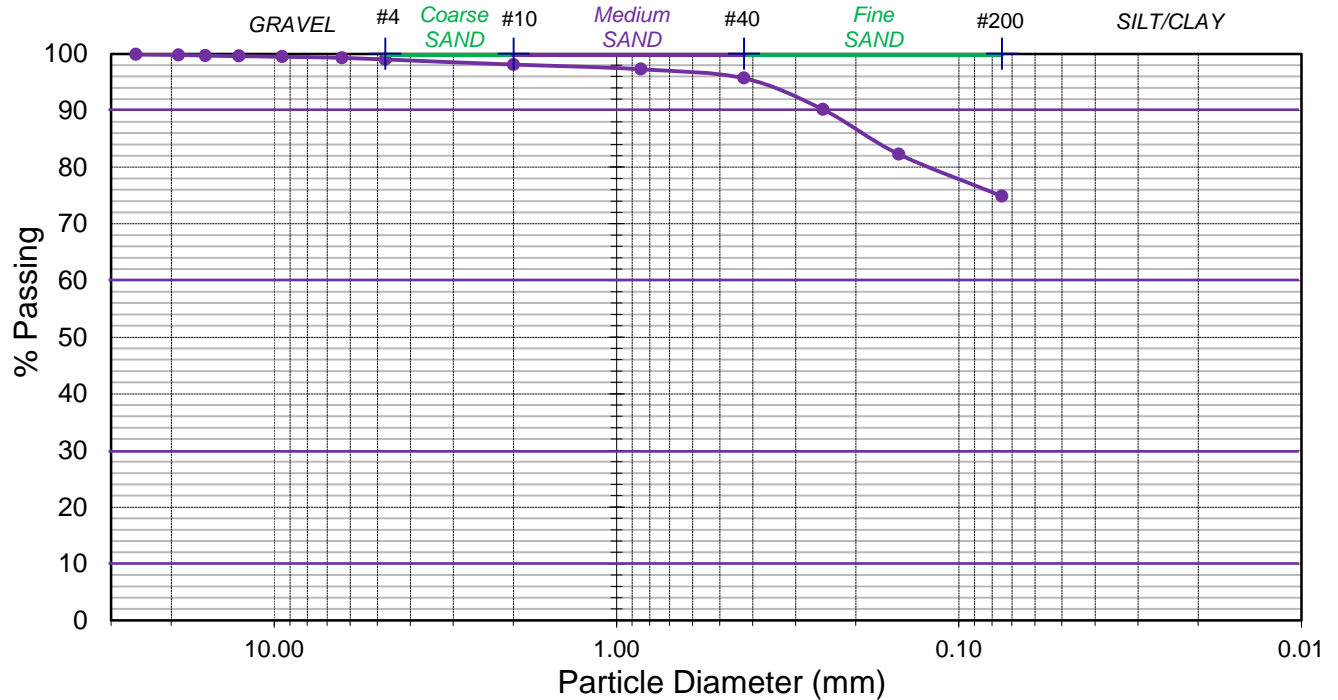
USCS Soil Classification: ML - sandy SILT

Sieve Number	Diameter (mm)	Soil Retained (%)	Soil Passing (%)	Particles
1"	25.4	0.1	99.9	Gravel
3/4"	19.05	0.1	99.8	
5/8"	15.9	0.1	99.7	
1/2"	12.7	0.1	99.6	
3/8"	9.5	0.1	99.5	
1/4"	6.35	0.2	99.3	
#4	4.75	0.3	99	
#10	2.0	0.9	98.1	Sand
#20	0.85	0.8	97.3	
#40	0.425	1.6	95.7	
#60	0.25	5.5	90.2	
#100	0.150	7.9	82.3	
#200	0.075	7.4	74.9	
Pan	< 0.075	74.9	74.9	Fines
	TOTAL:	100.0	0.0

Grain Size Distribution Curve Results:

% Gravel: 1 % Solids: 81.4
 % Sand: 24.1 % Moisture: 18.6
 % Fines: 74.9 % Organics: ----

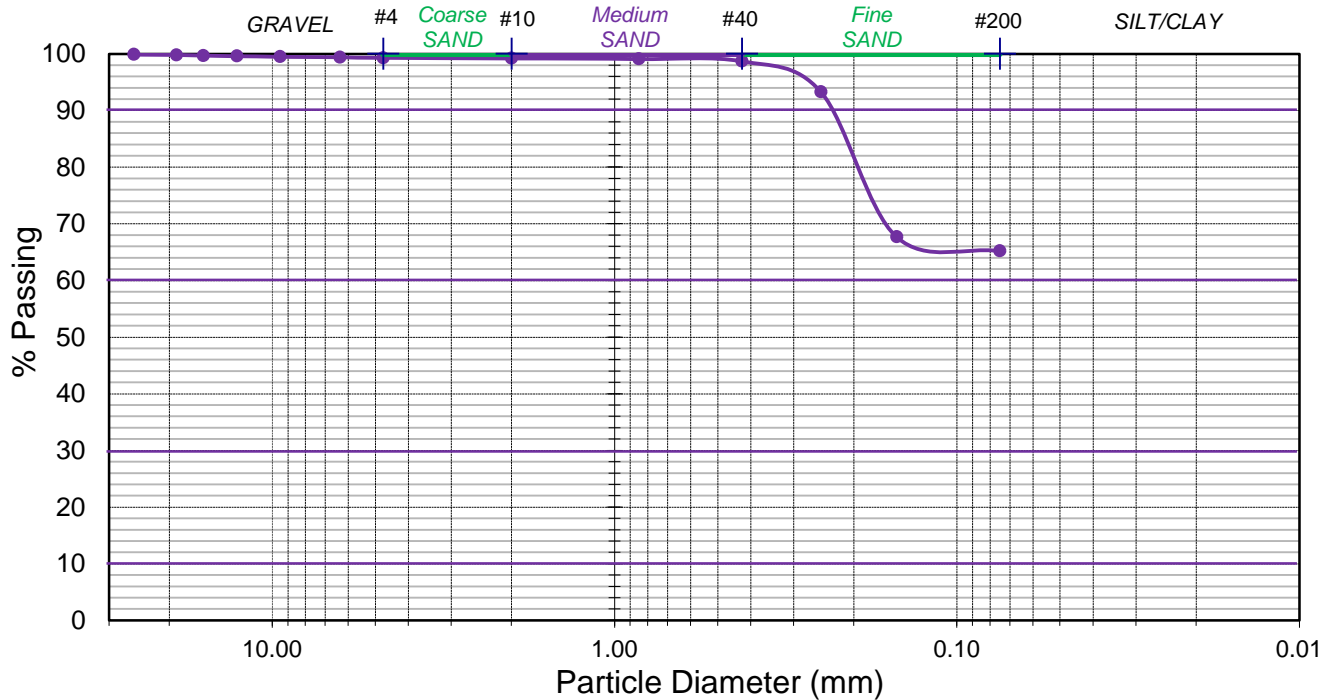
USCS Soil Classification: ML - sandy SILT

Sieve Number	Diameter (mm)	Soil Retained (%)	Soil Passing (%)	Particles
1"	25.4	0.1	99.9	Gravel
3/4"	19.05	0.1	99.8	
5/8"	15.9	0.1	99.7	
1/2"	12.7	0.1	99.6	
3/8"	9.5	0.1	99.5	
1/4"	6.35	0.1	99.4	
#4	4.75	0.1	99.3	
#10	2.0	0.1	99.2	Sand
#20	0.85	0.1	99.1	
#40	0.425	0.4	98.7	
#60	0.25	5.4	93.3	
#100	0.150	25.6	67.7	
#200	0.075	2.5	65.2	
Pan	< 0.075	65.2	65.2	Fines
	TOTAL:	100.0	0.0

Grain Size Distribution Curve Results:

% Gravel: 0.7 % Solids: 85.1
 % Sand: 34.1 % Moisture: 14.9
 % Fines: 65.2 % Organics: ----

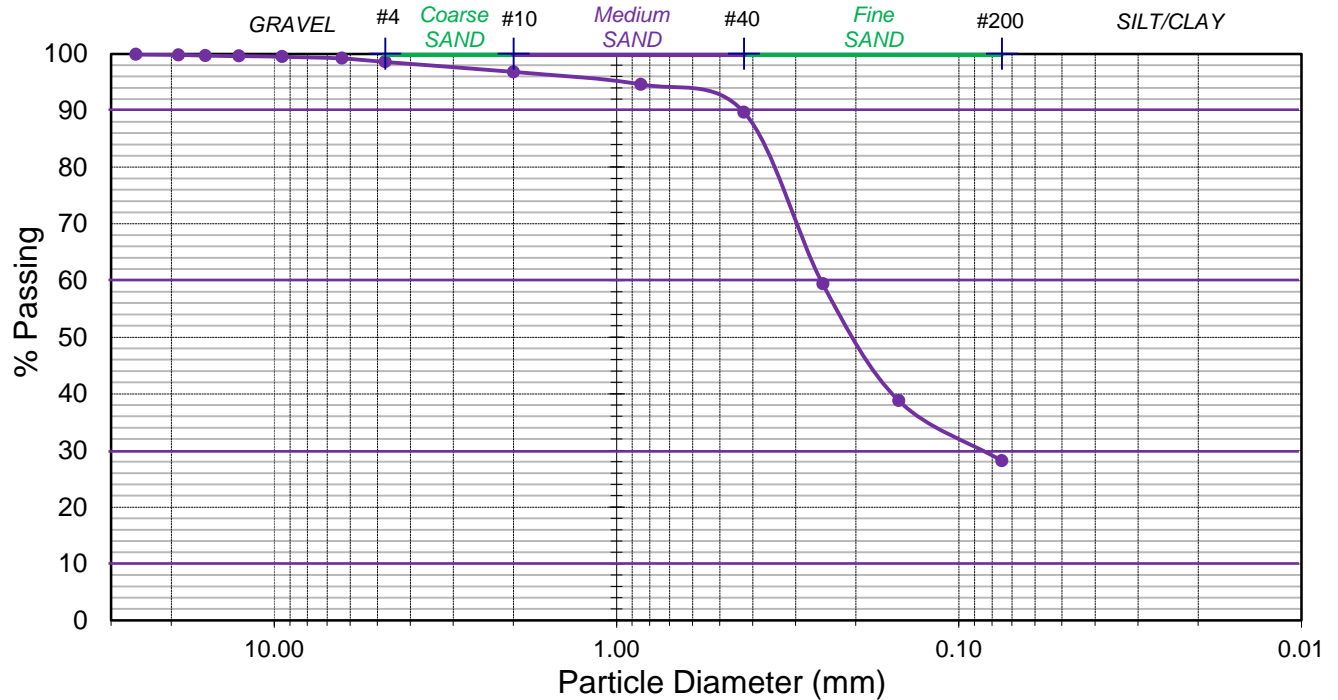
USCS Soil Classification: SM - silty SAND, trace gravel

Sieve Number	Diameter (mm)	Soil Retained (%)	Soil Passing (%)	Particles
1"	25.4	0.1	99.9	Gravel
3/4"	19.05	0.1	99.8	
5/8"	15.9	0.1	99.7	
1/2"	12.7	0.1	99.6	
3/8"	9.5	0.1	99.5	
1/4"	6.35	0.3	99.2	
#4	4.75	0.6	98.6	
#10	2.0	1.8	96.8	Sand
#20	0.85	2.2	94.6	
#40	0.425	4.9	89.7	
#60	0.25	30.3	59.4	
#100	0.150	20.6	38.8	
#200	0.075	10.6	28.2	
Pan	< 0.075	28.2	28.2	Fines
	TOTAL:	100.0	0.0

Grain Size Distribution Curve Results:

% Gravel:	<u>1.4</u>	% Solids:	<u>85</u>
% Sand:	<u>70.4</u>	% Moisture:	<u>15.0</u>
% Fines:	<u>28.2</u>	% Organics:	<u>----</u>

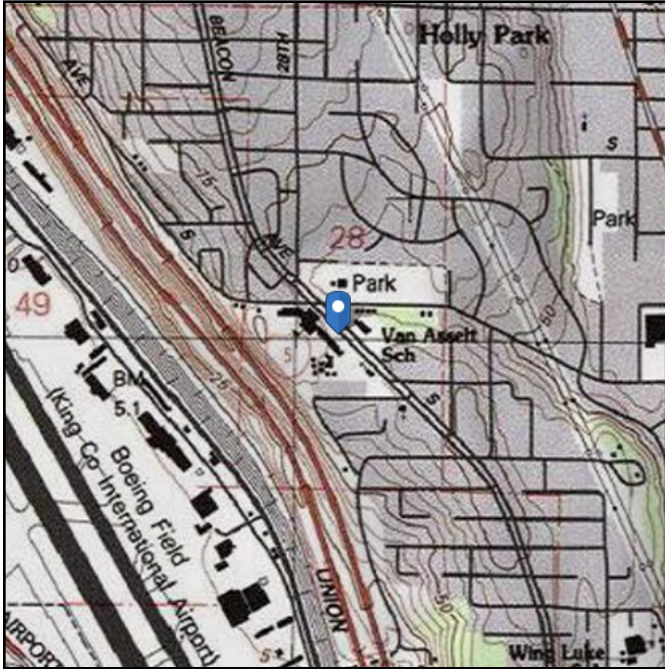
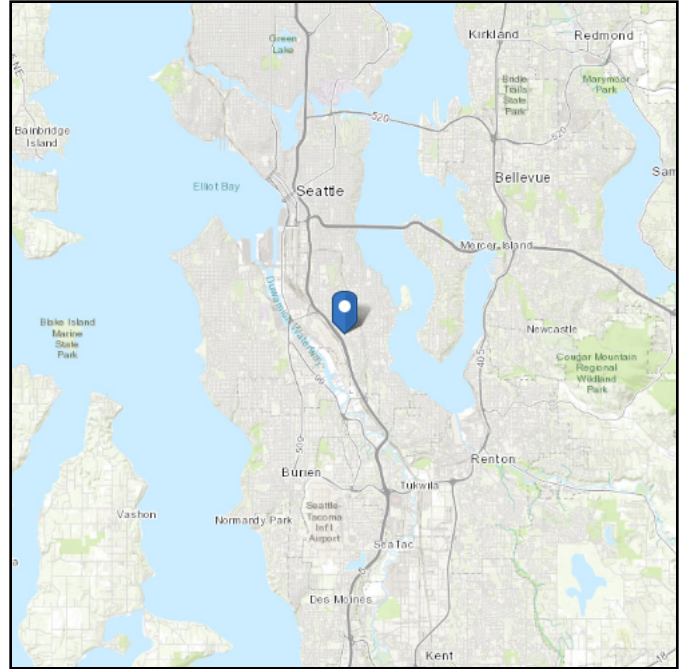
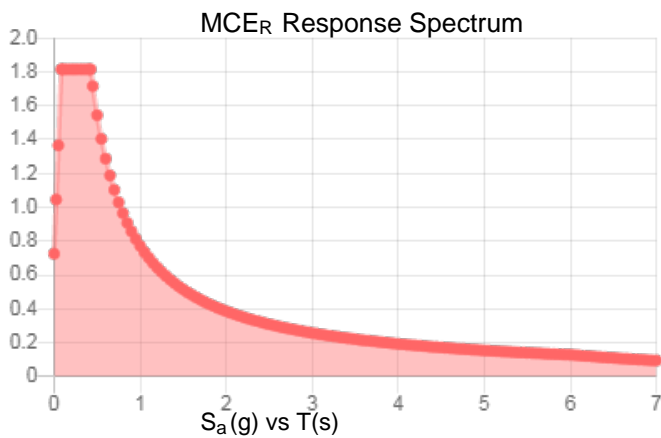
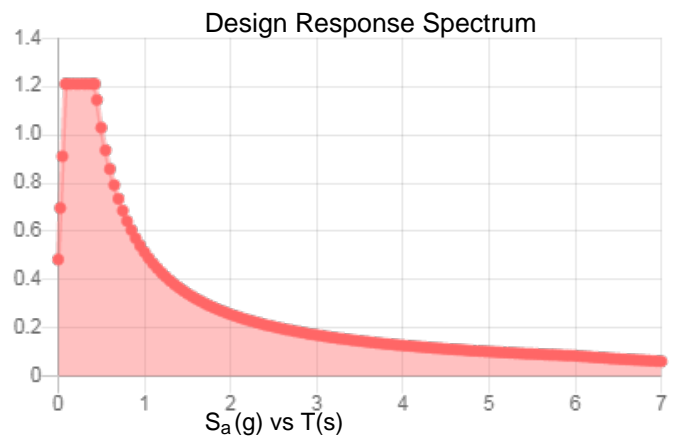
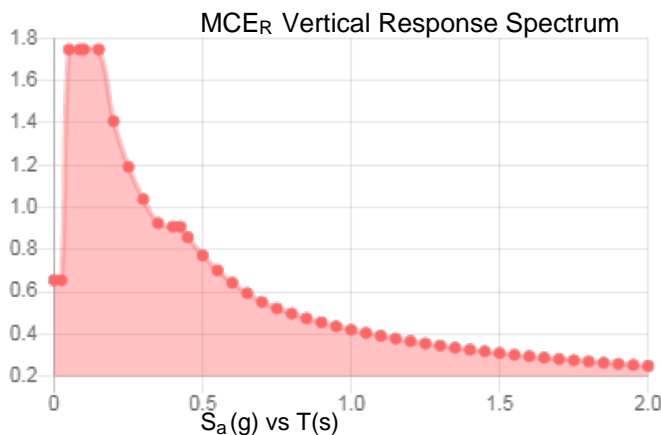
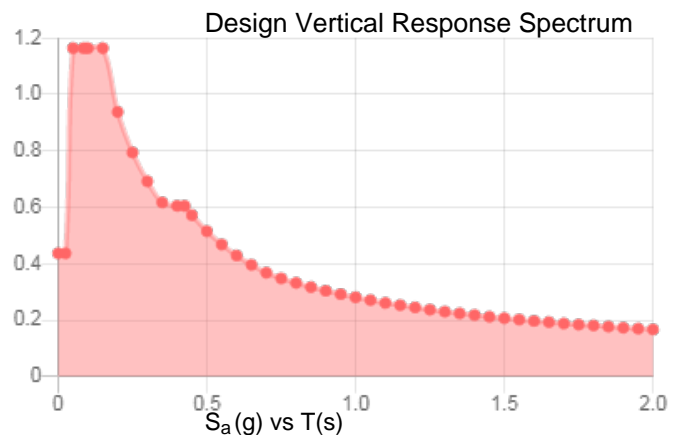
Standard: ASCE/SEI 7-16
Risk Category: II
Soil Class: C - Very Dense
Soil and Soft Rock

Site Soil Class: C - Very Dense Soil and Soft Rock

S_S :	1.513	S_{D1} :	0.515
S_1 :	0.523	T_L :	6
F_a :	1.2	PGA :	0.648
F_v :	1.477	PGA _M :	0.778
S_{MS} :	1.815	F_{PGA} :	1.2
S_{M1} :	0.772	I_e :	1
S_{DS} :	1.21	C_v :	1.203

Seismic Design Category D

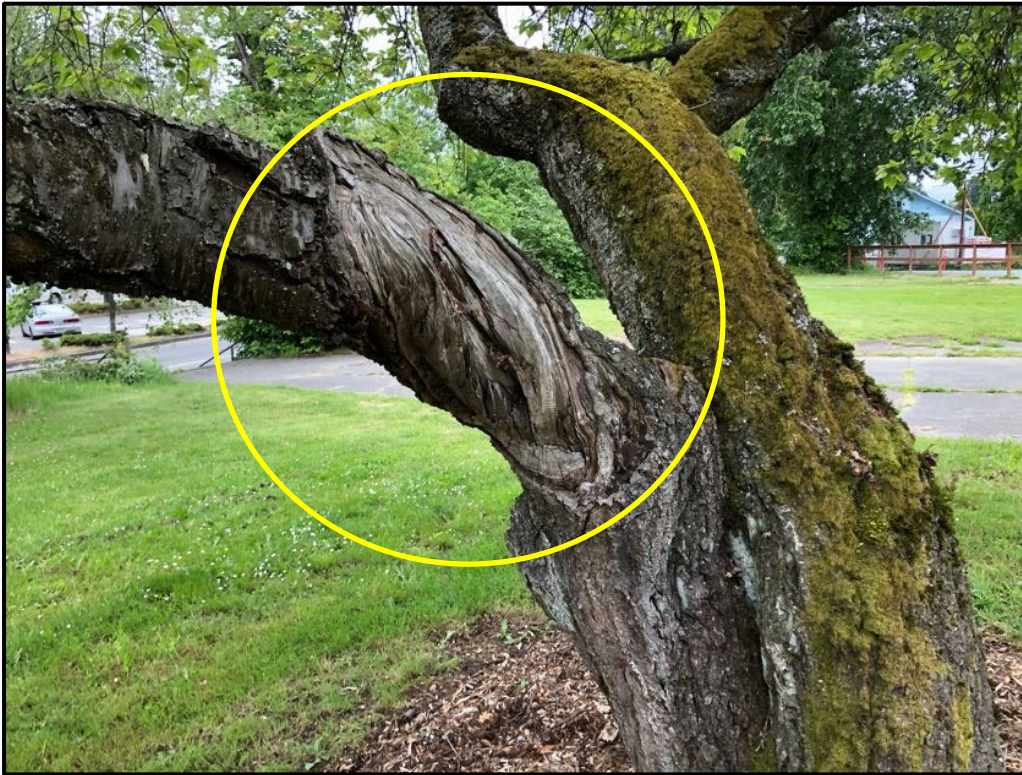
Photo 1. Exceptional tree 123, the yellow circle shows an old branch tear out.

Trees 123 (Photo 1), 125 (Photo 2), 126 (Photo 3), 129 (Photo 4), are all exceptional by size and regulated per the Directors Rule 16-2008.

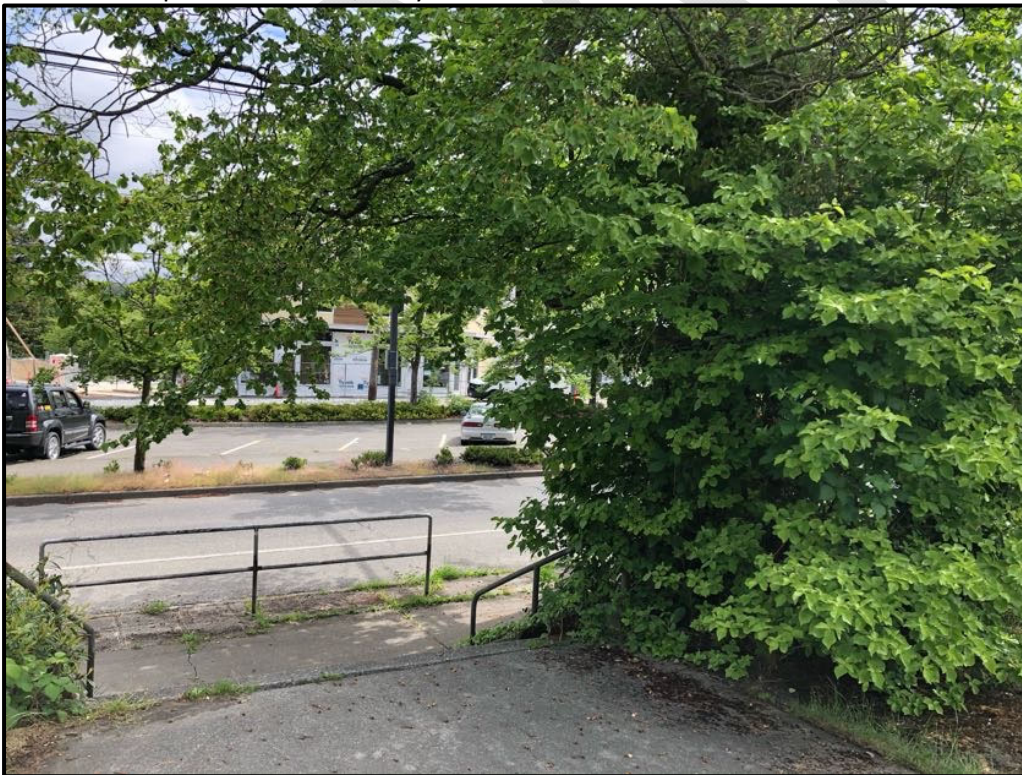
Photo 2. Exceptional tree 125 is in close proximity to an existing staircase and has a large amount of ivy on the trunk

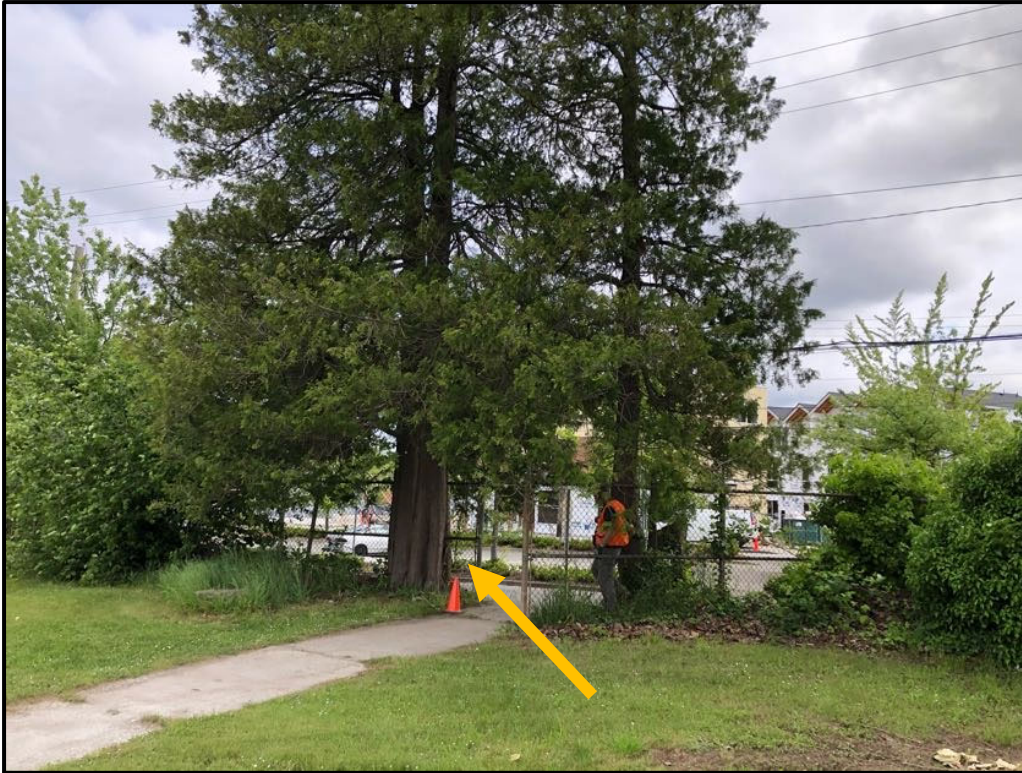
Photo 3. Exceptional tree 126, is in close proximity to an existing staircase and abutting the fence.

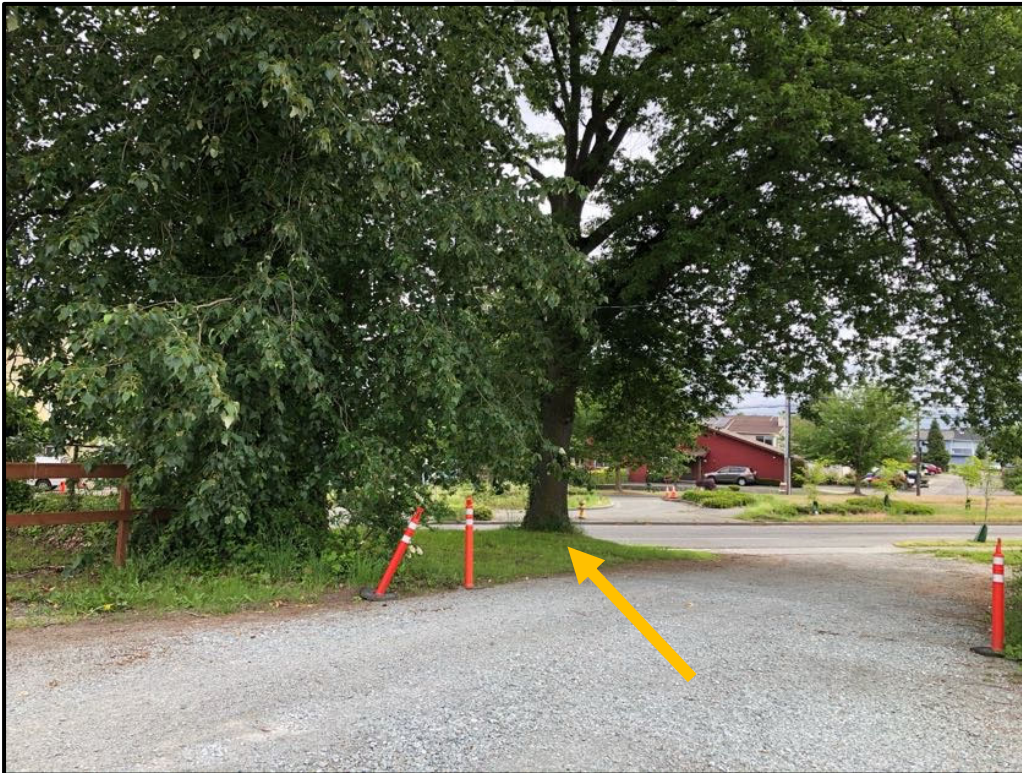
Photo 4. Arrow pointing to exceptional tree 129 is in close proximity to an existing gravel driveway.

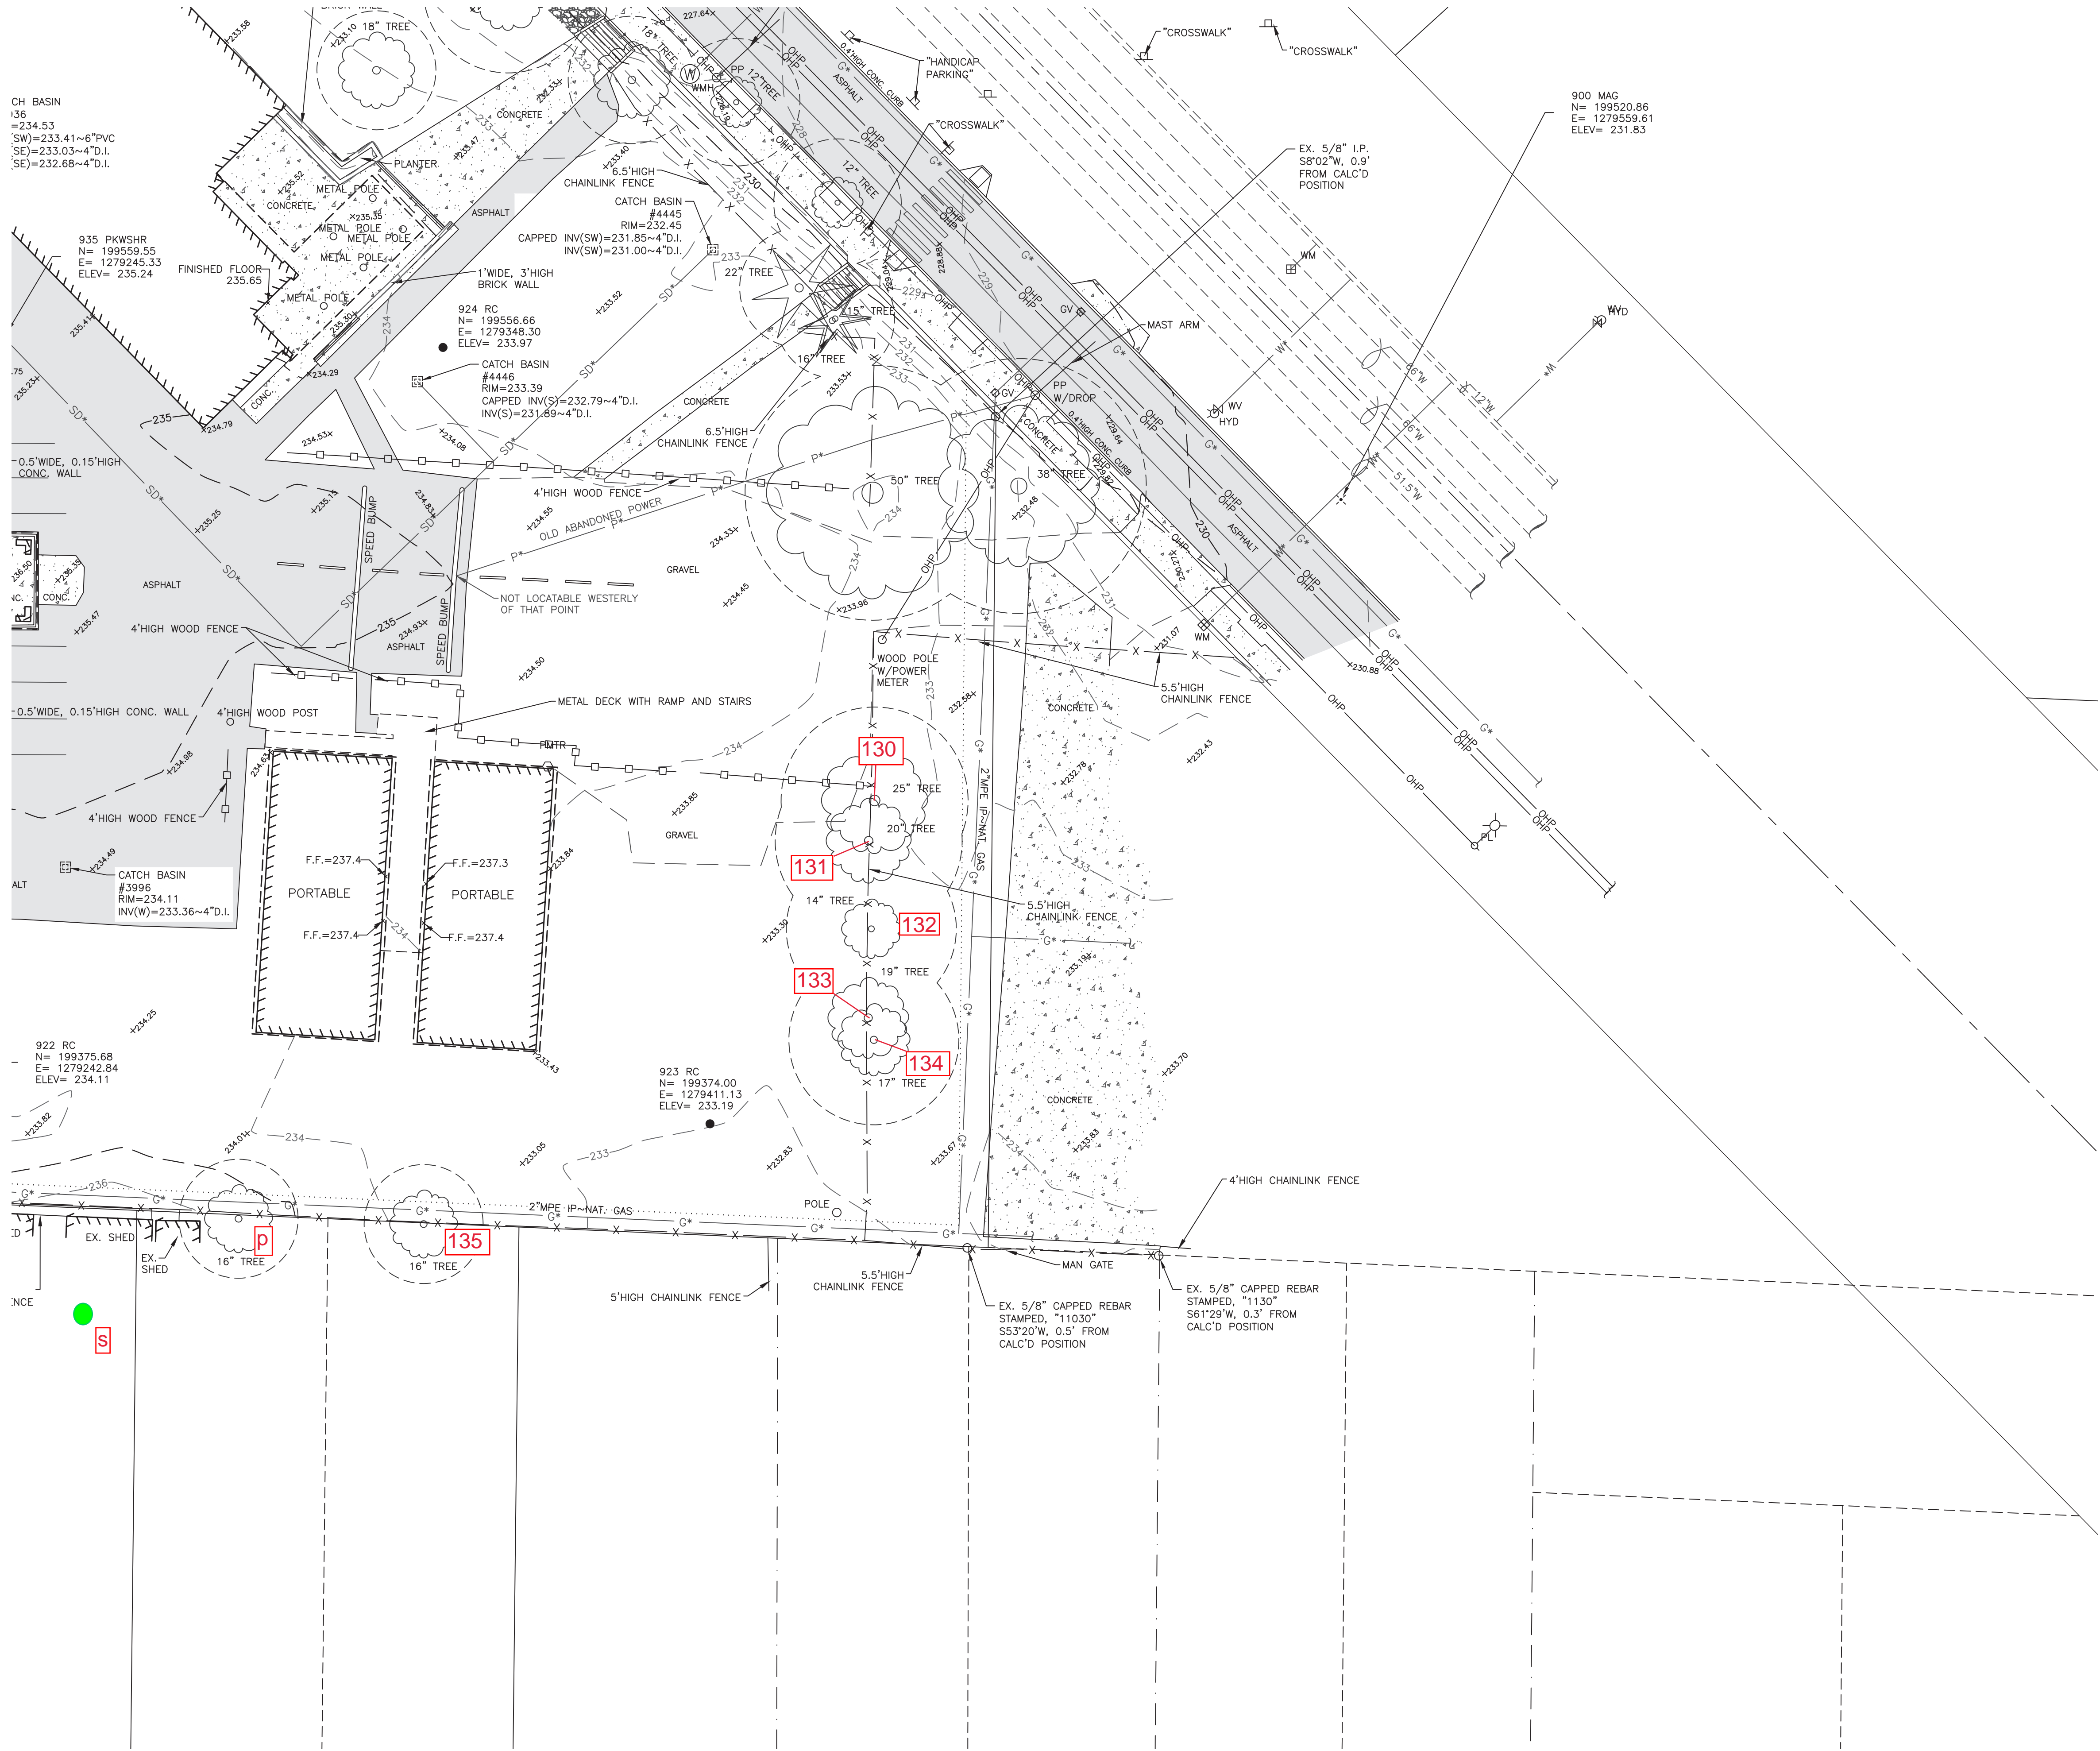
A PORTION OF THE
NE 1/4, SE 1/4, & THE NW 1/4, SE 1/4
ALL IN SECTION 28, TOWNSHIP 24 N, RANGE 4 E, W.M.

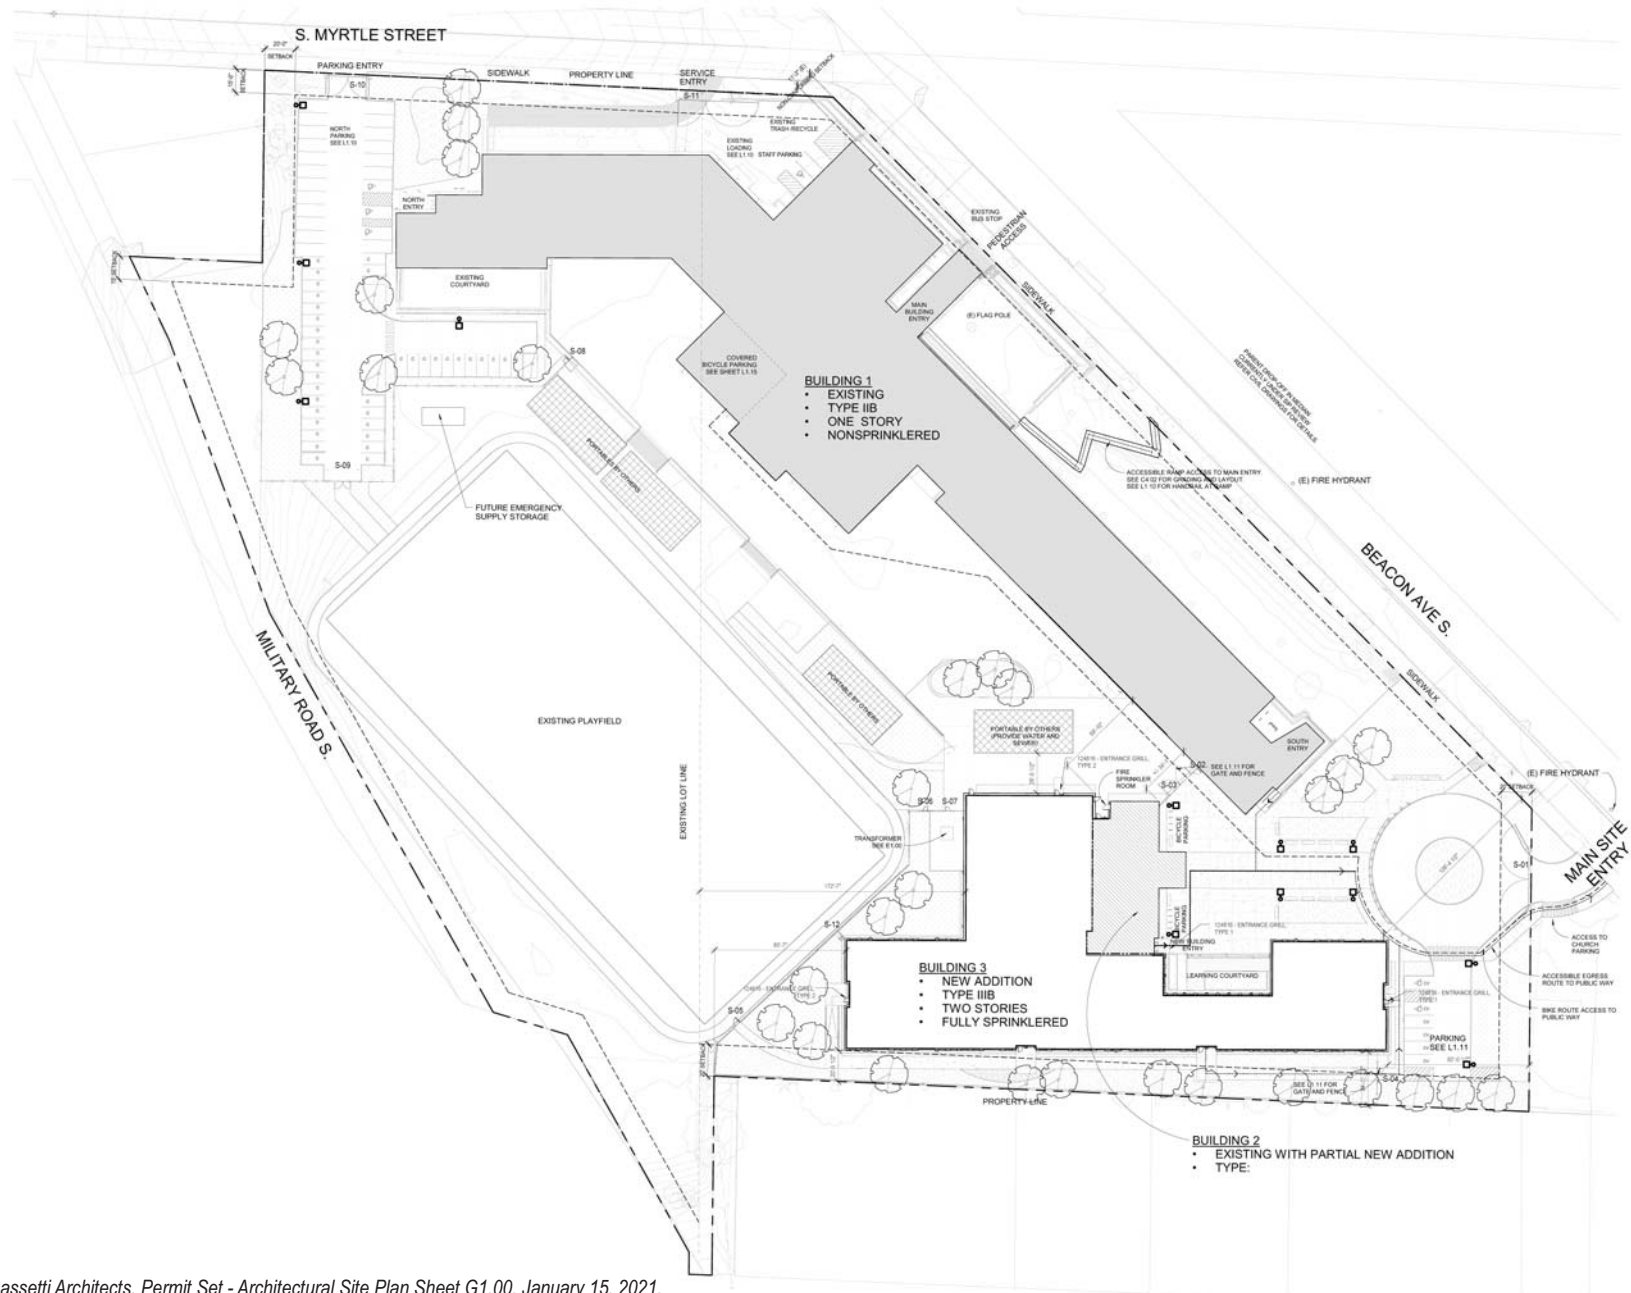
The site access configuration was developed through extensive coordination with SDOT, Seattle Department of Construction and Inspections (SDCI), the Seattle Schools Traffic Safety Committee (SSTSC), and SPS Transportation. Based on this coordination, the project would reconfigure the existing Beacon Avenue S median strip adjacent to the school site to create a school load/unload zone for automobiles. This median reconfiguration would consist of the elements listed below.

- The existing angle parking spaces would be converted to about 10 parallel load/unload/parking spaces, to accommodate passenger vehicle load/unload for students. During the morning arrival and afternoon departure periods, these spaces would be signed for School Load Only, but could be available for parking at other times of day.
- An additional mid-block crosswalk would be added extending across both directional segments of Beacon Avenue S and aligned with the school's existing main entrance (about 275 feet southeast of S Myrtle Street).
- Both the existing and new crosswalk would be raised to curb height within the median.
- ADA-compliant ramps would be added for the new and existing mid-block crosswalks across both segments of Beacon Avenue S.
- Speed cushions would be added approaching both crosswalks in both directions.
