Alki Elementary School Addition and Renovation Project

Draft SEPA Checklist

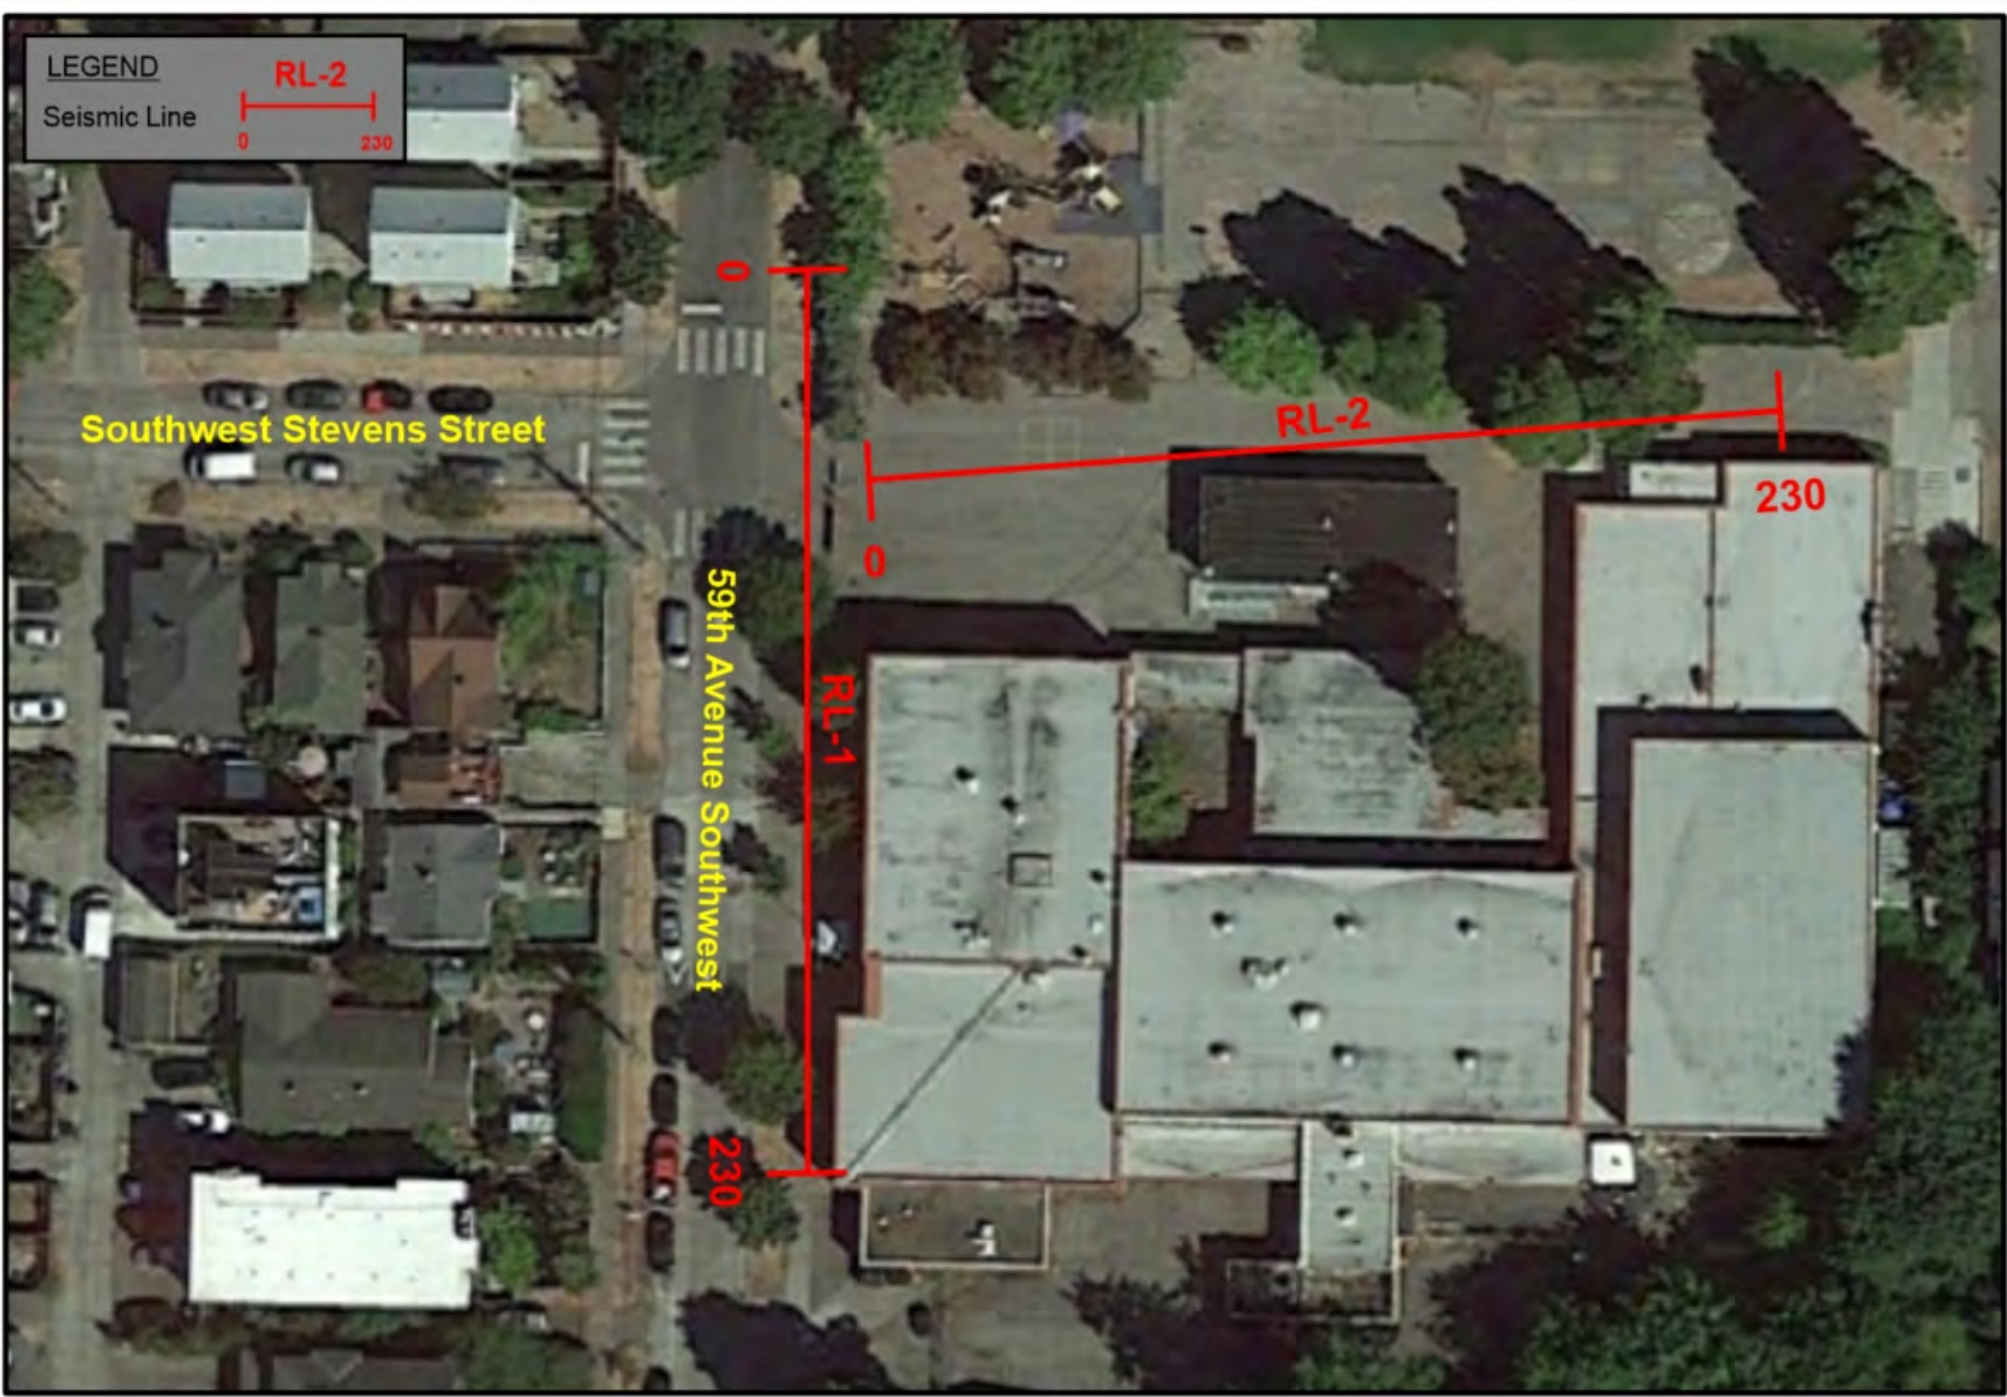
Figure 2

**SEISMIC LINE LOCATION
MAP**

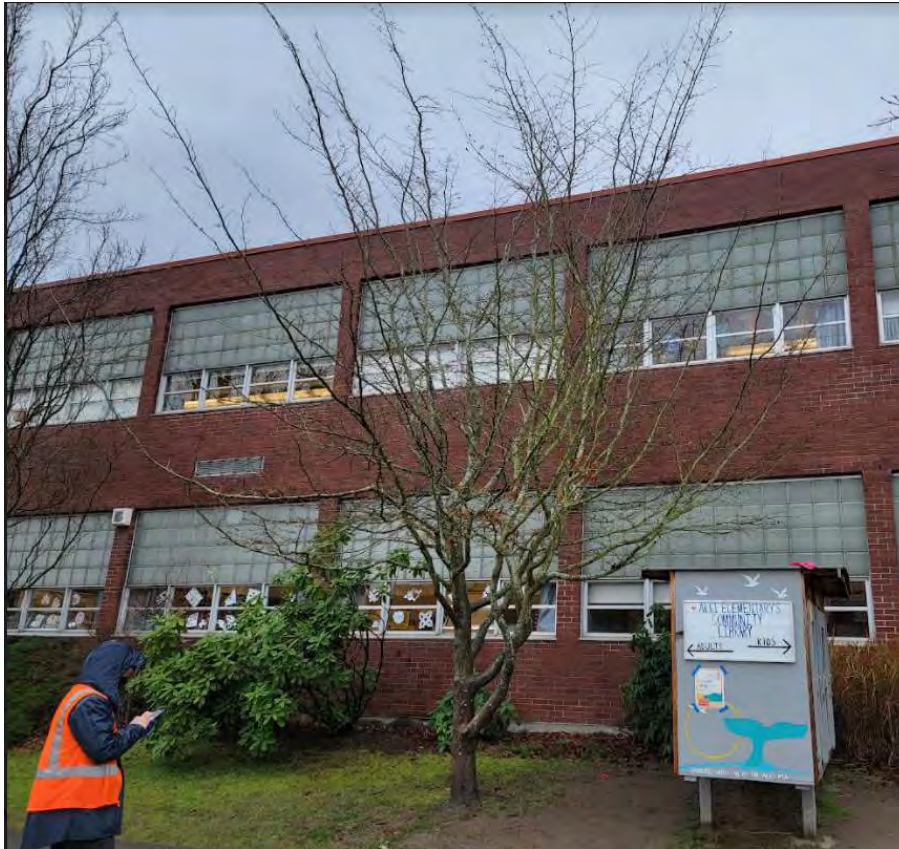
Photograph 5. View looking east at Tree 429, a Persian ironwood identified as a tree in the Seattle Public School's Stanford Tree collection program.

Tree 429 is a Persian ironwood (*Parrotia persica*) tree identified as being in the Seattle Public School's Stanford Tree collection program (Photo 5). This tree, and tree 430 and English oak (*Quercus robur*), are in good health and structural condition. Both are good candidates for retention if the building envelope is not extended to the west.

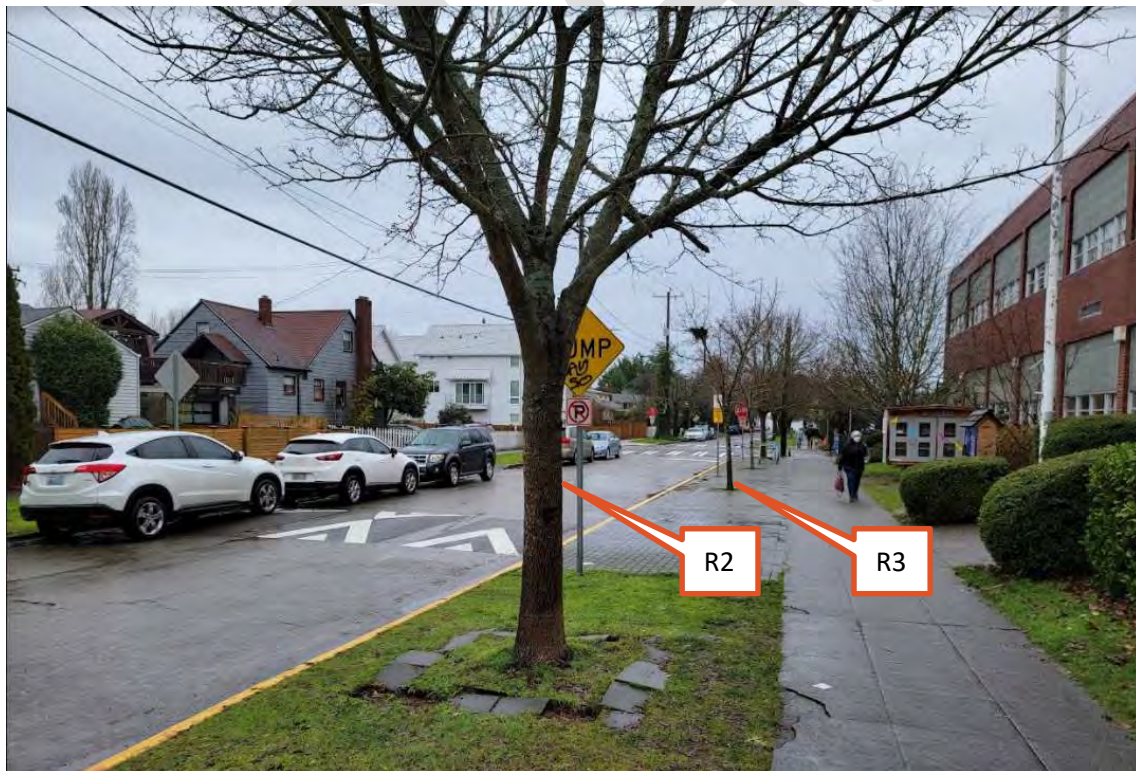
Photograph 8. View looking north at the trees in the right-of-way. The trees have signs that indicate they were donated by a local business and family.

Rights of ways trees are identified as R1 through R5. The trees located west of the school property within a planting strip between the sidewalk and road. All five trees are red maple (*Acer rubrum*) trees (Photos 7 & 8).

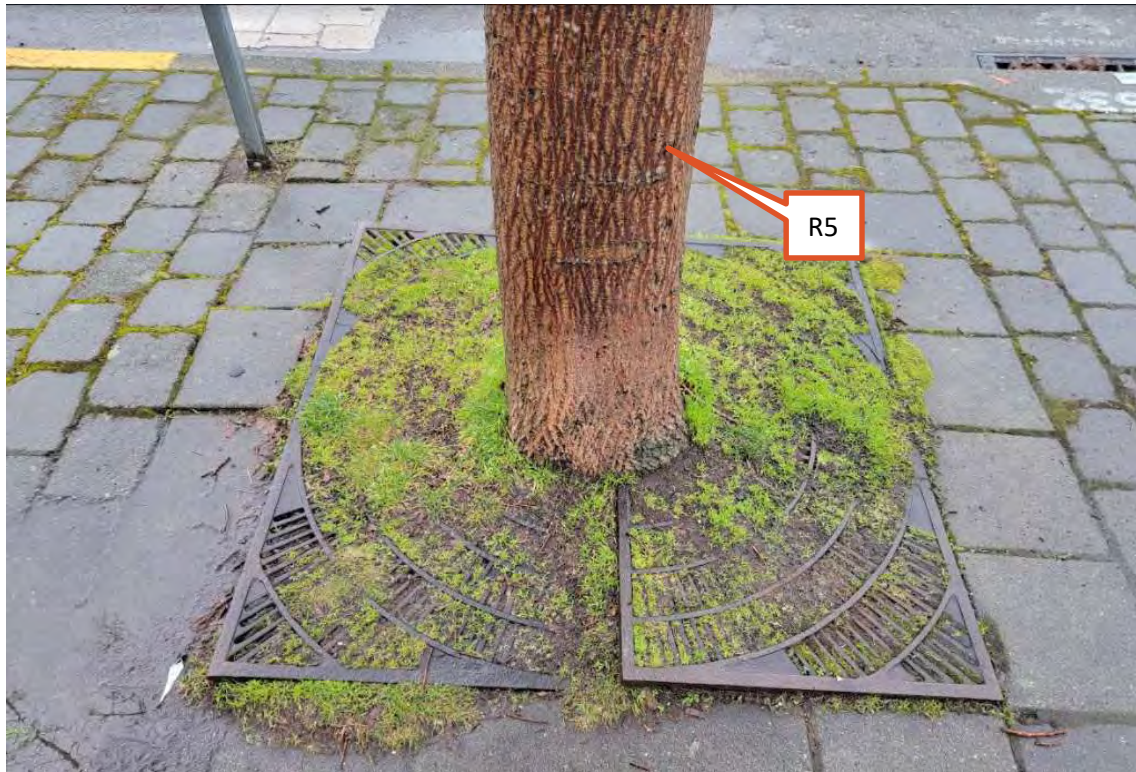
Photograph 9. Right-of-way trees to the north of the row are beginning to envelop the tree grates.

Each of the trees has an engraved paver indicating a company, person, or family that has dedicated the tree to the site. The base of Tree 5 has started to envelop the tree grate over the root zone (Photo 9). The grate will need to be cut away or removed to ensure the long-term viability of the tree.

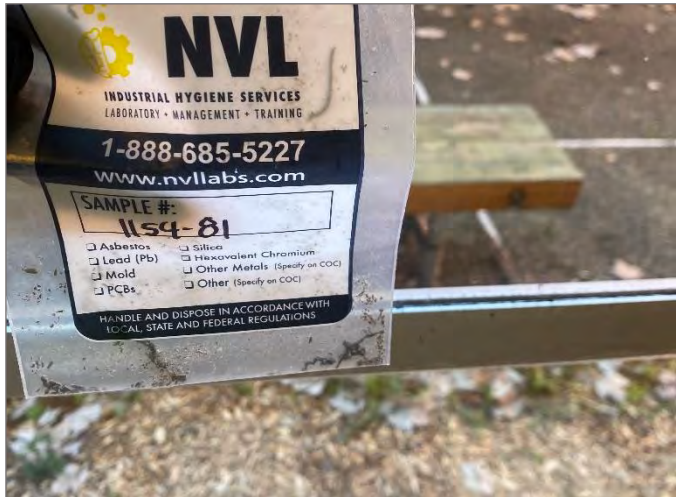
Photo #5: Sample 11541-81: **ACM Black window caulking (2-3% Chrysotile)** on metal frame windows 7'x7'

Location: North Central Corridor

Quantity: 150 SF

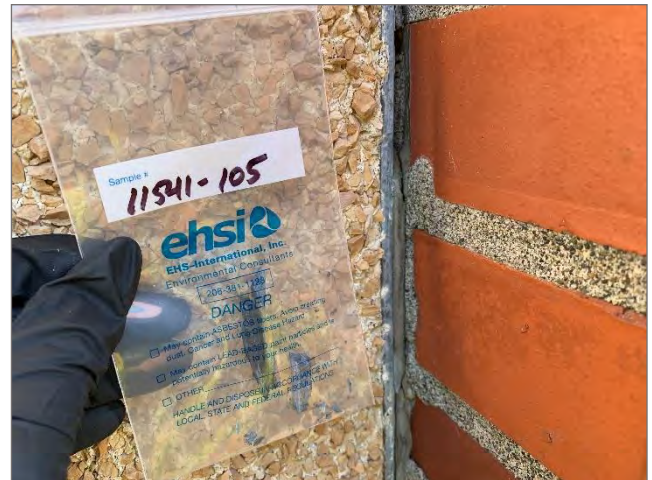
Photo #6: Sample 11541-105: **ACM Gray caulking (2% Chrysotile)** joining brick/marblecrete

Location: Throughout exterior

Quantity: 550 LF

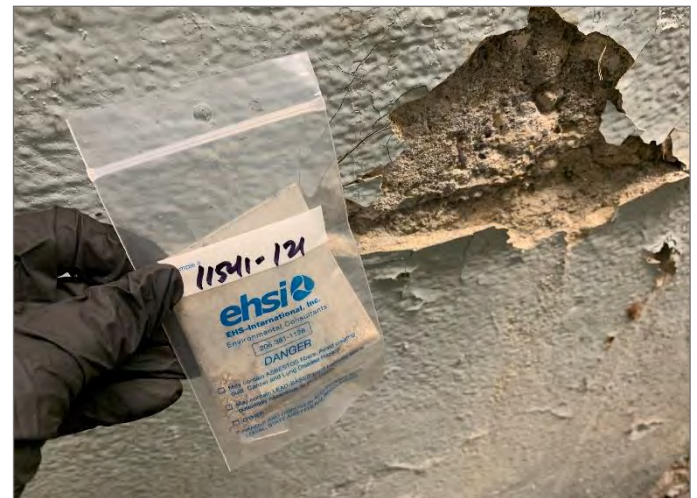
Photo #8: Sample 11541-121: **White skim coat (2% Chrysotile)** on concrete walls

Location: Boiler Room
