Alki Elementary School Addition and Renovation Project

Final SEPA Checklist

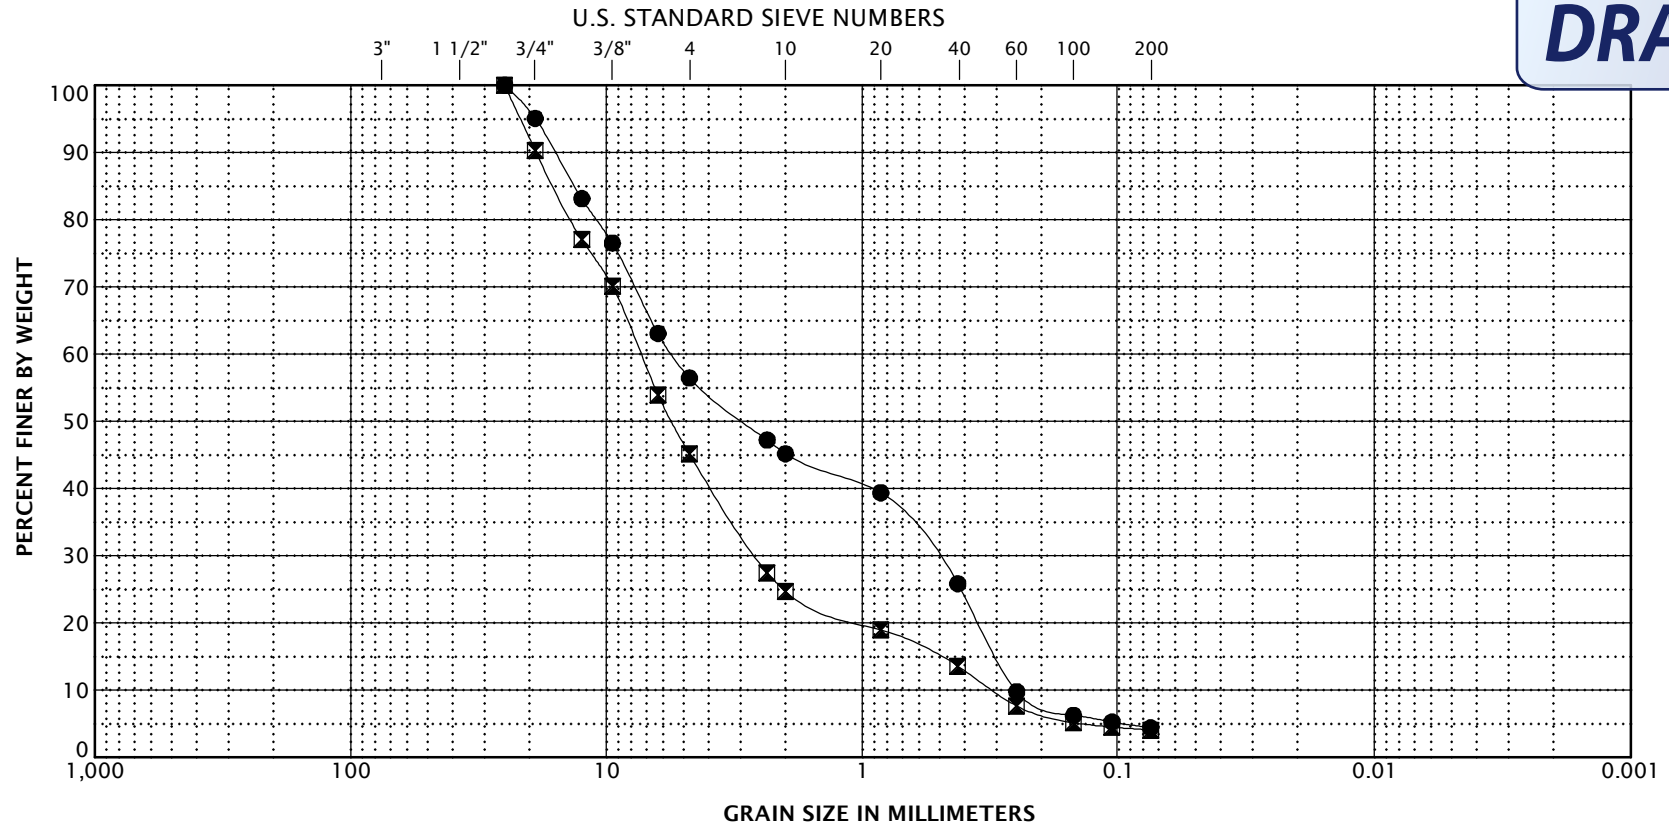
BOULDERS	COBBLES	GRAVEL		SAND			FINES	
		COARSE	FINE	COARSE	MEDIUM	FINE	SILT	CLAY

KEY	EXPLORATION NUMBER	SAMPLE DEPTH (FEET)	MOISTURE CONTENT (PERCENT)	D60	D50	D30	D10	D5	GRAVEL (PERCENT)	SAND (PERCENT)	SILT (PERCENT)	CLAY (PERCENT)
●	B-3	2.5	9	5.53	2.92	0.53	0.25	0.10	44	52		4
◻	B-6	2.5	6	7.35	5.55	2.61	0.31	0.14	55	41		4

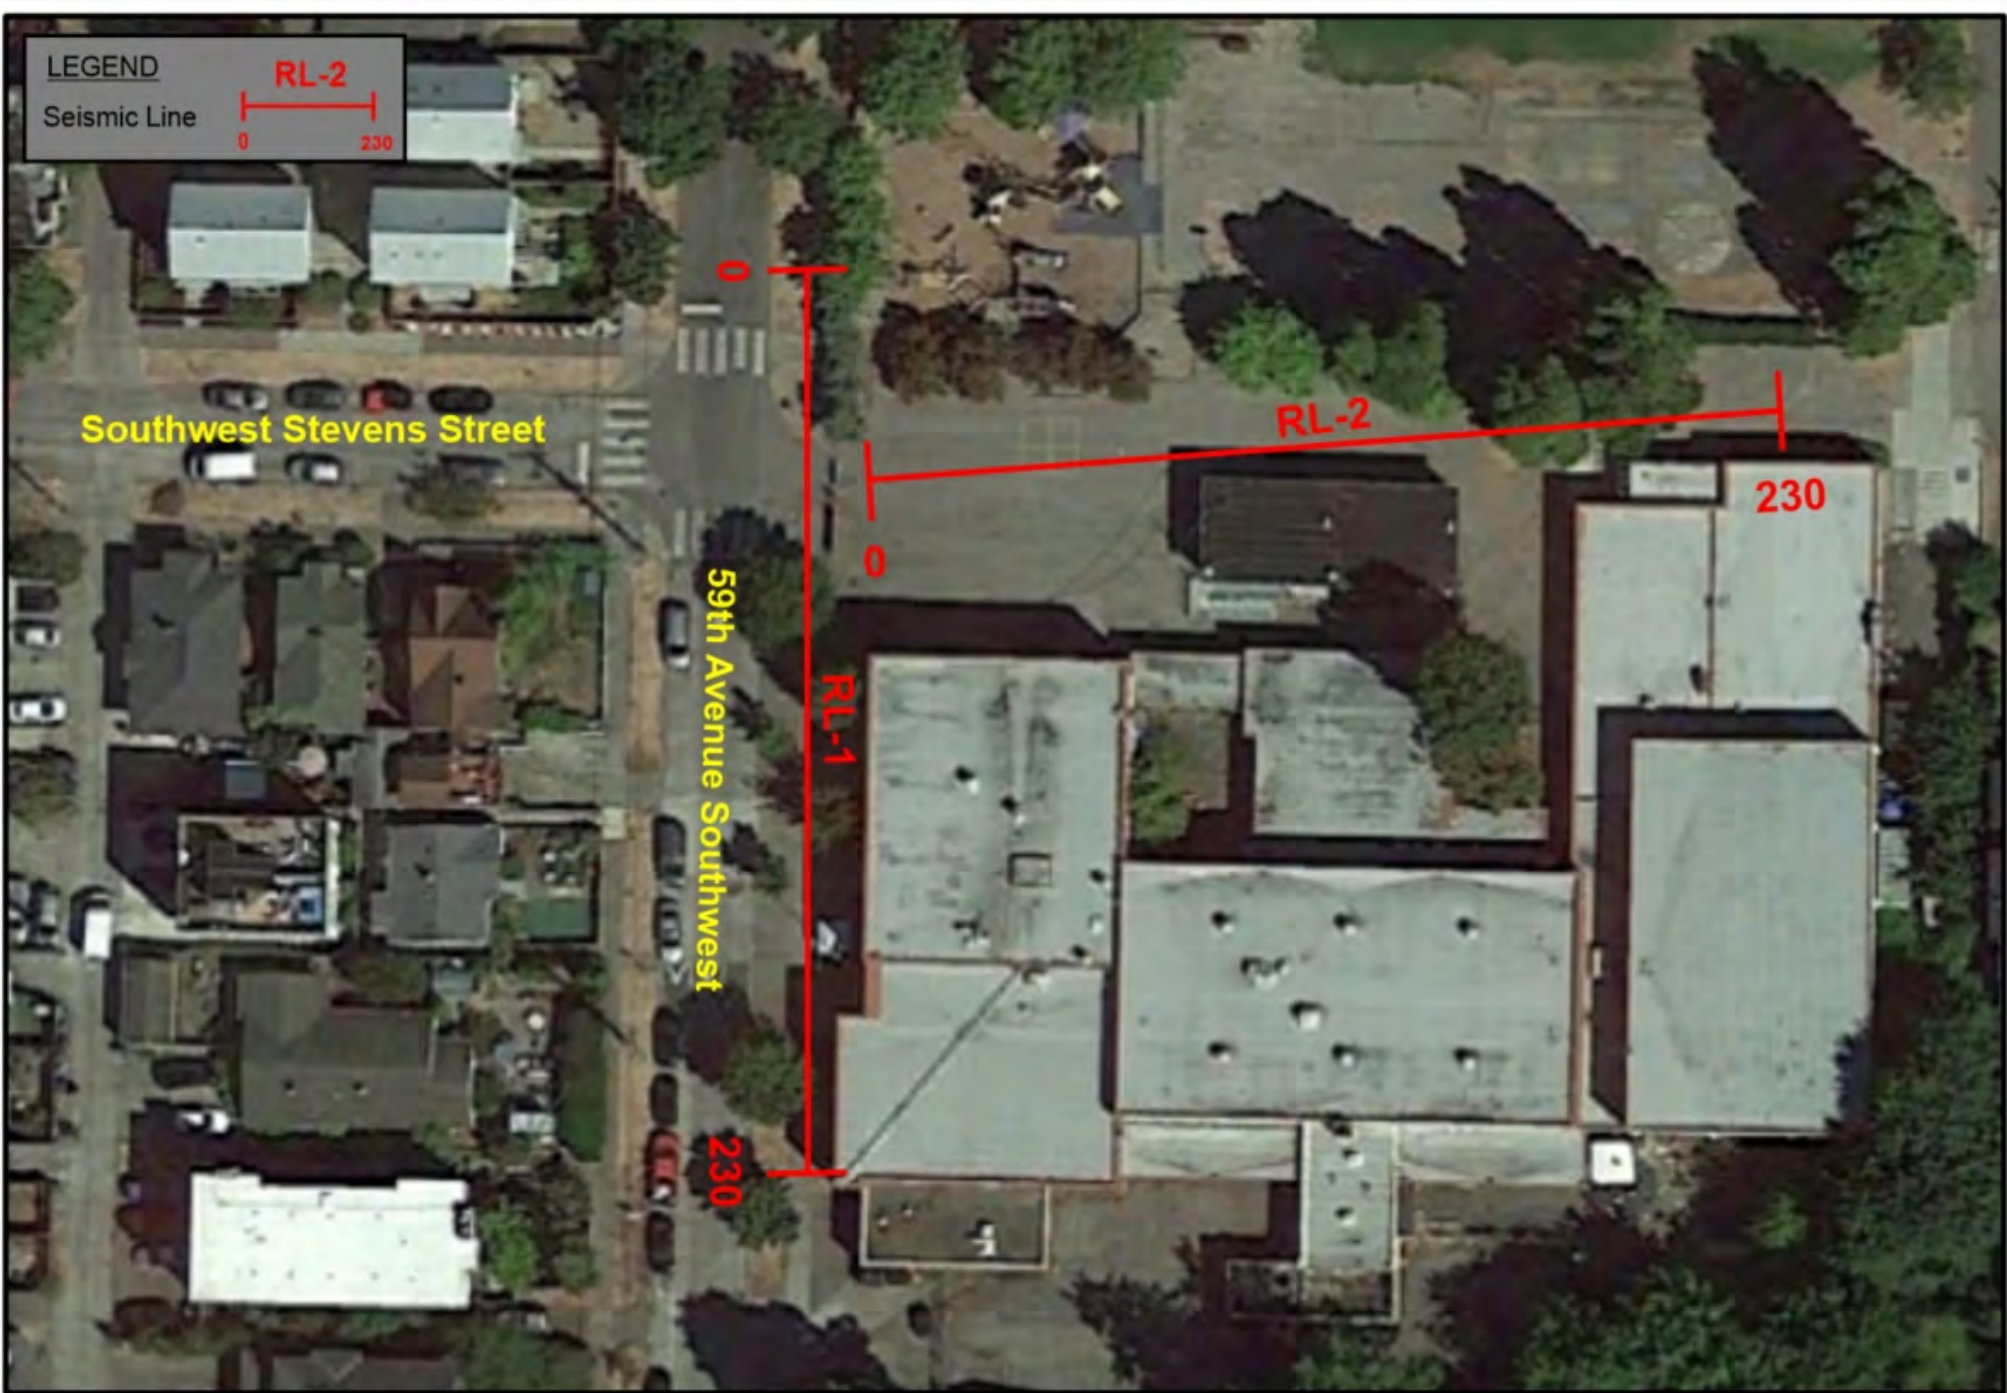
Figure 2

SEISMIC LINE LOCATION
MAP

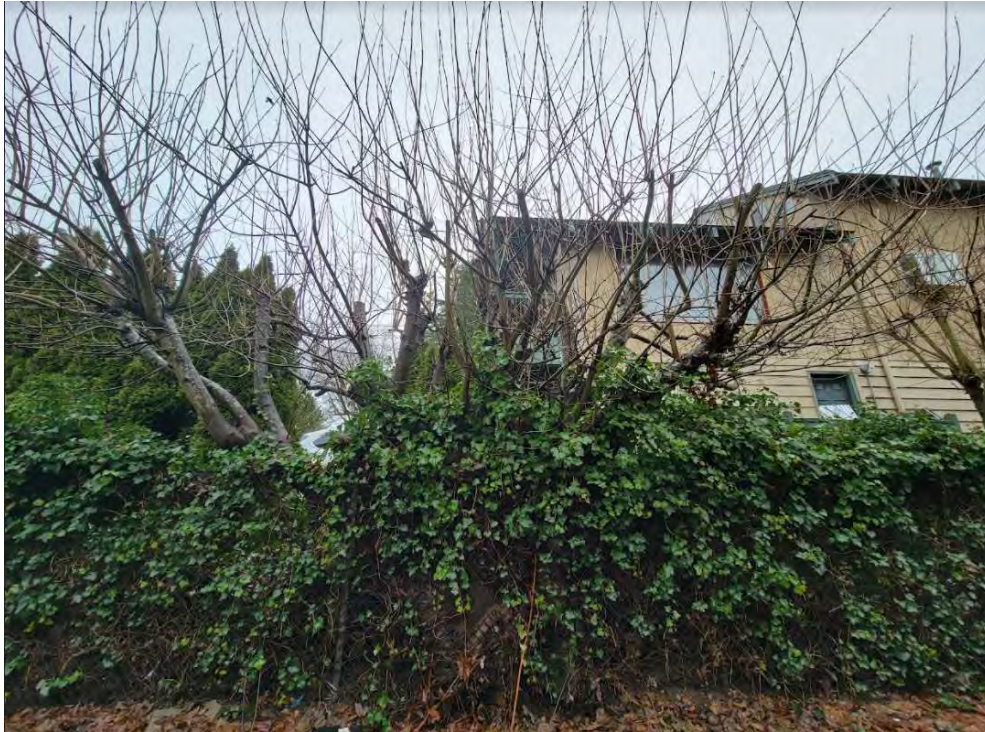
Photograph 1. Tree 399, located on the east perimeter of the property. The tree is growing between a retaining wall and a fence, limiting access to the base for an accurate diameter measurement.

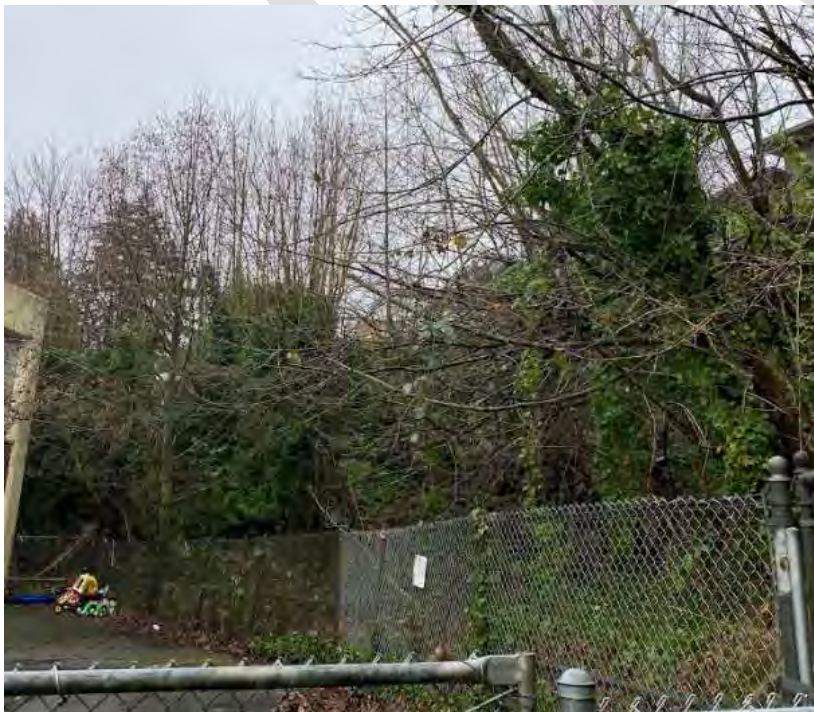
Photograph 2. View looking at the southeast corner of the property. In this section tree numbers range from 400 through 425.

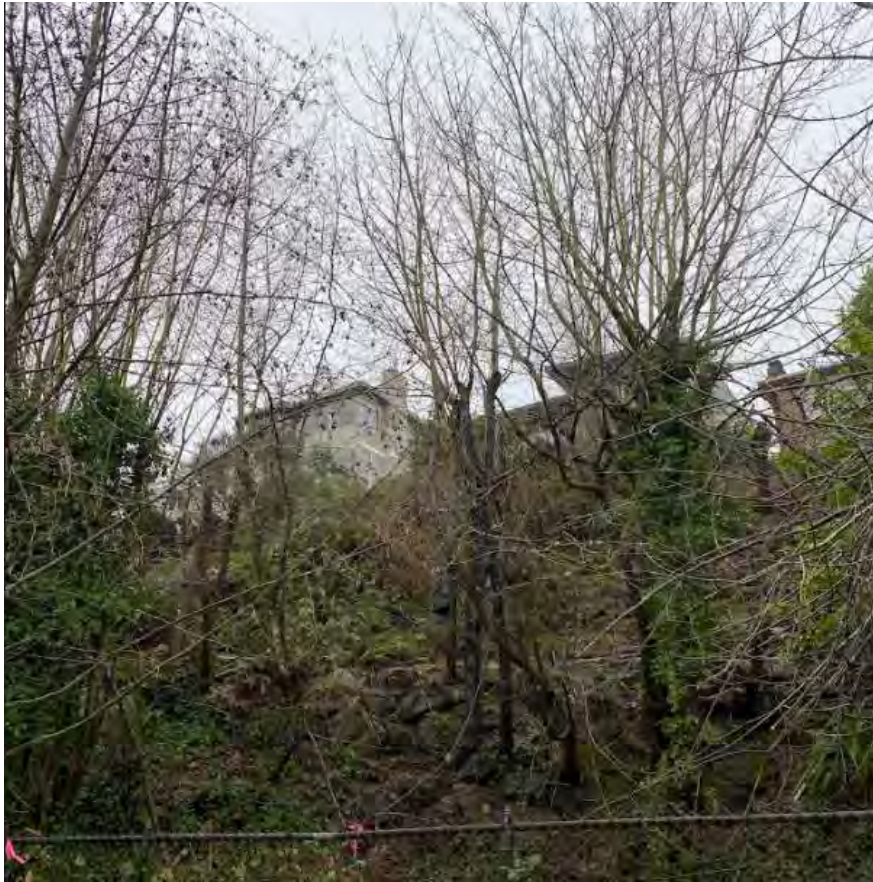
Photograph 3. View looking towards the rockeries in the southeast section of the site.

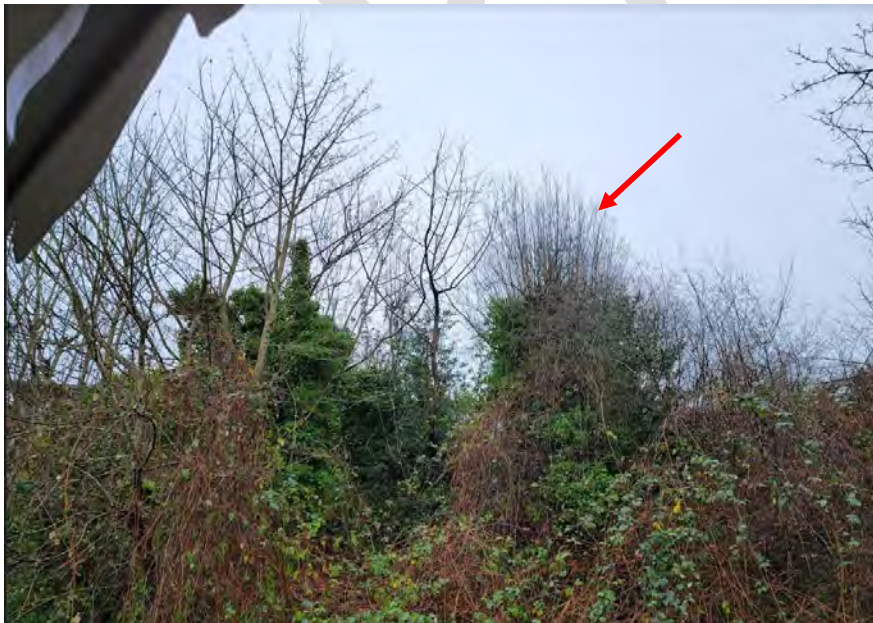
Photograph 4. View looking south at Trees 419 through 425. The trees are covered in invasive vines. The red arrow points to Tree A, an off-site tree that may qualify as exceptional once positively identified.

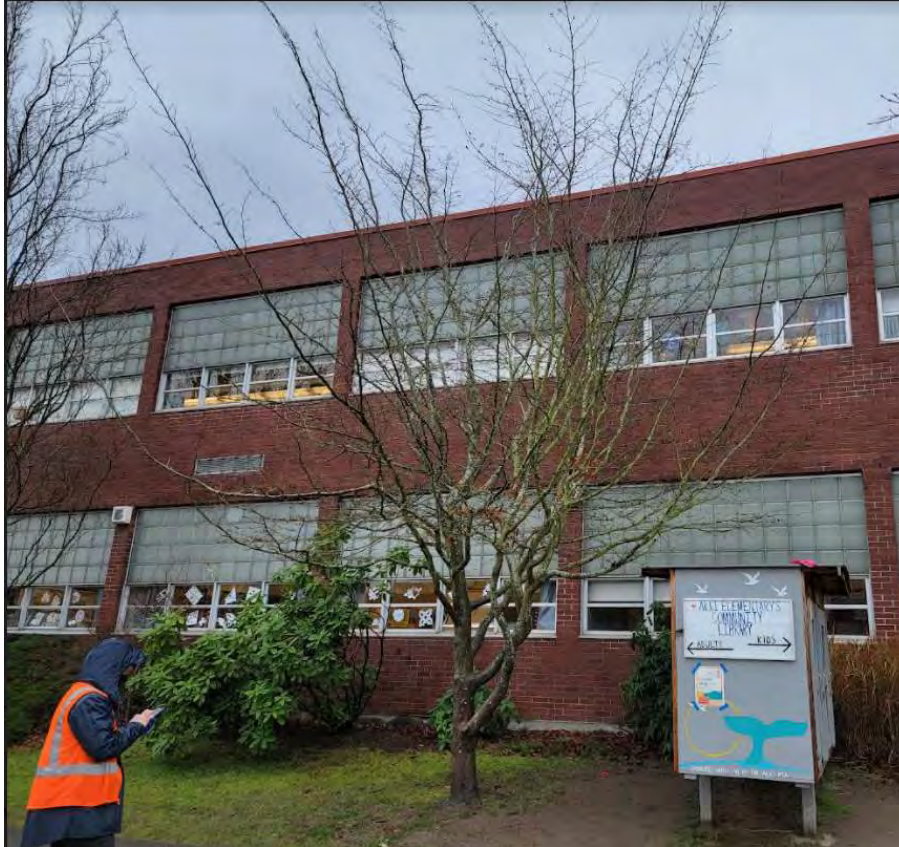
Photograph 5. View looking east at Tree 429, a Persian ironwood identified as a tree in the Seattle Public School's Stanford Tree collection program.

Tree 429 is a Persian ironwood (*Parrotia persica*) tree identified as being in the Seattle Public School's Stanford Tree collection program (Photo 5). This tree, and tree 430 and English oak (*Quercus robur*), are in good health and structural condition. Both are good candidates for retention if the building envelope is not extended to the west.

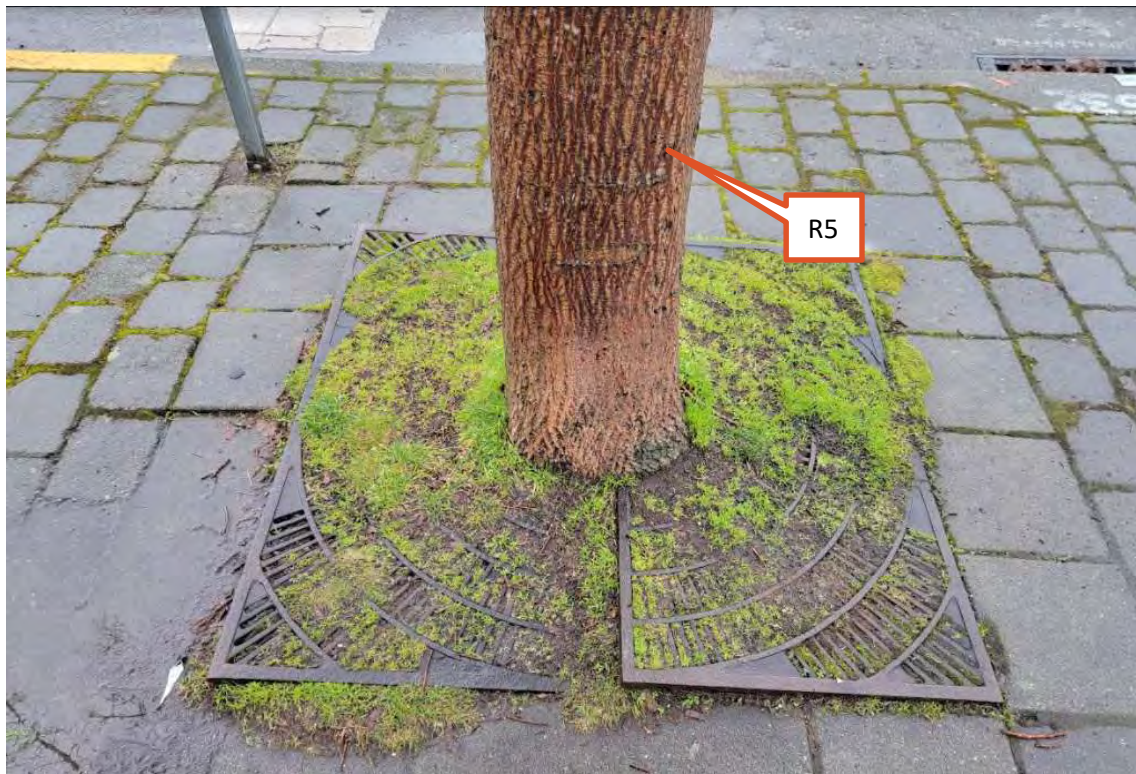
Photograph 9. Right-of-way trees to the north of the row are beginning to envelop the tree grates.

Each of the trees has an engraved paver indicating a company, person, or family that has dedicated the tree to the site. The base of Tree 5 has started to envelop the tree grate over the root zone (Photo 9). The grate will need to be cut away or removed to ensure the long-term viability of the tree.

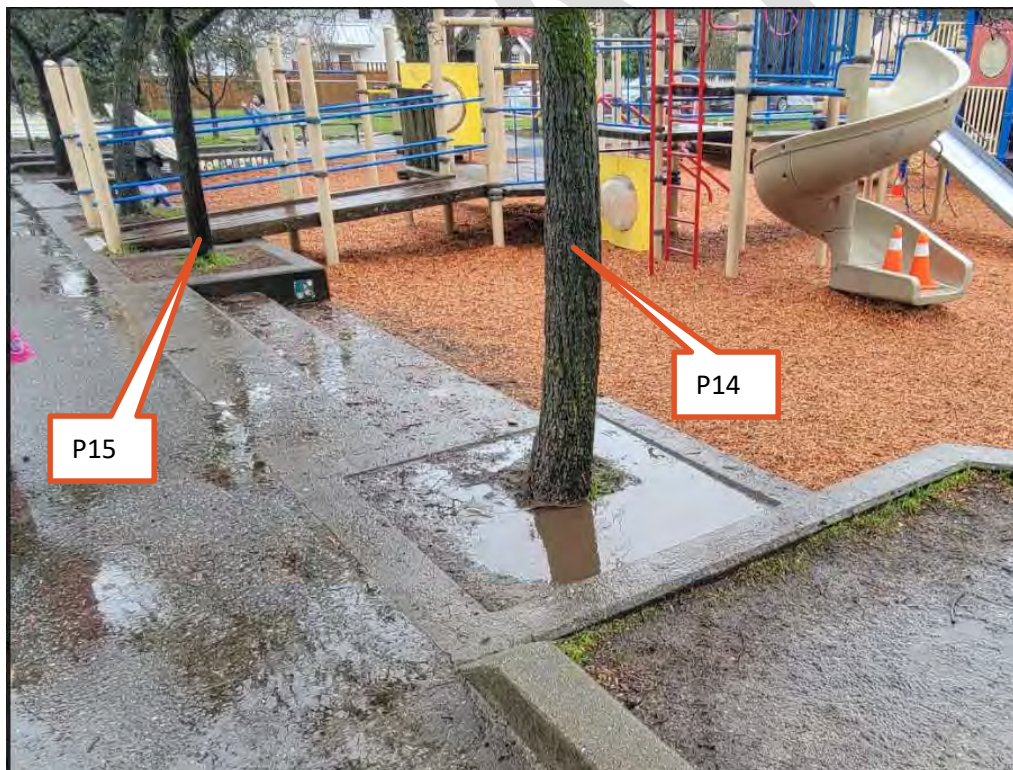
Photograph 12. View looking at the saturated soils at the base of trees near the play area.

Parks trees are identified as P1 through P18 (Photos 10 through 13). Trees P1, P3, P4, and P5 are Incense cedar (*Calocedrus decurrens*) trees that meet the city's definition of an exceptional tree. The soils below all of the park's trees is highly compacted. This has reduced the drainage capacity of the soil (Photo 12). All of the trees are located sufficiently away from the Seattle Public Schools property where redevelopment is unlikely to have a negative impact on tree health or structure.

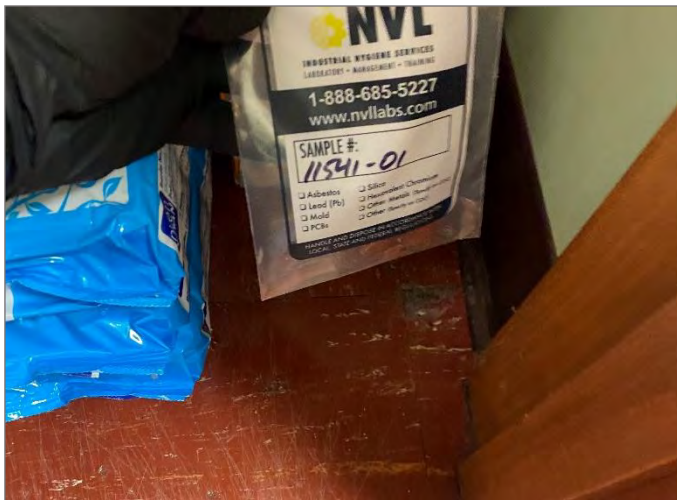
Photo #1: Sample 11541-01: **ACM Red 9'x9' vinyl tile (6% Chrysotile)** on black mastic (on concrete)
Location: Throughout Office
Quantity: 3,000 SF

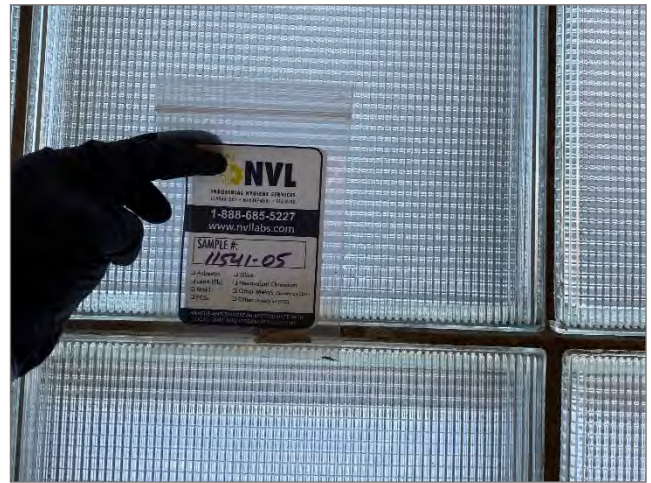
Photo #2: Sample 11541-05: **ACM Gray caulking (3% Chrysotile)** on fogged glass window 4'x11' w/ 1'x1'x6" glass panes
Location: Throughout west-facing side of school
Quantity: 792 LF

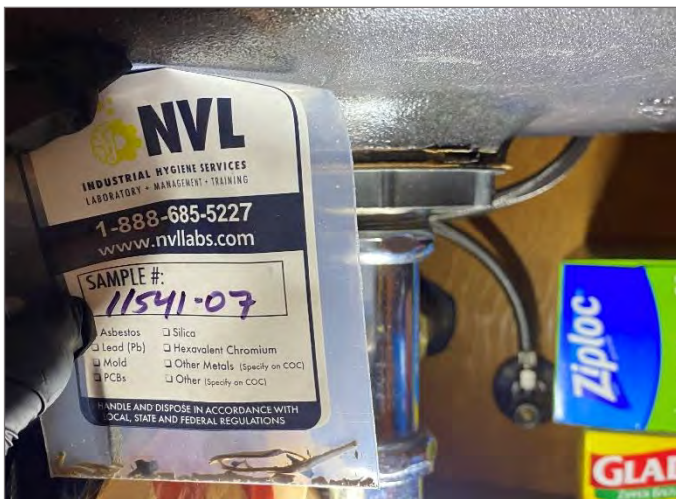
Photo #3: Sample 11541-07: **Black rubber sink gasket** on **ACM yellow mastic (4% Chrysotile)** on yellow paper (on metal pipe 2" OD)
Location: Throughout
Quantity: 7 EA

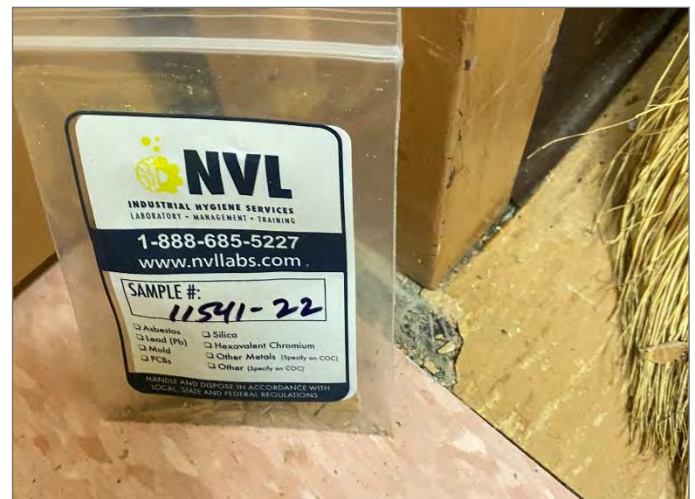
Photo #4: Sample 11541-22: **Various colored 9'x9' vinyl composite tile & various colored 12'x12' vinyl composite tile** on **ACM black mastic (3% Chrysotile)** on concrete
Location: Throughout 1st Floor
Quantity: 24,000 SF

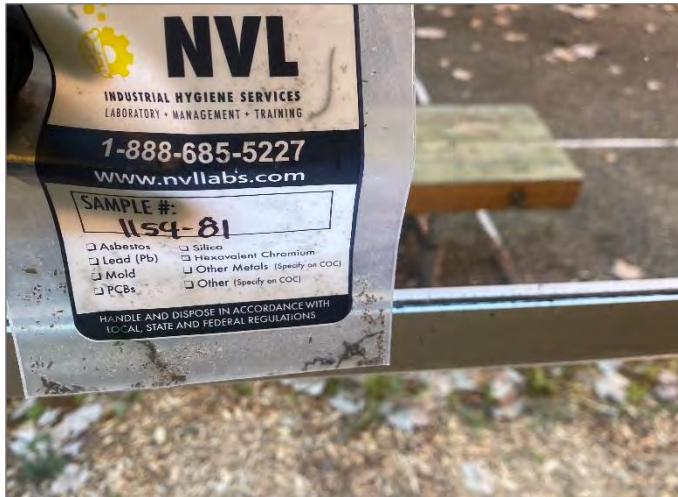
Photo #5: Sample 11541-81: **ACM Black window caulking (2-3% Chrysotile)** on metal frame windows 7'x7'

Location: North Central Corridor

Quantity: 150 SF

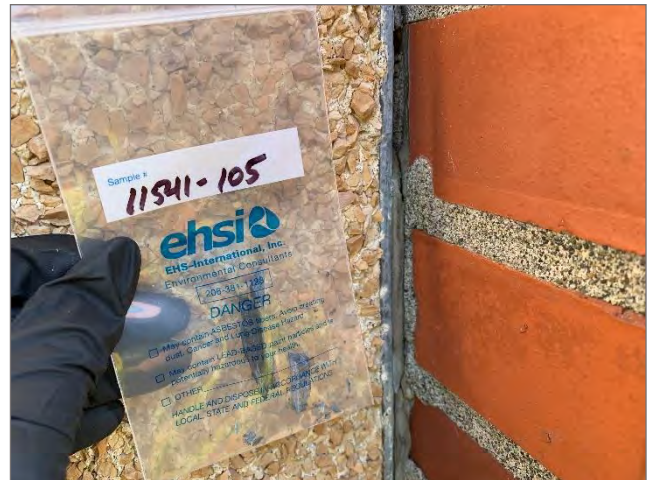
Photo #6: Sample 11541-105: **ACM Gray caulking (2% Chrysotile)** joining brick/marblecrete

Location: Throughout exterior

Quantity: 550 LF

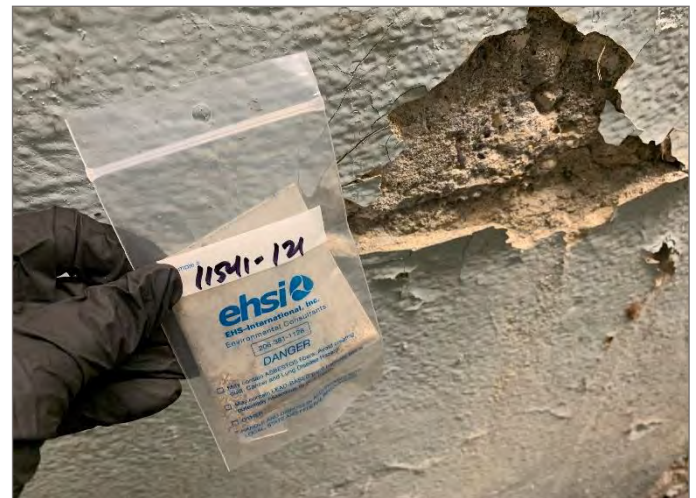
Photo #8: Sample 11541-121: **White skim coat (2% Chrysotile)** on concrete walls

Location: Boiler Room

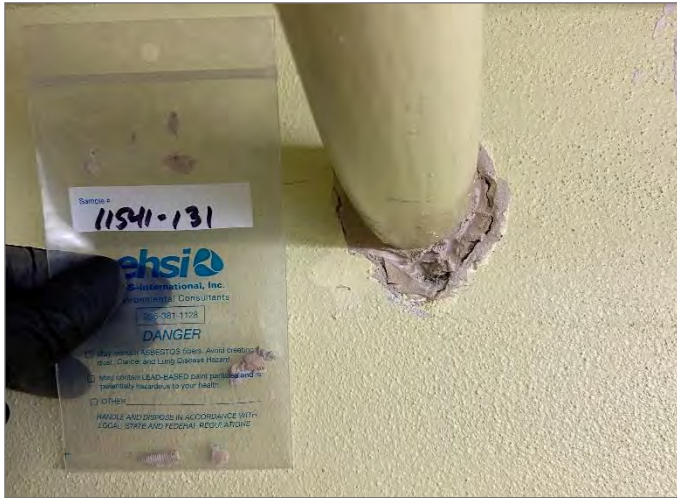
Photo #9: Sample 11541-131: **ACM Beige firestop (2% Chrysotile)** on GWB
Location: Stock Room
Quantity: <2 SF

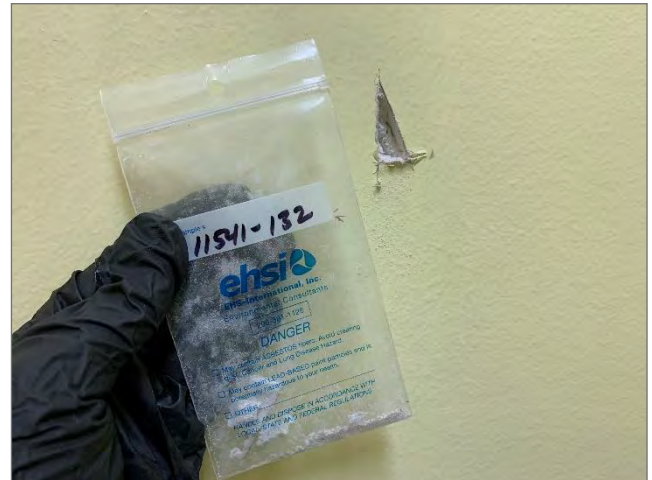
Photo #10: Sample 11541-132: **ACM White jc (2-3% Chrysotile)** on GWB
* <1% when composited as part of GWB system
Location: Throughout First Floor
Quantity: 4,000 SF

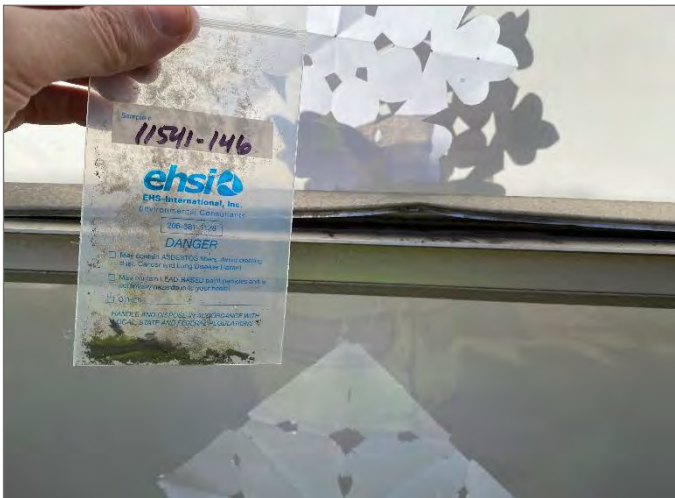
Photo #11: Sample 11541-146: **ACM Gray caulking (4% Chrysotile)** on metal frame window 5'x7'
Location: Throughout Exterior
Quantity: 540 SF / 30 EA

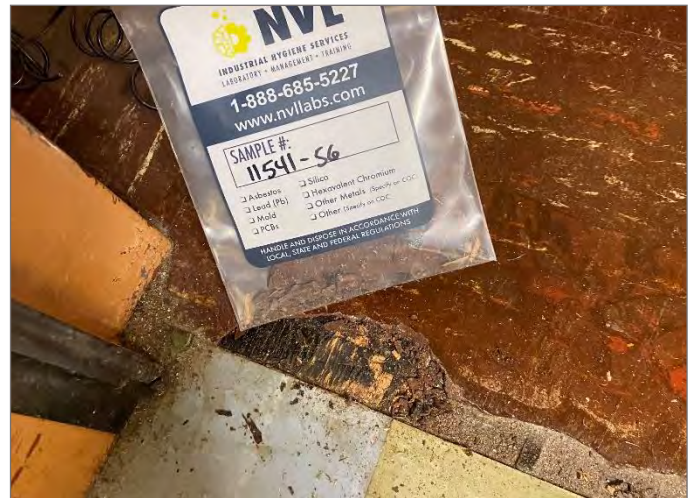
Photo #12: Sample 11541-56: **ACM dark brown 9'x9' vinyl tile (3-4% Chrysotile)** on black mastic (on wood)
Location: Throughout Second Floor
Quantity: 260 SF

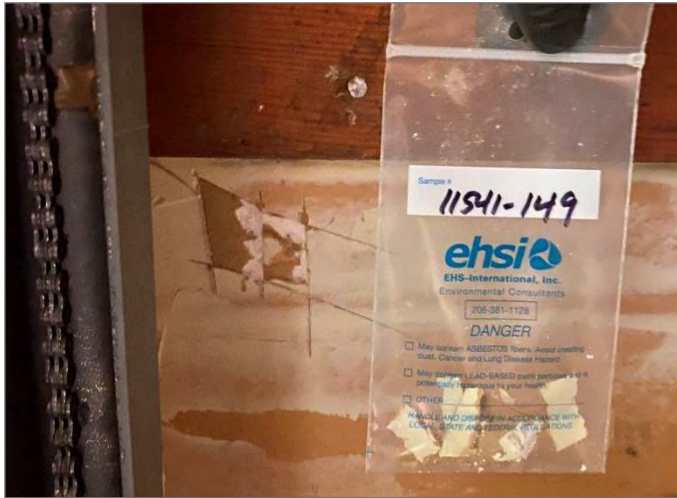
Photo #13: Sample 11541-149: **ACM White jc (2% Chrysotile)** on **GWB**
***<1%** when composited as part of **GWB** system
Location: Throughout Second Floor
Quantity: 5,600 SF

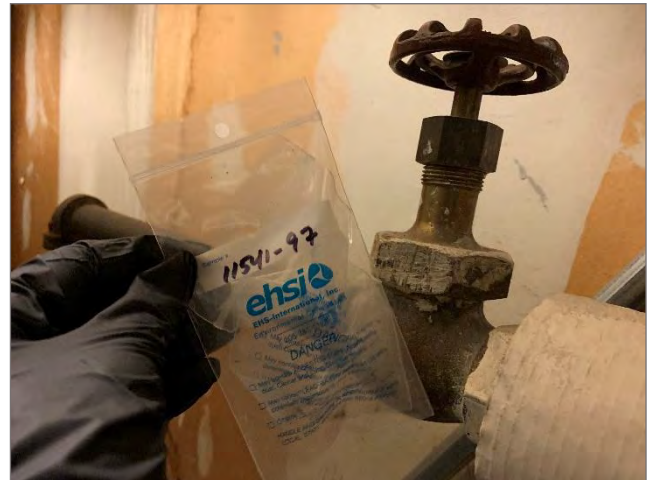
Photo #14: Sample 11541-97: **ACM Residual TSI (<1-20% Chrysotile, 15% Amosite)** on pipe
Location: Throughout
Quantity: 5 SF

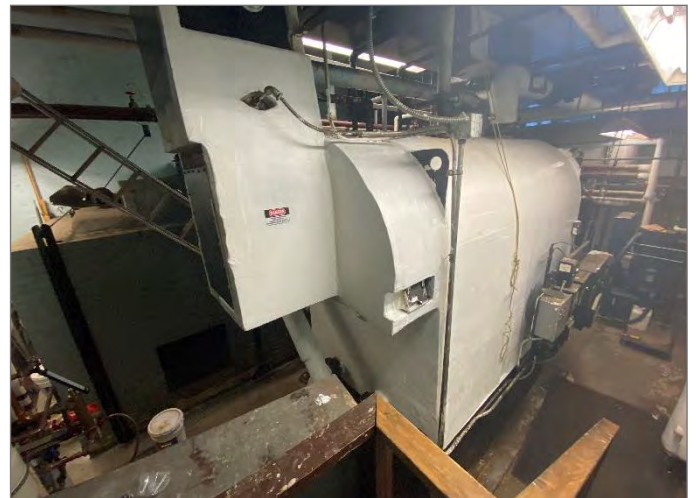
Photo #16: Assumed ACM painted TSI on boilers/equipment
Location: Boiler Room
Quantity: 1,033 SF
