**STATE ENVIRONMENTAL POLICY ACT
DETERMINATION OF NONSIGNIFICANCE (DNS)
NORTHGATE ELEMENTARY SCHOOL PROJECT**

Northgate Elementary School Project

Final SEPA Checklist

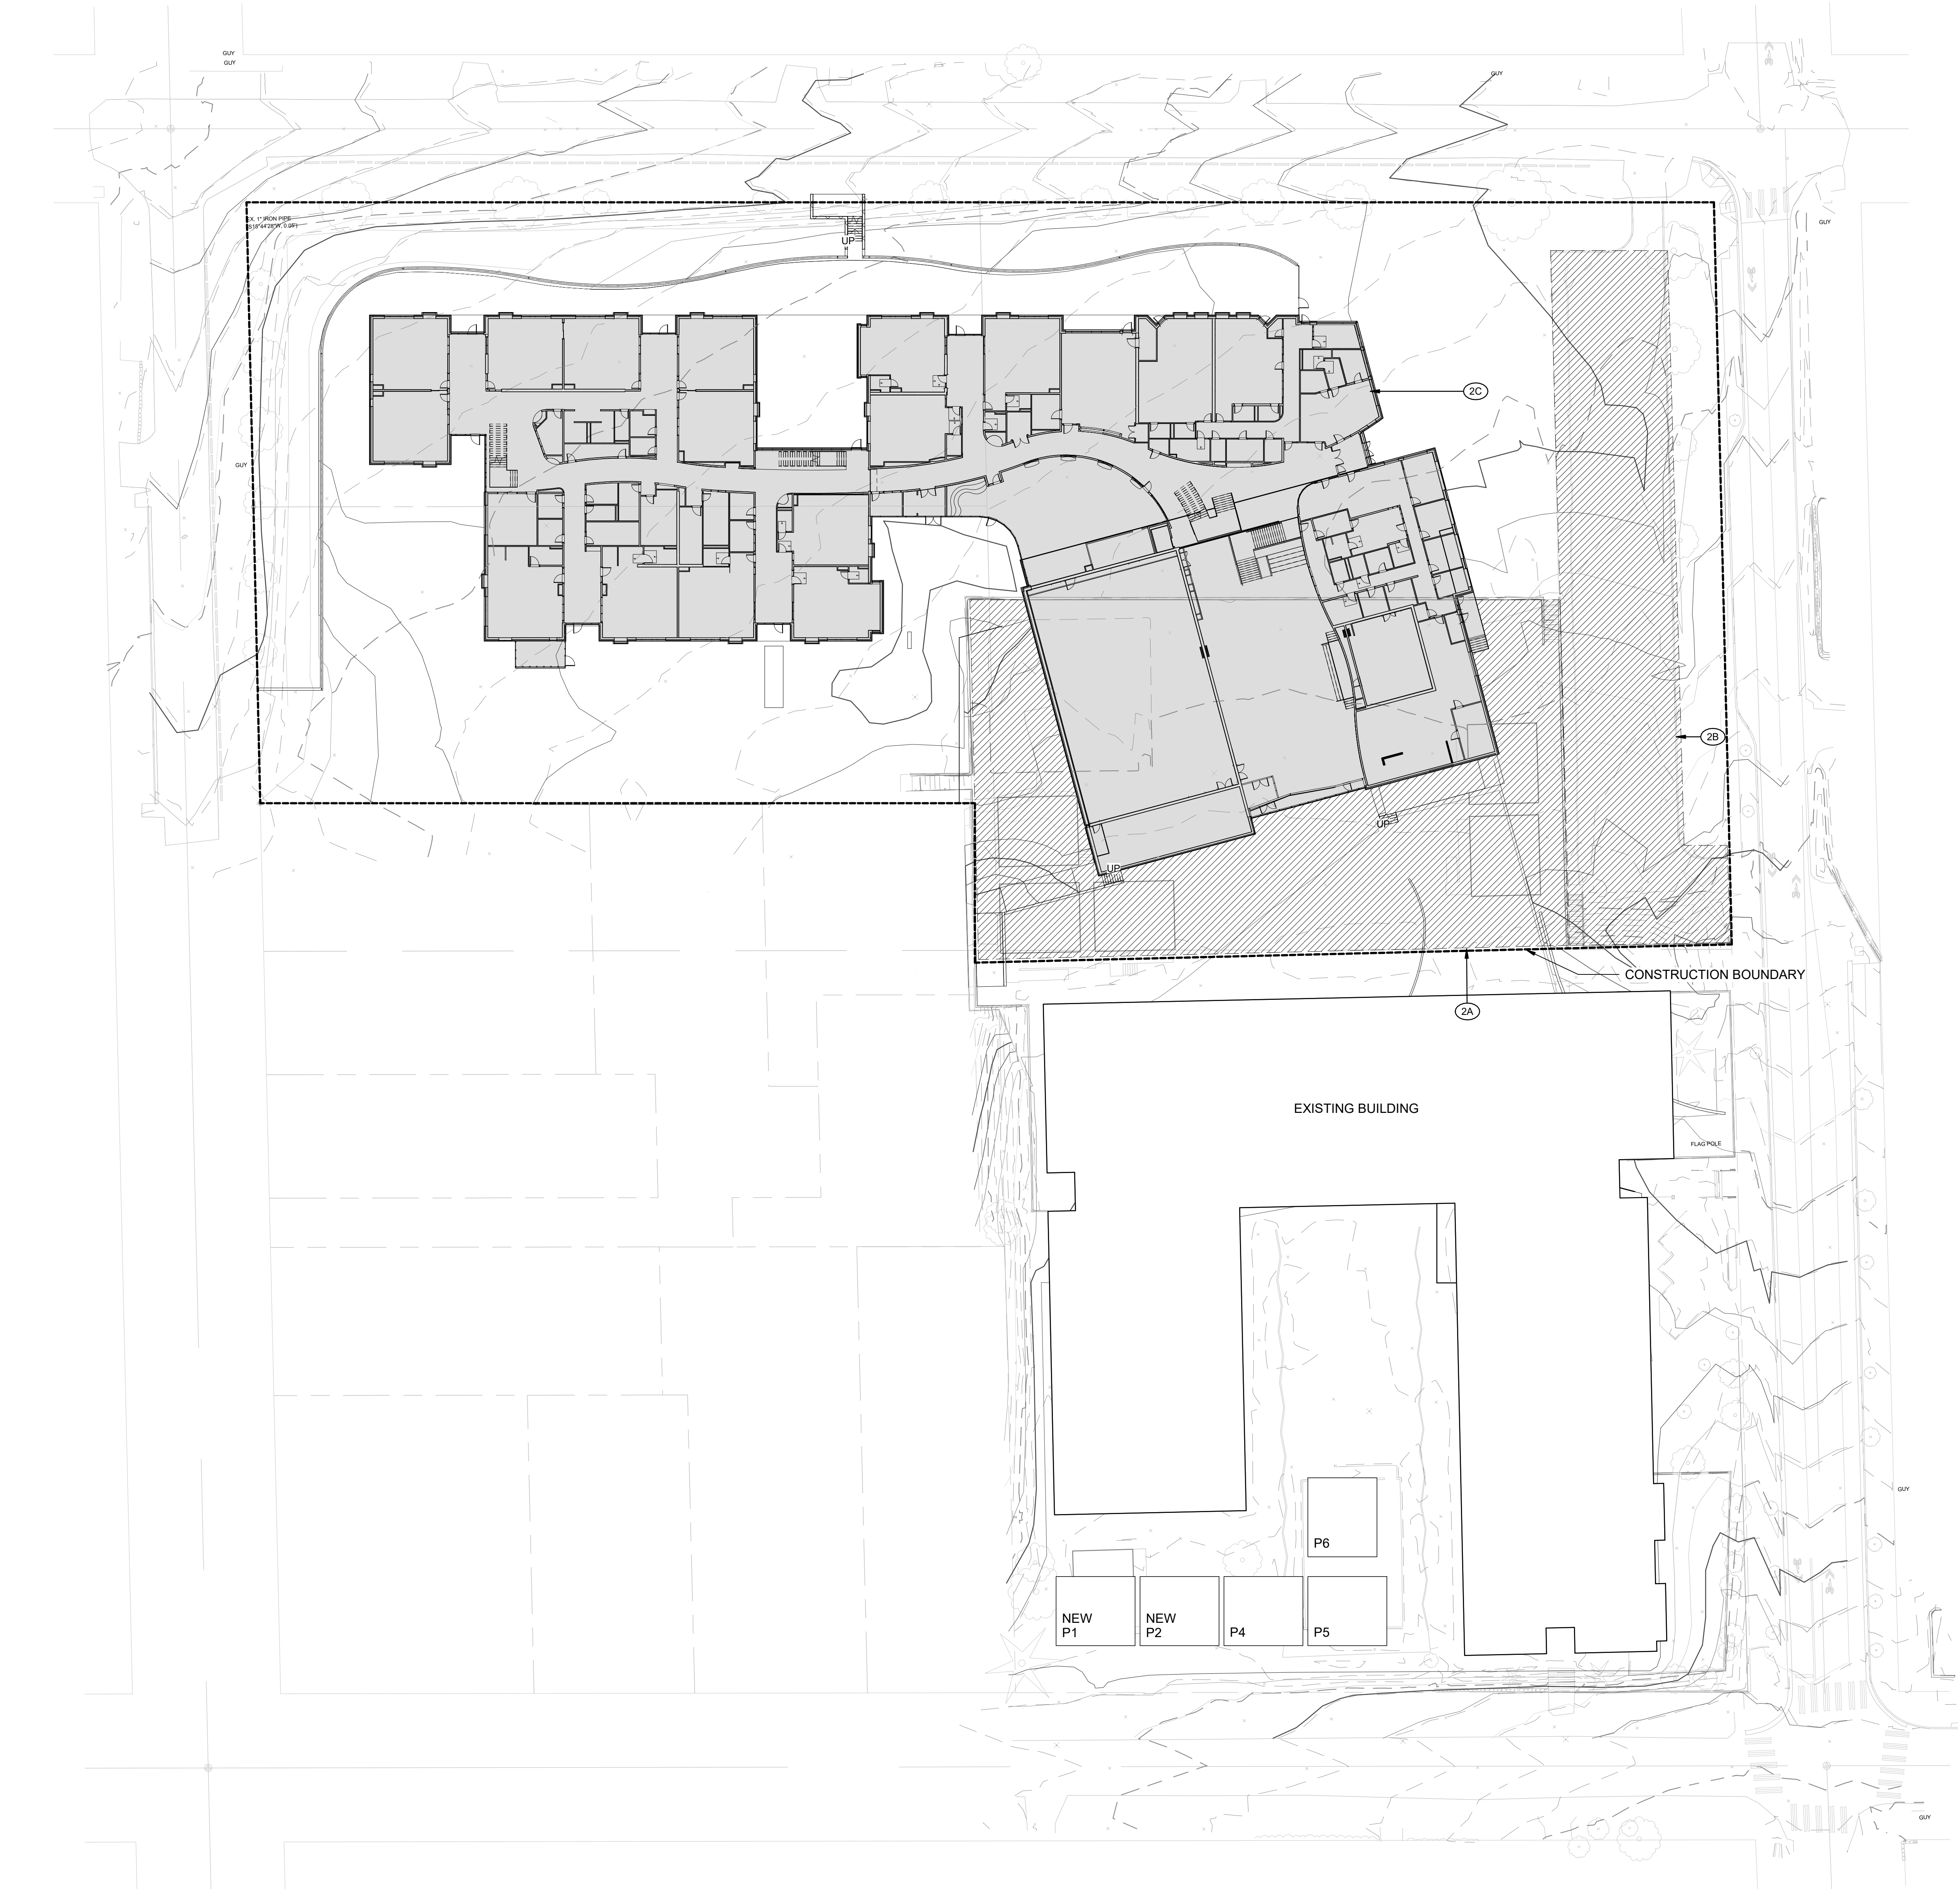
PHASING PLAN 2 - CONSTRUCTION
Scale: 1" = 30'-0"

- PHASING PLAN - NOTES**
- (PHASE 1) EXISTING PORTABLES 1, 2, & 3 DEMOLISHED ON-SITE. EXISTING PORTABLES 4, 5, & 6 RELOCATED ON-SITE TO THE SOUTH OF THE EXISTING BUILDING ALONG WITH 2 NEW PORTABLES. PORTION OF LANDSCAPING WALL DEMOLISHED AND TEMPORARY FENCING CONSTRUCTED TO CREATE TEMPORARY PLAY AREA.
 - (PHASE 2) EXISTING PLAY YARD DEMOLISHED. NEW BUILDING CONSTRUCTED NORTH OF EXISTING BUILDING.
 - (PHASE 3) FINAL SITEWORK IS COMPLETED. EXISTING SCHOOL BUILDING DEMOLISHED AND NEW PLAY FIELDS CONSTRUCTED.

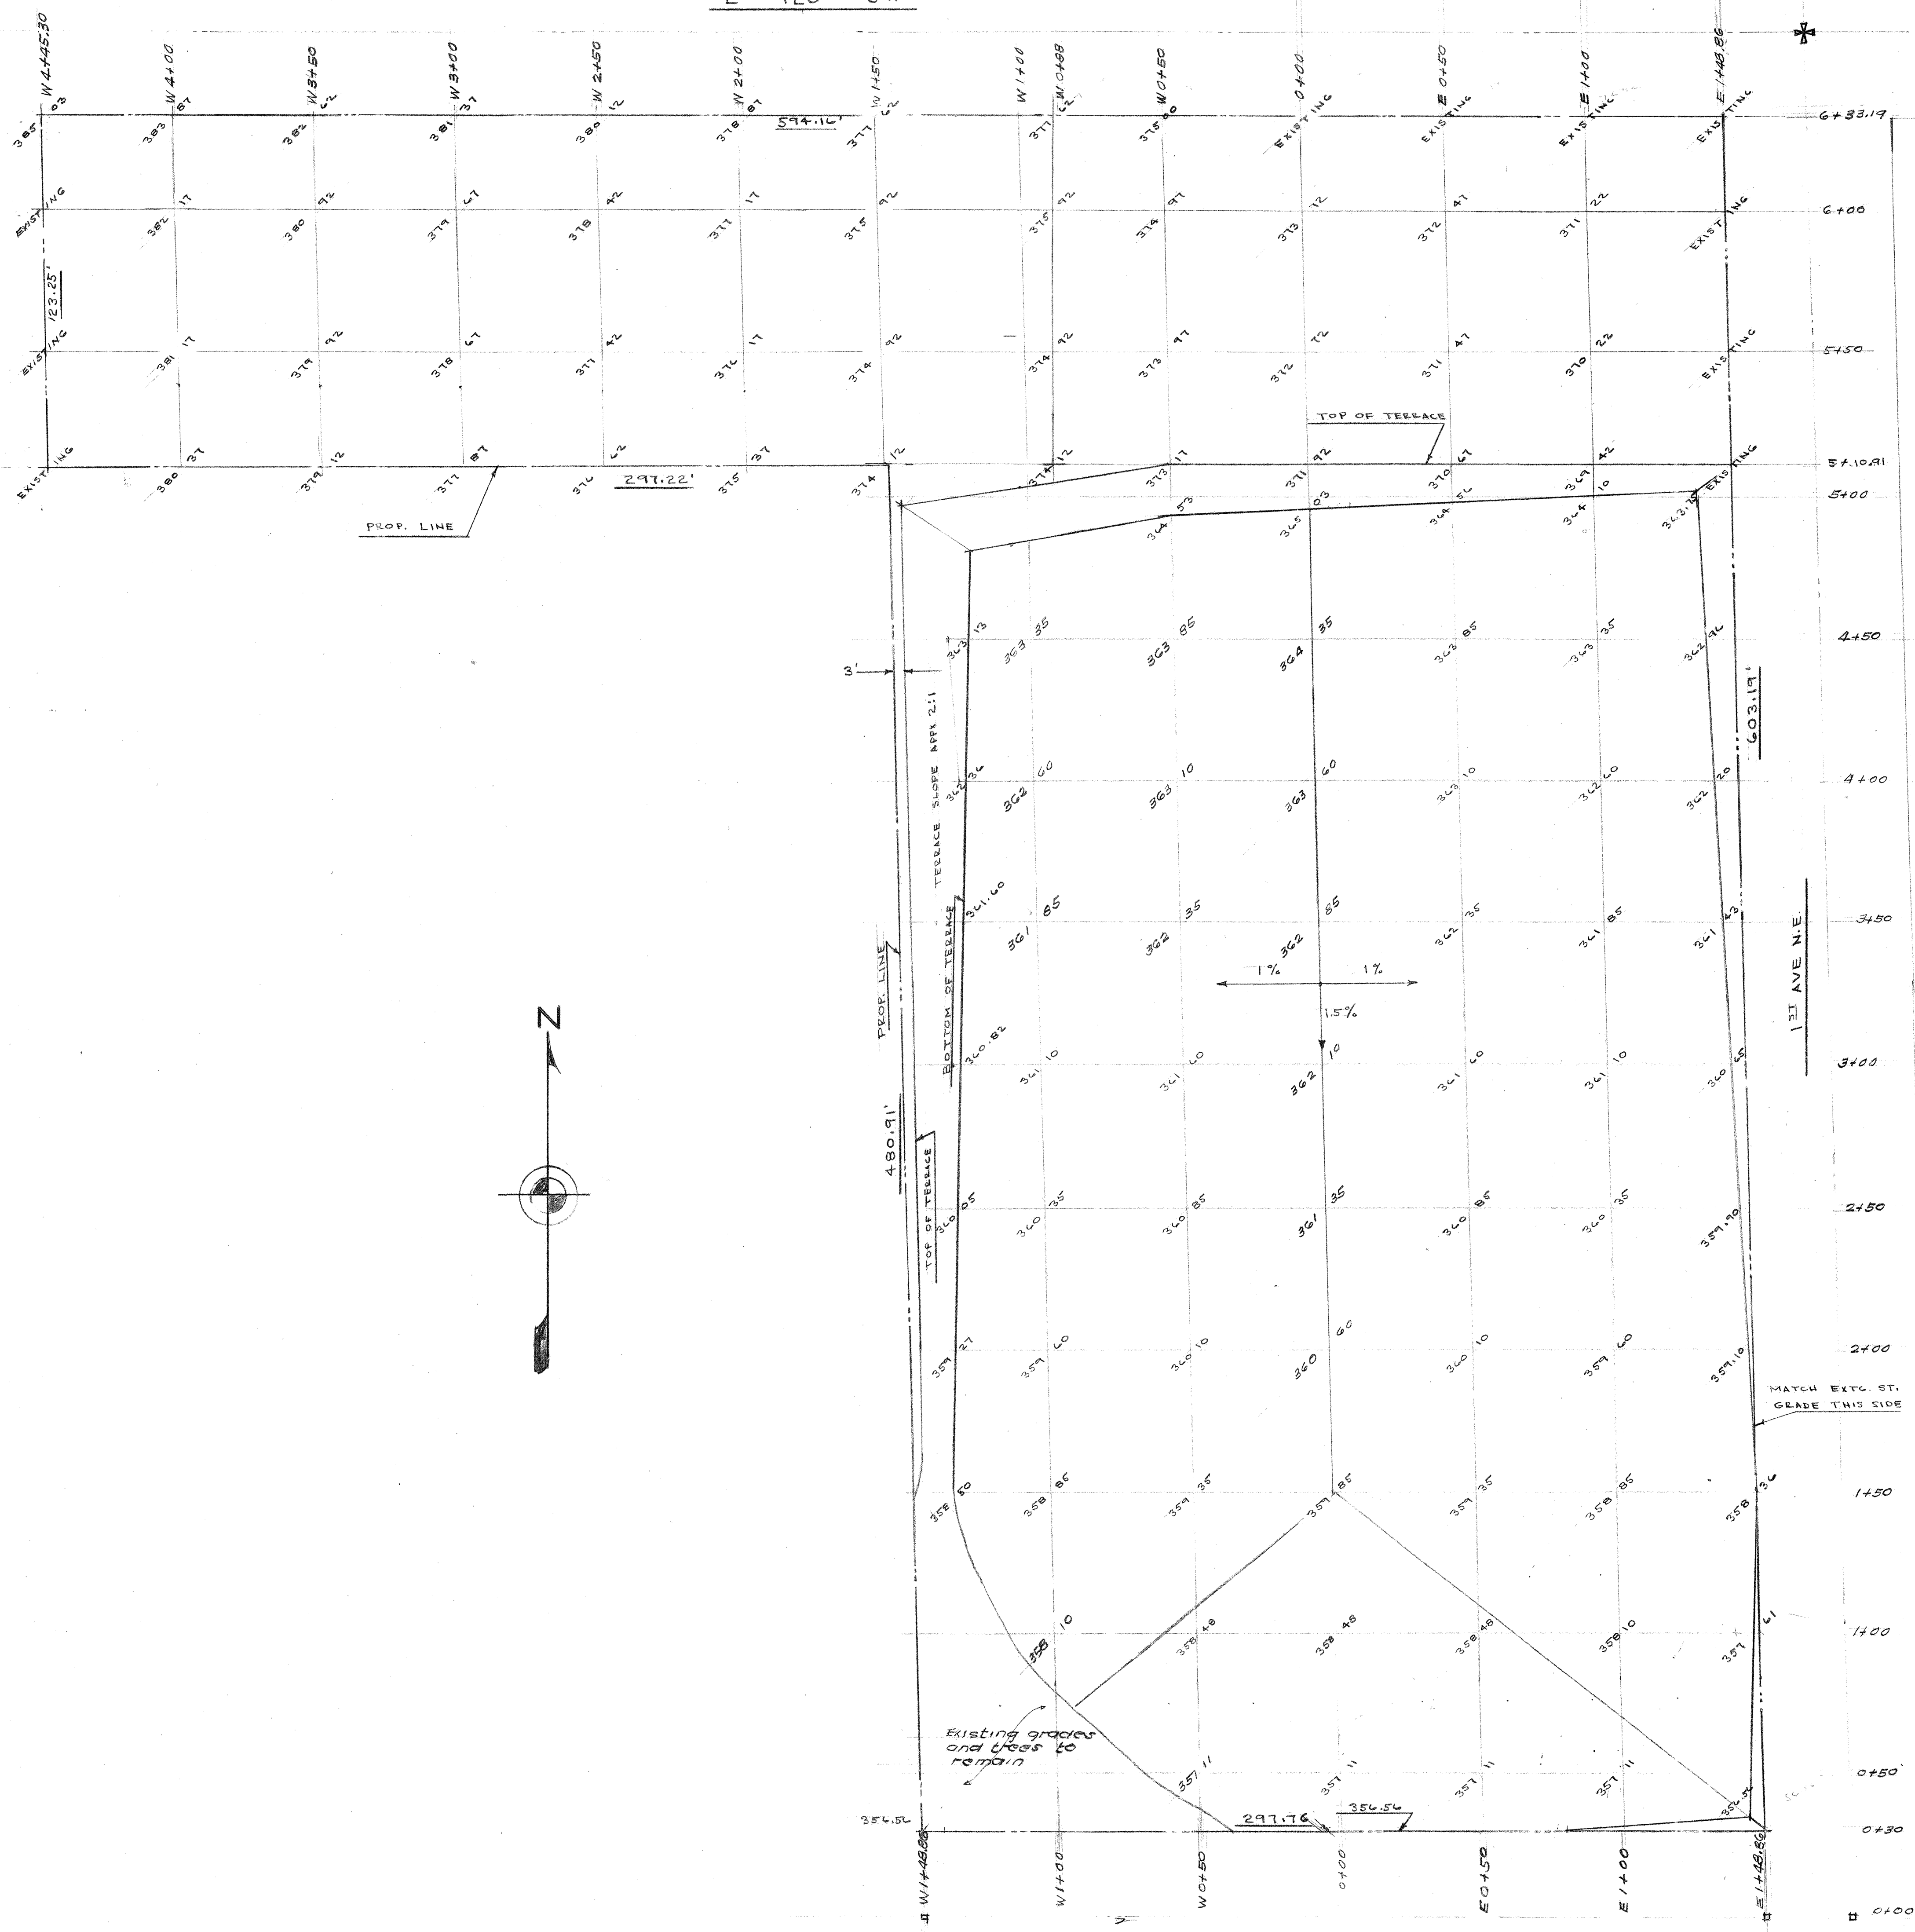
SOUTH HALLER LAKE SITE			
GRADING PLAN			
DATE 6-24-53	SEATTLE SCHOOL DISTRICT NO. 1 MAINTENANCE DEPARTMENT O. A. CHRISTIANSON, Director 810 DEXTER AVENUE SEATTLE, WASHINGTON		SHEET NO. 1 OF 1
DRAWN BY W.L.	APPROVED		DATE
CHECKED BY	APPROVED		DATE
BUSINESS MANAGER

NOTE
ALL ELEVATIONS SHOWN ARE FINISHED GRADES.
SEE SURVEY SHEET FOR ORIGINAL GRADES.
CUT EQUALS FILL
OWNER'S ESTIMATE OF VOLUME OF CUT 9,500 CY.
CONTRACTOR SHALL VERIFY THE ABOVE
FIGURE & BASE HIS BID ON HIS OWN CALCULATIONS.
NORTH PORTION SHALL BE GRADED PRIOR TO
SOUTH PORTION.
ELEVATIONS SHOWN ON LOWER LEVEL ARE
LOWER THAN SHOWN.

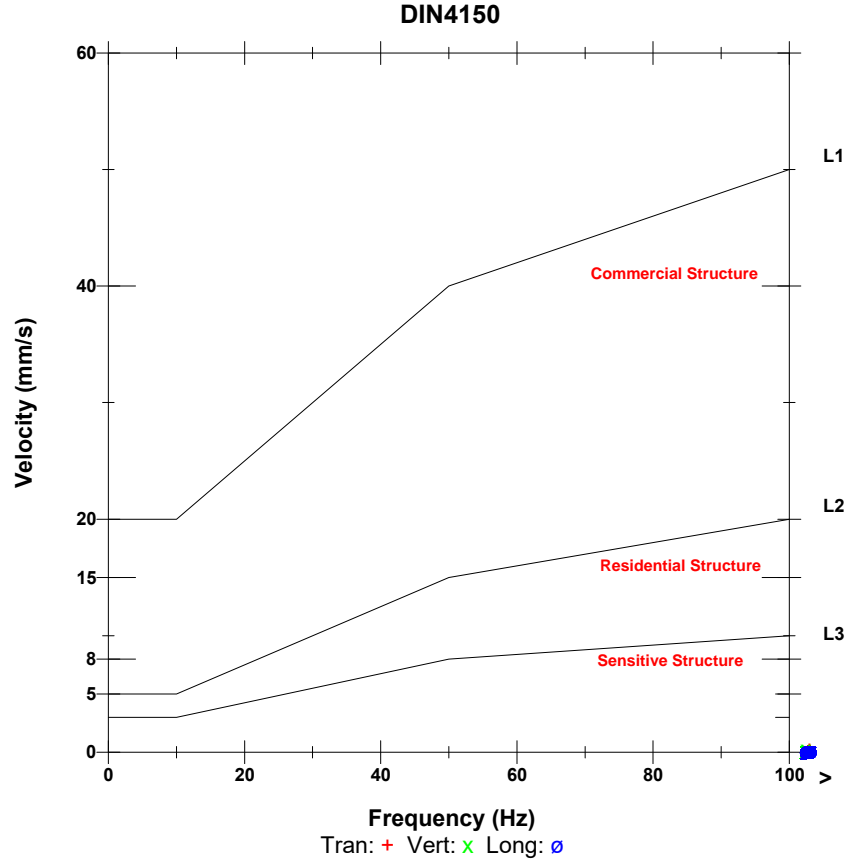
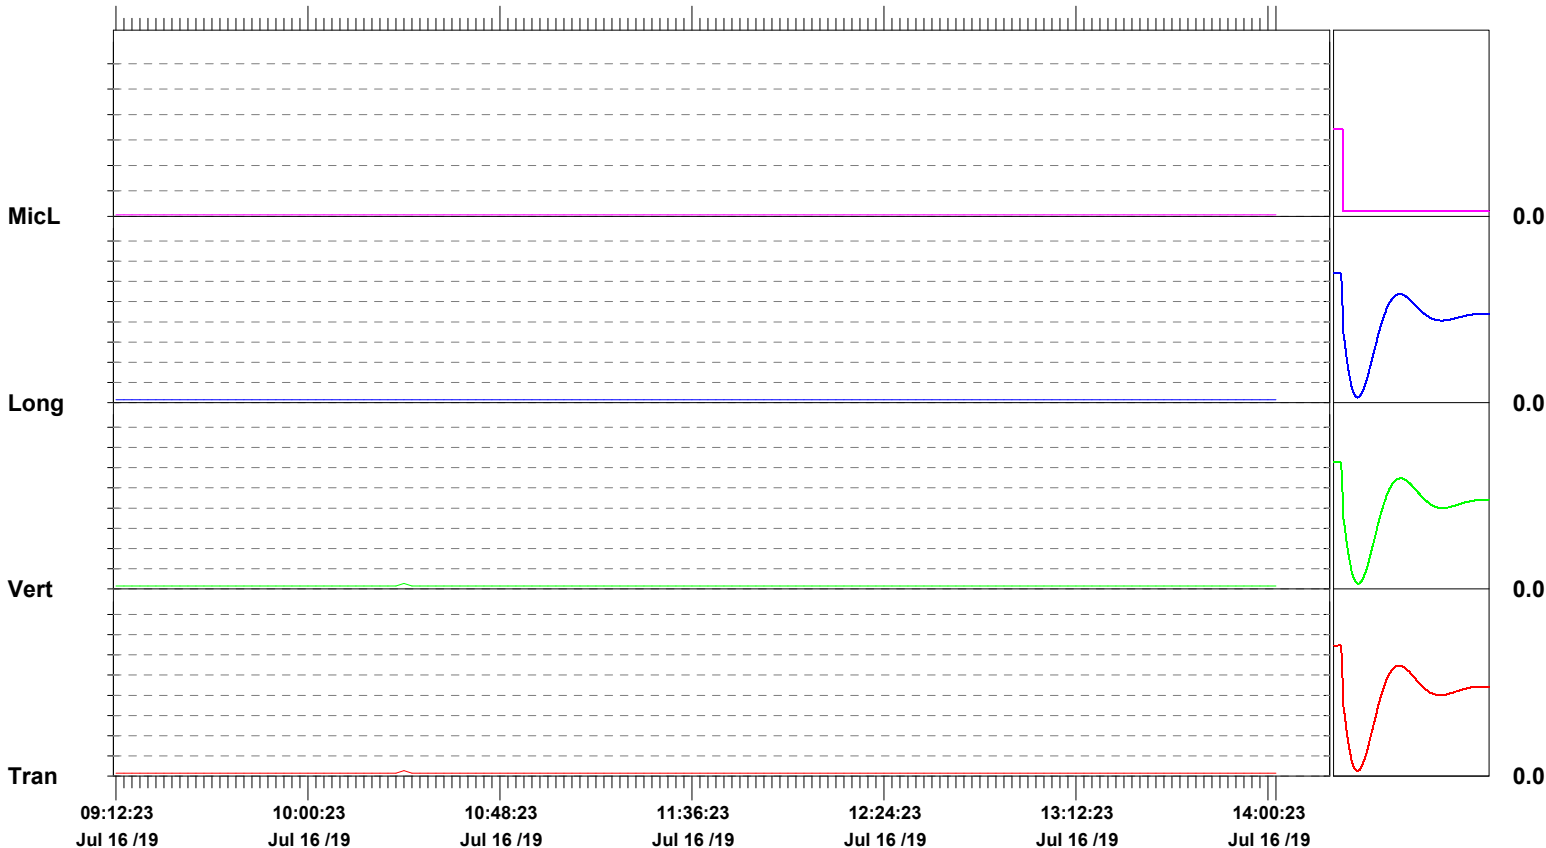
Peak Vector Sum 0.381 mm/s on July 16, 2019 at 10:22:38
N/A: Not Applicable

Time Scale: 2 minutes /div **Amplitude Scale:** Geo: 1.000 mm/s/div Mic: 5.000 pa.(L)/div

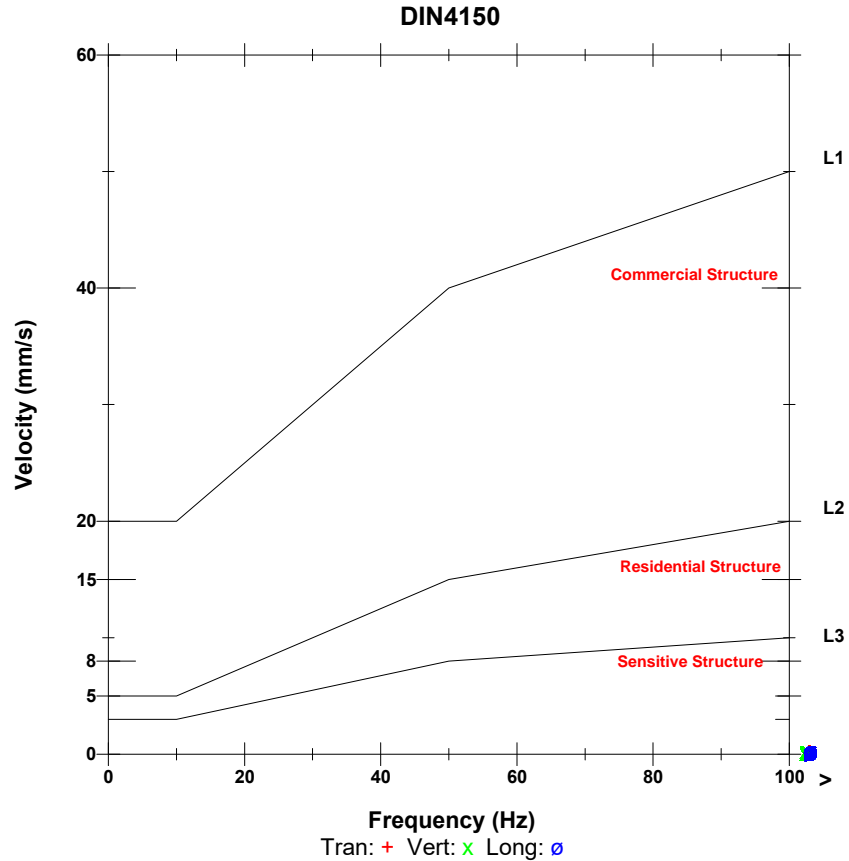
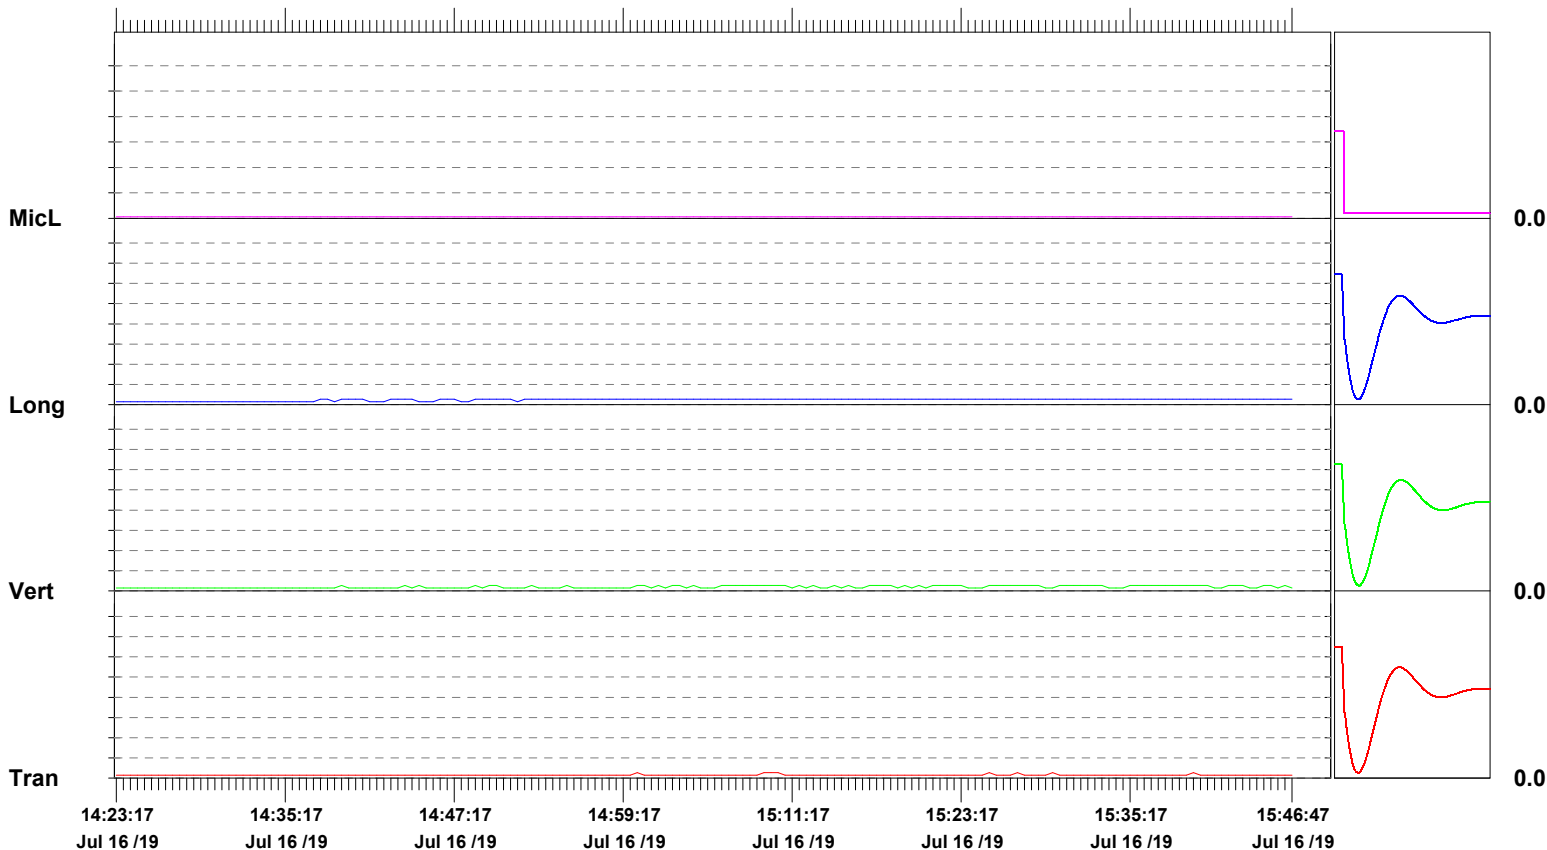
Peak Vector Sum 0.381 mm/s on July 16, 2019 at 15:09:17
N/A: Not Applicable

Time Scale: 30 seconds /div Amplitude Scale: Geo: 1.000 mm/s/div Mic: 5.000 pa.(L)/div

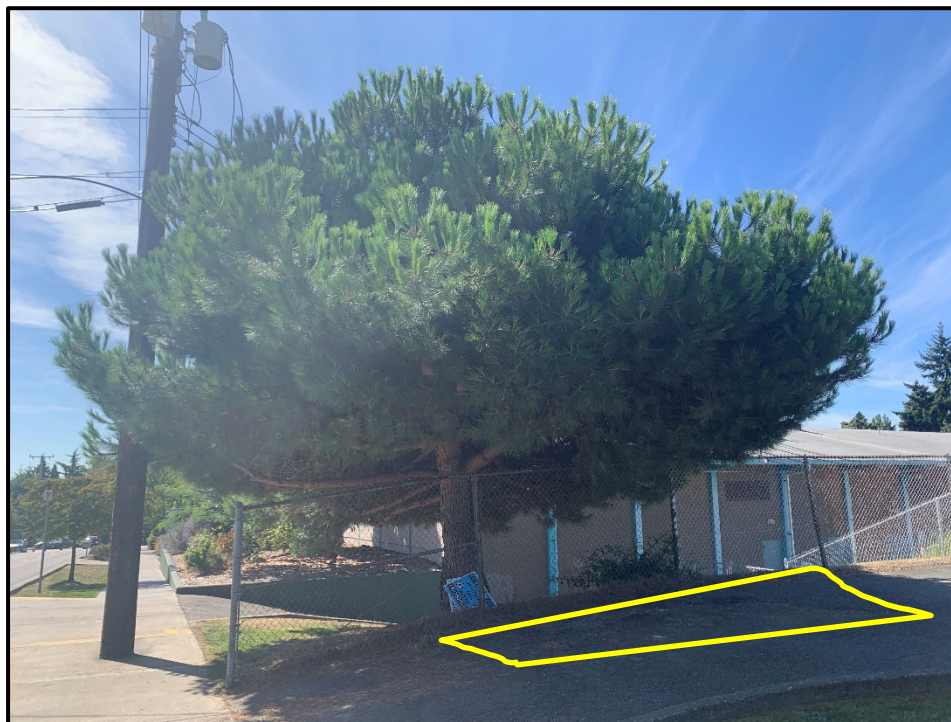
Photo 2a. Tree 424, an exceptional Japanese red pine, has structural roots in conflict with asphalt to the east (yellow).

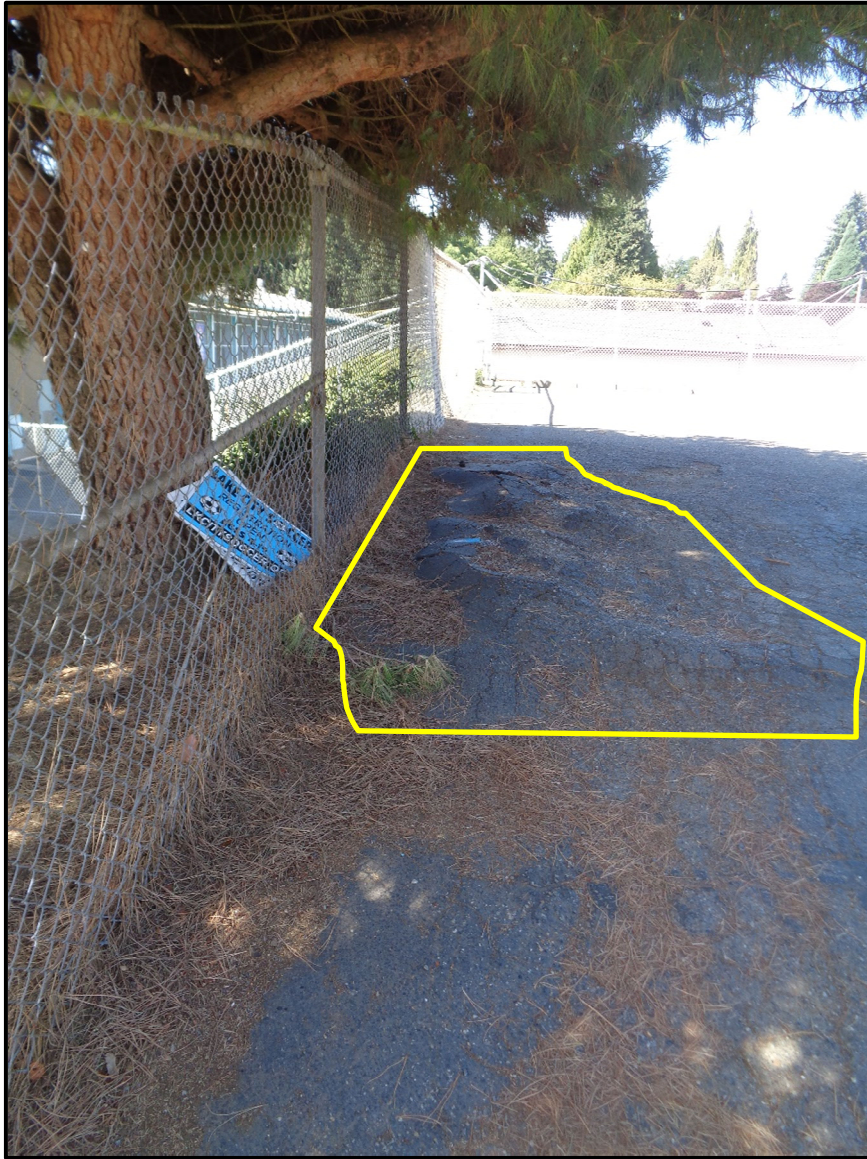
Photo 2b. Detail of structural roots of tree 424 in conflict with asphalt to the east.
